Welding Saved Foreign Exchange

By J. JAIN*

I. Repair of Forge Hammer

II. Repair of Rollers for Isothermal Annealing Furnace

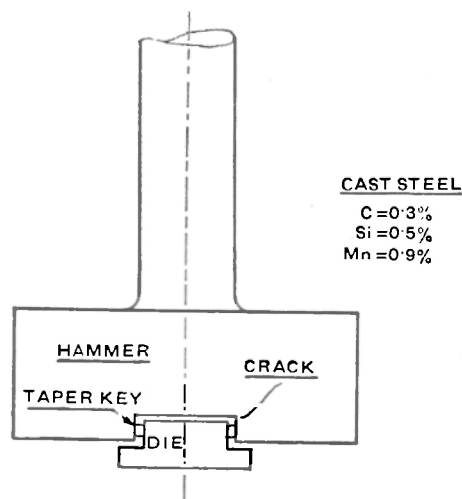
Fig-1

The forging dies are held in the inverted piston head by means of solid taper keys (Fig. 1). The hammering of these keys into the dovetail causes uncontrolled impact loading on its sides. After about 12 years of service, cracks were detected at the dovetail corners. These cracks ran quite deep into the hammer.

It was decided that the cracked portion would be machined out completely and a new block would be fitted there. The design of the new block was considered to be an important factor. The block has to withstand the impact of forging as well as the forces coming into play due to hammering-in of the keys for changing and setting the dies.

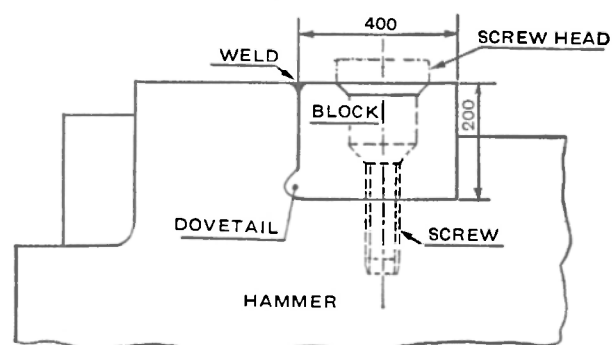
Fig-2

The block was designed in such a way that it is joined with the main body by (i) dovetailing, (ii) screwing and (iii) welding (Fig.2).

The block dimensions are 200×400×1000 mm.

After about one year of service the other side of the dovetail cracked. The cause of the failure was believed to be the fatigue of the hammer material.

1. For dovetailing, a liberal radius was given at the corner and the block slipped inside.

2. The block was drilled and tapped together with the hammer body. Six holes of varying depths were located in a zig-zag manner. Six nos. of reinforcing bolts of varying length were screwed into their respective holes. The heads were afterwards gouged out carefully as shown in the fig. All round the block, V-preparation with an opening of 70° and a depth of 50 mm was done by oxy-cutting and grinding.

(a) Electric arc hand welding process was used for welding the studs and the block. On the basis of the chemical composition and the mechanical strength of the hammer low hydrogen electrodes were selected.

(b) The studs were welded with the block. The head cavities were filled with the weld material. The block was then welded all around with the hammer.

(c) Care was taken not to heat the hammer excessively. Deformations were not appreciable due to low heat input. Weld surfaces were finish ground afterwards. Special care was taken to avoid undercuts and to keep the surfaces free from stress concentration points. Testing of weldments was thought not to be necessary.

This side of the hammer was also repaired in the same way as the first side.

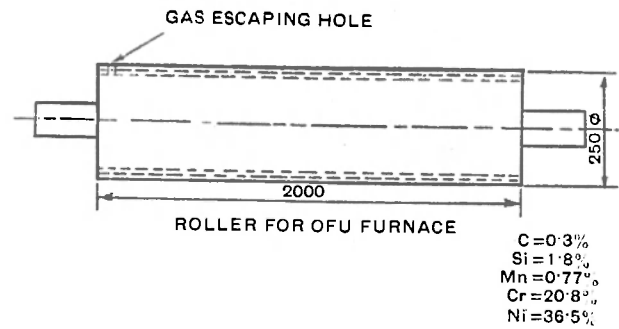
Fig -3

The furnace was supplied to Telco's Forge Division by OFU, Ofenbau Union., West Germany. It is used for heat treatment of forged components. The operating temperature is 1050°C. For continuous transport of the annealing components, it has got rollers of about 250 mm. (Fig. 3). The furnace has cost the Company about 4 million rupees in foreign exchange.

After about 6 months of service, it was found that 6 transporting rollers were damaged. Four of them showed longitudinal as well as circumferential cracks but the remaining two had burst due to explosion. The failure of these rollers could have been due to :

The chemical analysis of the material was found to be 0.51% C, 1.8% Si, 0.77% Mn, 20.8% Cr and 36.5% Ni. which conforms to the specifications given by the supplier.

These rollers are centrifugally cast. The damaged rollers showed two layers, the thickness of the outer layer being 9 mm and that of inner layer being 7 mm. The furnace, during its 6 months of operation, worked at below its operating temperature of 1050°C. The conveyor was also never reported stuck during the operations. The rollers were provided with gas-escaping holes, located on the charge carrying area. These were found to be blocked with scale and rust. A high pressure must have built up inside the rollers, resulting thereby in the rupture of the roller material.

Luckily, two spare rollers were available with the furnace. It was decided to replace the two broken rollers with these spare rollers. The badly deformed and damaged portions of the other four rollers were parted off by sawing and then replaced by the good portions taken out from the two broken rollers. These were joined by electric arc hand welding. Some imported electrodes of similar composition were also readily available. The deformation of rollers caused by bursting was taken into account and carefully corrected during the assembly. With proper welding sequence and care, the rollers were then welded.

The gas escaping holes were shifted from the charge-carrying area to the end supports under the brick wall to avoid their blocking due to scale and dust in future.

After welding the cut pieces to the rollers, they were heated to about 800°C and straightened mechanically. They were rolled under a heavy weight of a loco frame slab.
