# Parent Metal Cracking in a Combination Weld Tube

Crack formation, due to improper preheat treatment, in combination welds of tubes, for superheater block assembly is analysed.

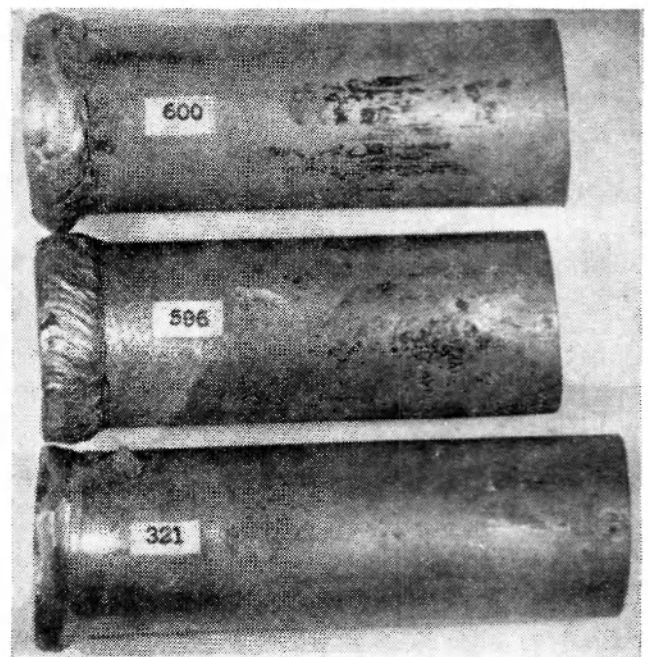
Steel tubes, size 35×5.6 mm and specification 10CrMo 910 of DIN 17175 (2¼Cr, 1%Mo steel) were welded with tubes 38×6 mm of CSN 415123.1 (½%Cr, ½%Mo, ¼%V steel). The welding was carried out by arc welding process using CMB 83M electrode  $\phi$ 2.5 mm (Rutile type—equivalent to E 8013 Bl). Before welding, the joints were supposed to have been preheated to temperature of 150-250°C by flame torch. After sometime, circumferential cracks parallel to the weld were observed at the Heat Affected Zone of the 10Cr Mo910 tube side (Fig. 1). One of the three failed samples was taken for detailed investigation.

Fig. 1. Photograph showing cracks in the heat affected zone. Mag : IX

The material used and the welding consumables are as per the requirements and set procedure. The troostite martensitic structure as revealed by the micro examination and high hardness values at the heat affected zone is due to insufficient preheating temperature and which in turn has aided the cold cracking by Hydrogen. This could have been avoided if a little more care had been taken to maintain proper preheat temperature.

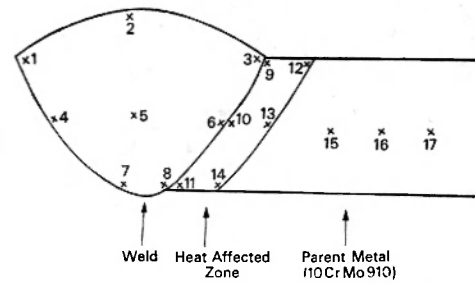
Sketch-A

Across the section, detailed hardness survey using a vickers diamond indenter was carried out at various zones of the welded piece (Ref. : Sketch-A)

Imp. No.	Position of Impression	Specimen from good portion	Specimen from cracked portion
1.	Weld	226	215
2.		232	215
3.		232	205
4.		226	238
5.		232	232
6.		226	244
7.		232	257
8.		232	250
9.	Fusion zone (10CrMo910)	386	340
10.		386	386
11.		392	386
12.		244	271
13.		250	271
14.	232	271	
15.	Parent Metal (10CrMo910)	183	179
16.		183	183
17.		187	183

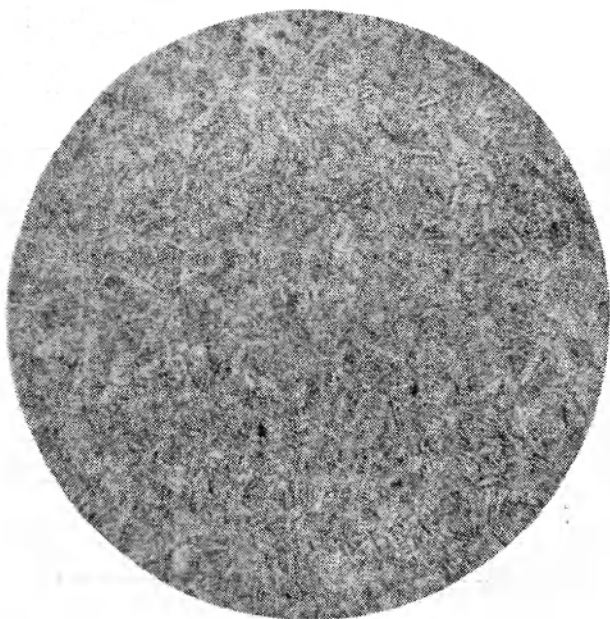
Sample No.	Position of specimen	Microstructure
596	Good Parent Metal portion (10CrMo910)	Banded structure of fine ferrite + pearlite. Grain size finer than ASTM 8.
	Weld	Columnar structure over a limited area at the top + refined grains at other regions.
	Fusion zone (10CrMo910)	Structure consists of Troostomartensite (Fig. 2).
	Failed portion	Structure similar to that of good portion (Fig. 3)

Fig. 2. Microstructure in the heat affected zone of S. No. 576-Good portion Etchant : 3% Nital Mag : 125X

The chemical analysis of the tube material and spectral analysis of the weld indicate that the recommended material and welding electrodes have been used. Hence possible deviation could have been due to the pre or post weld heat treatments. Since the failure has happened before post weld heat treatment, the only possible cause may be improper preheating. The microstructure consisting of Troostomartensite

and high hardness at the Heat Affected Zone confirms that internal stresses developed during the thermal transformation due to improper preheating temperature might have been one of the reasons for the heat affected zone cracking. The other possibility being the type of electrode used i.e. a rutile type electrode which is susceptible for hydrogen—cracking if proper precautions are not strictly adhered to.

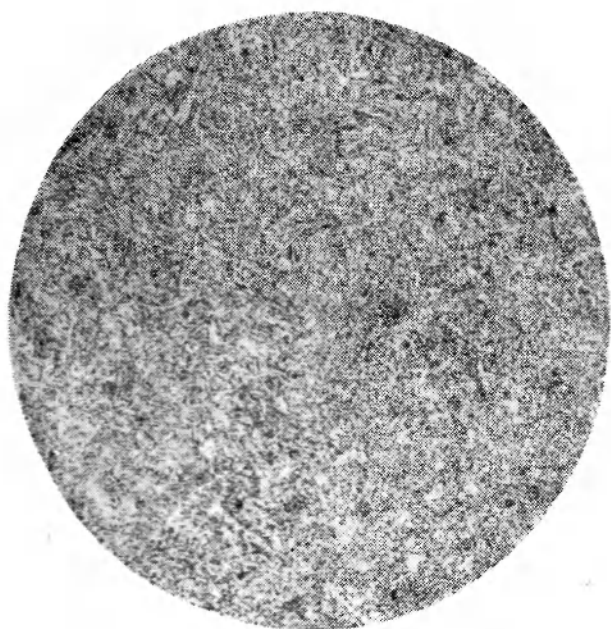
*Fig. 3. Microstructure of the fusion zone (PM + Weld) on S. No. 576-failed portion. Etchant ; 5% Nital. Mag : 125X*
