Total Quality Control Approach for reduction in percentage repair for new water conductor system khopoli

V. P. Amodekar

ABSTRACT

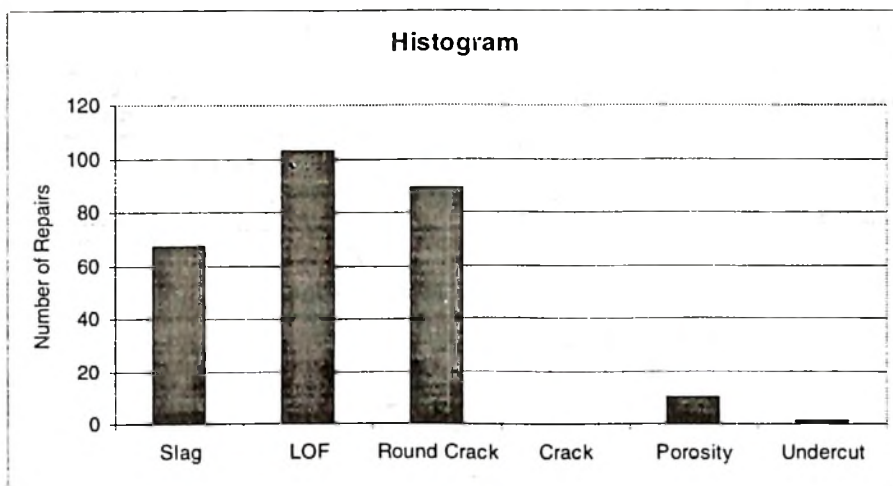
Fig. 1

Total Repair	Type of repair					
		Slag	LOF	Fish Eye/ Rounded crack	Crack	Porosity	Undercut
Long seam	142	35	58	47	0	2	0
Circular seam	128	32	45	42	0	8	1
Total	270	67	103	89	0	10	1

Table : 1

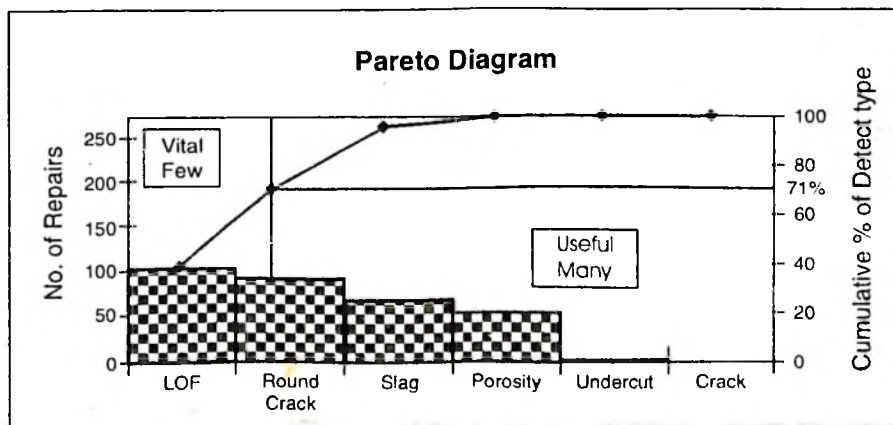
Fig. 2

- b) Lack of fusion, fish eye and slag were prominent defects
- c) Welding procedure employed was new for welders and employed for first time
- d) Improper storage and use of flux leads to fish eye type crack

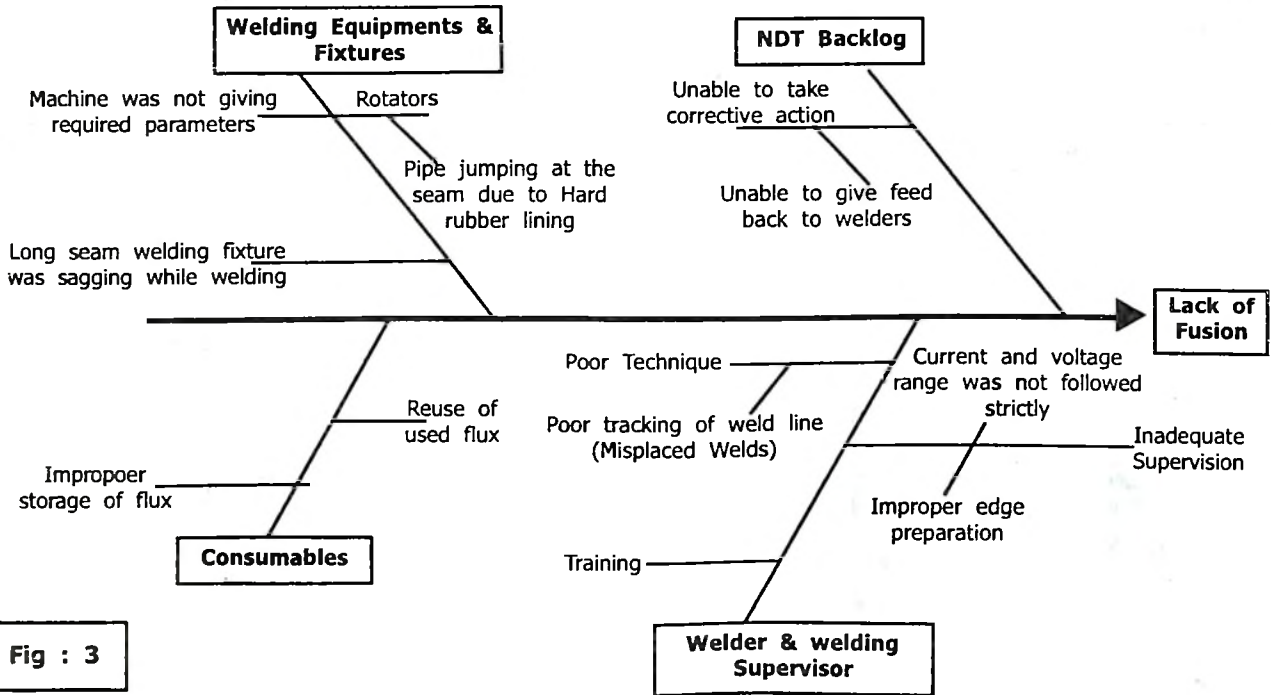
CAUSE EFFECT DIAGRAM FOR LACK OF FUSION

- e) Rotators had a problem, pipe was jumping while long seam passes rotators
- f) Welding machines were not giving required welding parameters.

g) Welding supervision was inadequate and less qualified

- a) Additional NDT contractors were mobilized to get the NDT done in time for immediate corrective action
- b) Old Welding machines were replaced with new machines
- c) Flux storage procedure given by manufacturer was followed with more care.
- d) Quantity of flux was increased while welding joints so that arc cover was increased.
- e) Long seam at the rotators were made flush by grinding to avoid jumping of pipe while welding circular seam.
- f) Additional welding supervisor were employed for night shift.
- g) Welder performance report was prepared monthly. Welders were warned if percentage repairs exceeded satisfactory level. The welders were disqualified if they were not able to improve performance even after repeated warnings. Feedback was given to welders, some times welders were warned and some welders disqualified on the basis of poor performance.

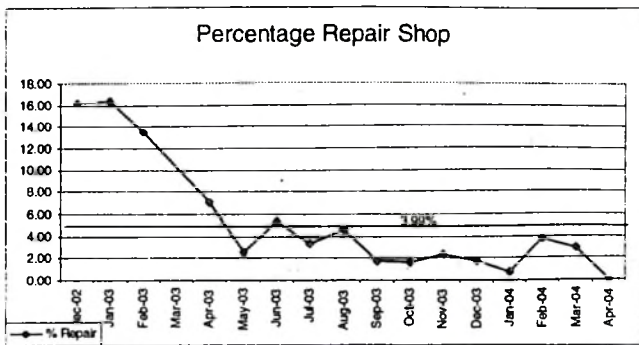
Fig. 6

The repair percentage was reduced from 16% to within 4% for following months as shown in figure 6. The before and after pareto diagram was drawn and as shown in figure 7. Similar exercise was done for erection repair percentage and monitored Below 4% as shown in figure 8.
