Reclamation By Welding - Improvement In Cost & Productivity

A. Dutta Roy, M. K. Sarkar & N. K. Sharma

Tata Steel, Jamshedpur - 831 001, India

Paper presented at the Seminar on " Welding in Steel & Allied Industries : Reclamation & Fabrication (WRF'98), July 16-17, 1999 at Jamshedpur, Organised by IIW, Jamshedpur Branch.

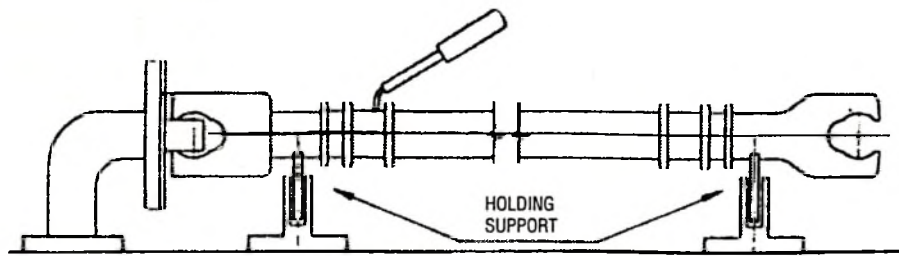
Fig. 3 : Arrangement of automated welding fixture of sleading spindle

The spindle was stress relieved before undercutting although no appreciable drop in stress was noticed. After undercutting the journals were ultrasonically tested

and then welded by automated MAG (Metal Active Gas) process with solid wire. Arrangement of the automated fixture is shown in Fig. 3.

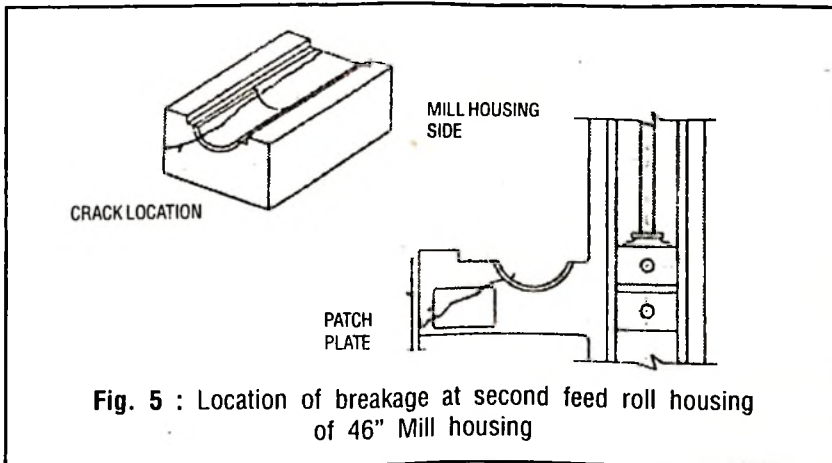
Fig. 5 : Location of breakage at second feed roll housing of 46" Mill housing

Problem : 46" Mill housing at RM-2 has both 1st and 2nd feed roll housings integral to the main housing. In Dec, 90, the bottom portion of 2nd feed roll housing showed crack, which was welded during a weekly shutdown. However, within 48 hours of operation the housing failed from the same location resulting in total mill outage.

The failure resulted in breakage of the roll neck housing into two

pieces. The bearing seat was found worn out and built up on previous occasions, the crack originating from the earlier welds (Fig. 6a). While cleaning the broken piece and main housing the existing defective welding had to be removed. The problems of reconditioning were :

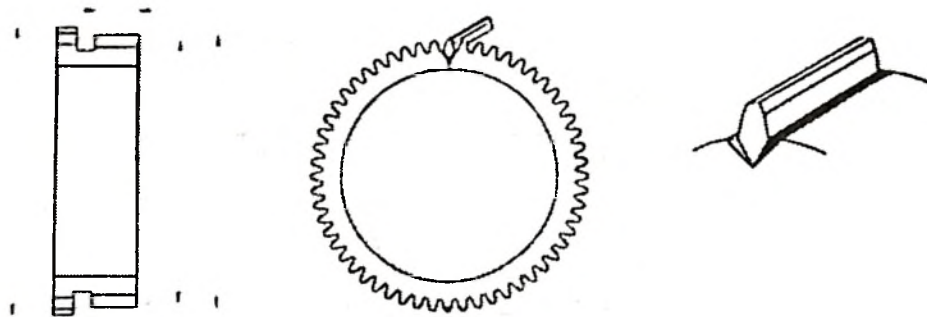
Fig. 7 : Assembly of pre-machined gear teeth on the hoist of billet handling crane

meter dia. hoist gear of crane no. 1 failed due to 5 broken teeth at locations shown in Fig. 7. The crane operation was stalled due to non-availability of a spare gear.

Solution : 5 individual gear teeth were made out of forgings of IS 2004 grade and then machined at the root to ensure full penetration weld preparation. The portion of the gear with uprooted teeth was machined down and individual pieces were then assembled to the gear. Full penetration welding

of individual tooth were done with necessary precaution of preheating, back gouging, etc. The arrangement, similar to fixing of dentures by dentists, is shown in Fig. 7. After welding, the gear was machined to the required accuracy.

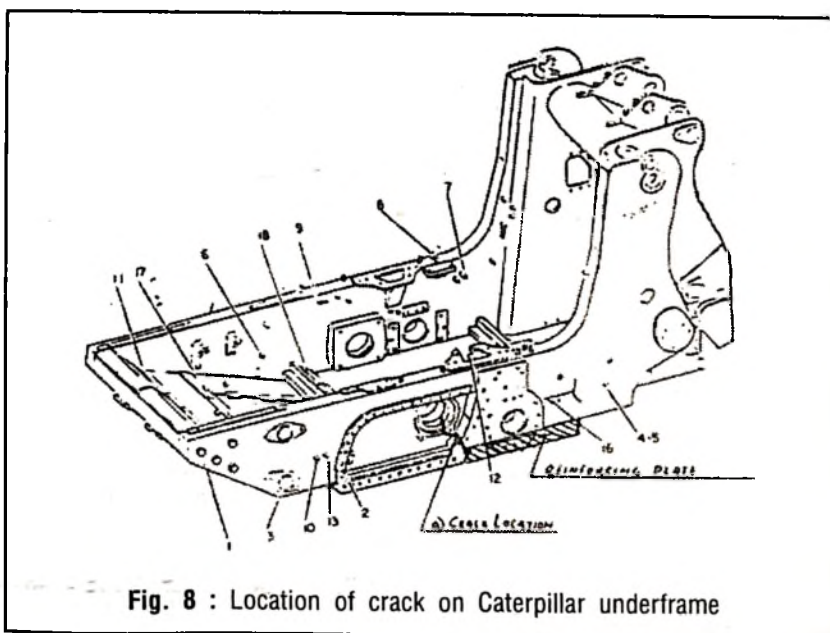
Fig. 8 : Location of crack on Caterpillar underframe

Problem : Caterpillars (model 973) used at steel melting shops are put into extremely demanding service condition of pitside material handling. The underframe of the vehicle showed repeated failure at the particular location marked in Fig. 8. Site as well as shop repair by gouging and welding could not prevent repeated occurrence.

Solution : The cracks were originating from the bottom edge of the frame, near the location of change in section. It was noticed that the failure was common to both the vertical sides of the underframe at identical locations. Also, all vehicles of the particular model were prone to similar chassis failures. Analysis of the design revealed chances of stress rising at the section changeover location due to tensile loading. Hence the location was strengthened with a butt plate as shown in Fig. 8.
