# HARD FACING WITH COBALT BASE ALLOY - STELLITE-1

Central Workshop, Indira Gandhi Centre for Atomic Research, Kalpakkam - 603 102

(This paper, presented at the National Welding Seminar-1995 at Cochin, has received the K.C.P. Award for the First Best Paper on Fabrication)

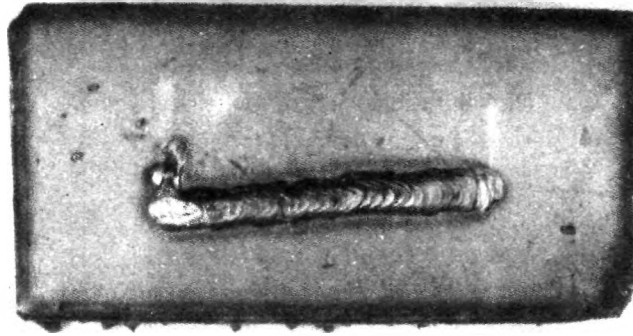
Fig. 3 : Linear Welding by bead on plate

- i. Linear welding by bead on plate (Fig. 3)
- ii. Circular layer on a thick plate (Fig. 4)
- iii. Circular layer on a thin plate, say 6 mm (Fig. 5)

The results of the examination revealed that in the Model-1, no cracks were found irrespective of whether the welding was done on a thin or a thick plate.

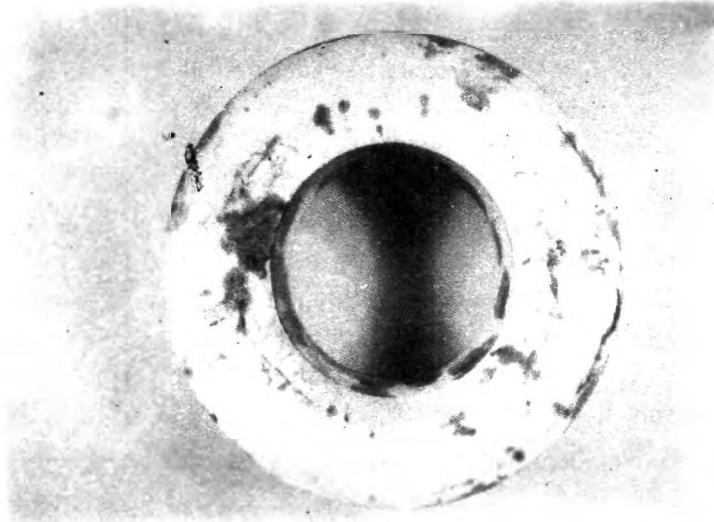
Fig. 4 : Circular layer : Thick plate

Model-2 revealed the same type of defects as encountered in the actual job.

- i. The very hard stellite material cannot take the shrinkage stress, and invariably the stress gets relieved through the so-called "Stress Relief Checks" manifest in the models described above.

- ii. If the parent metal could accommodate shrinkage stress by distortion the weld metal remains defect-free.
- iii. The shrinkage stress is more severe in an endless circular bead than in the straight bead with open ends.

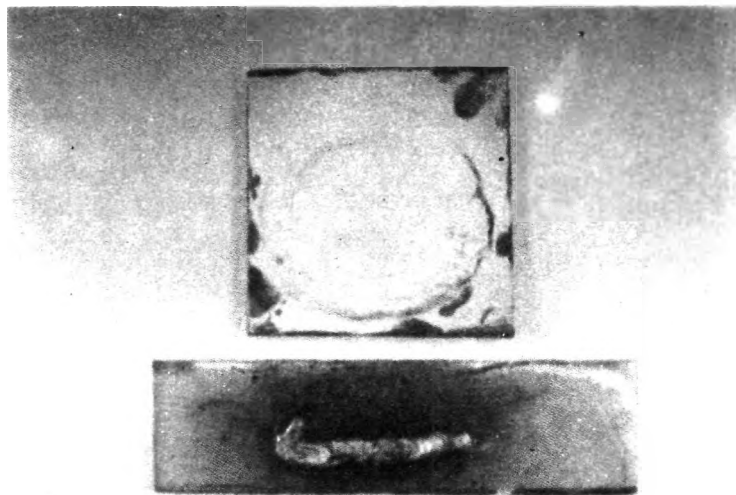
Fig. 5 : Circular layer : Thin plate

Model-3 was found to be defect-free but the parent material was heavily distorted.

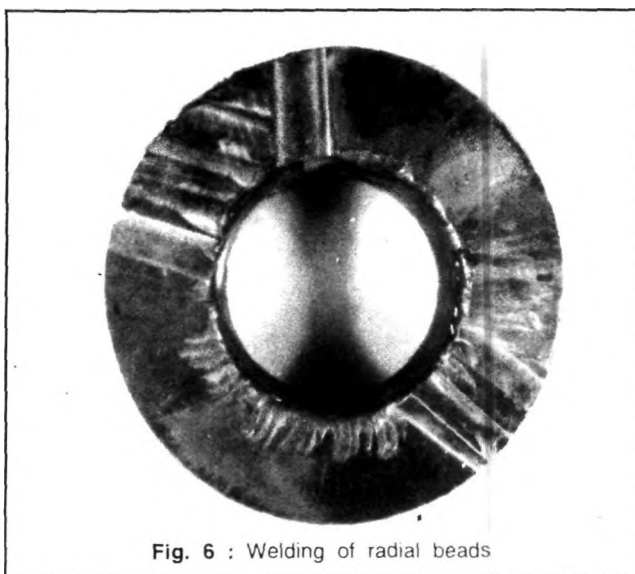
Fig. 6 : Welding of radial beads

The result was excellent and indeed amazing, with an increased weld speed as well. On the spot, the ingenuity of the welder has further improved the method for a better result and in countering the tendency for defects at the closing joint of the loop. The technique followed is shown in Fig. 6. At this stage, the redundancy of the groove was noticed and the process of machining a groove for weld deposit was given up.

The earlier difficulties and the consequent analysis have enthused the authors to contemplate on a new technique to reduce the shrinkage stresses to a minimum. The first choice was to weld for short lengths, say to a length of 30-35 mm, following a typical weld sequence. When this idea was envisaged on a circular bead for a considerable width, an unattractive weld appearance was visualised. This led to an idea to weld radial beads.

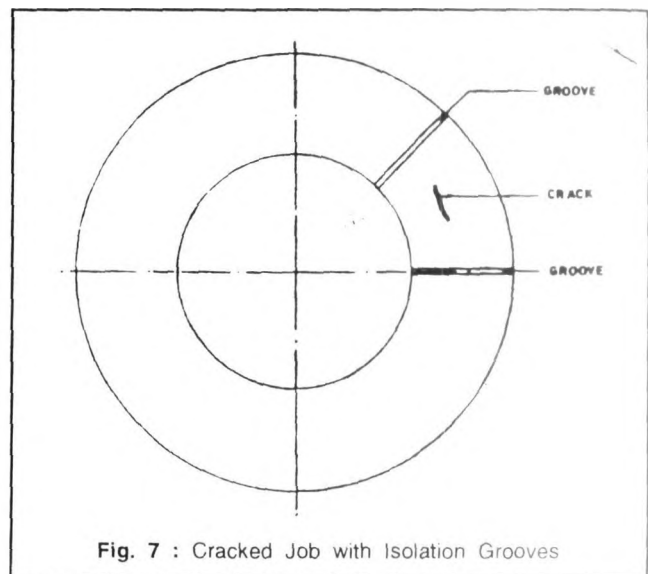
Fig. 7 : Cracked Job with Isolation Grooves

This process gave a good result with no major defects. Small cracks were noticed across the

bead near the closing pass. These were removed by mild gouging and a second layer was welded with the same parameters. Cracks were found near the closing pass again. The cracks were isolated by making radial grooves on either side of the crack as shown in Fig. 7. Grinding with a flexible shaft grinder to make grooves resulted in the propagation of these defects. But they were contained between these grooves. The defective layer between the grooves was removed by milling.

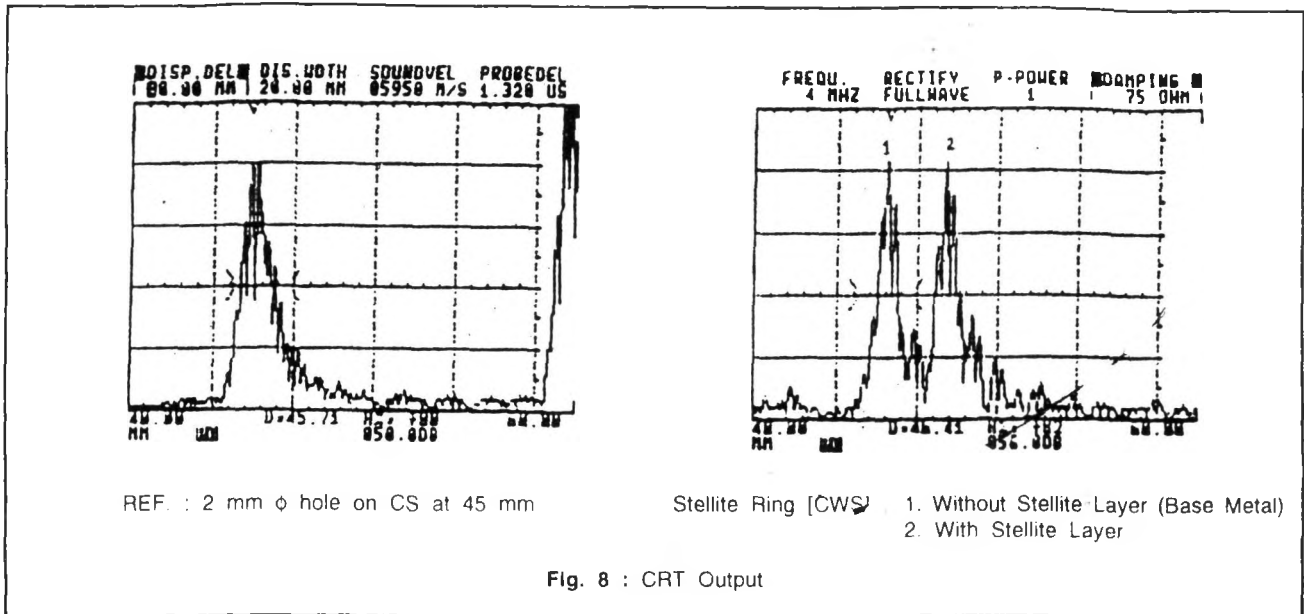
Besides visual and L.P. examinations, U.T. was also conducted to examine the soundness of the bond, and the stellite layer was volumetrically examined by employing both normal and angular probes. A 2 mm dia side drilled hole was used as reference. The scanning was employed on the opposite face of the stellite portion with 10% overlap. This examination revealed defect-free bonding. The CRT output report is shown in Fig. 8.

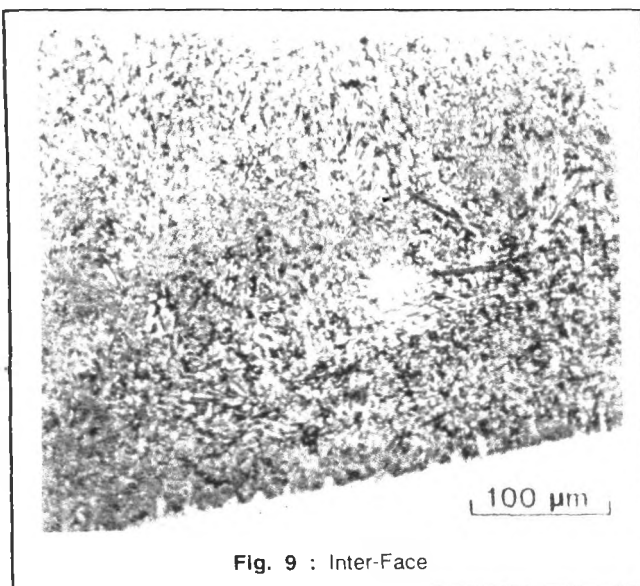
Fig. 9 : Inter-Face

boiling Murakami reagent. The stellite substrate was found to be free of defects such as porosities and cracks (Fig. 9). This indicated that a good metallurgical bond had formed between stellite and substrate. The hard facing consisted of plates and particles of chromium carbide in a hard matrix. The bottom layer had a finer structure of carbide (Fig. 10) than the top layer (Fig. 11), where hexagonal carbides and plates were bigger.

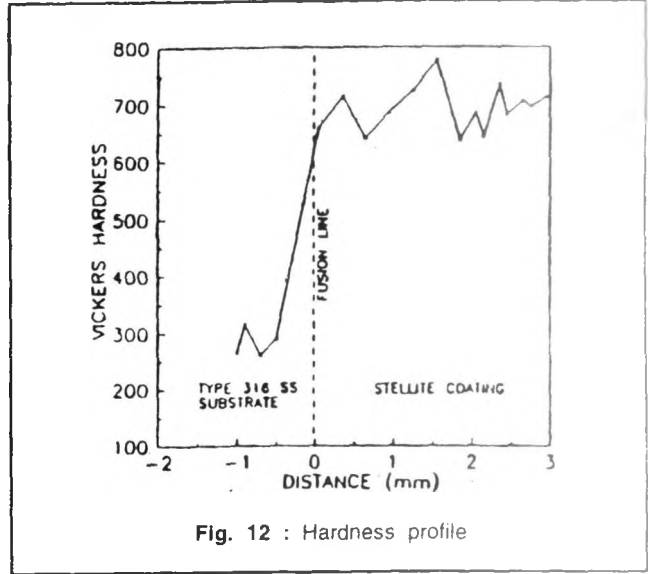
Fig. 12 : Hardness profile

The profile of the hardness readings is shown in Fig. 12. The hardness data shows that the value increases from the substrate hardness of 265 VHN to about 650-700 VHN in the hard facing. This value was verified by full scale vicker test, which gave a reading of 195 VHN at substrate and 627-760 VHN in the faced area.
