In-situ repair of multiple cracks present in the RTJ groove of high pressure hydrogen bearing DHDS reactor by welding

Swapan Kumar Bagchi, Chief Inspection Manager, Haldia Refinery, Indian Oil Corporation Ltd,

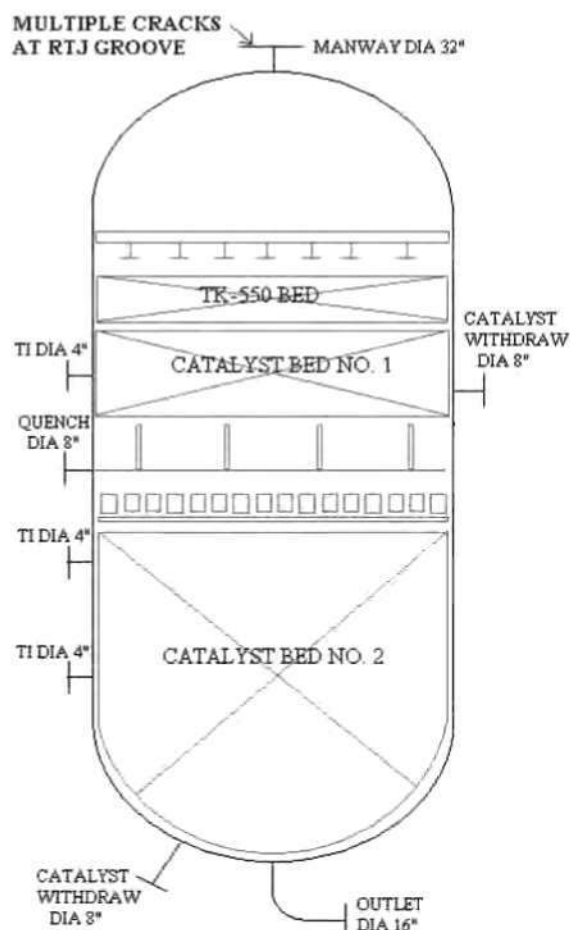
The reactor was offered for inspection after unloading of catalyst and completion of passivation. Apart from thorough visual inspection, the Non Destructive Testing (NDT) like D.P. testing and hardness measurements of RTJ groove, gaskets, Ultrasonic Examination of welds and cladding disbonding testing by ultrasonic method, In-situ metallography were carried out. During the dye penetrant testing (DP test) of RTJ groove after opening of man way flange and RTJ gasket, multiple cracks with circumferential and transverse branches in the RTJ groove location were observed (**Fig. 1**).

Fig.1: The cracks at RTJ groove in the schematic drawing of Reactor

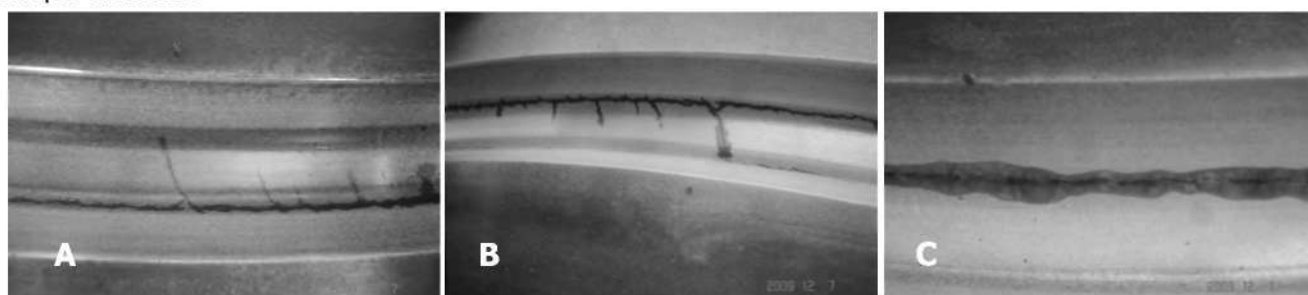
As the presence of multiple cracks of such dimension cannot be allowed to operate at the high pressure hydrogen bearing reactor with respect to the operating conditions, the multiple cracks at the RTJ groove were repaired by in-situ welding and machining in urgent basis to minimize the shutdown time of unit.

Fig. 2 : Multiple cracks observed at RTJ groove of the top manway flange (A) Outer side of RTJ manway flange- circumferential cracks with transverse cracks (B) Inner side of RTJ manway flange- circumferential cracks with transverse cracks (C) Outer side of RTJ manway flange- circumferential cracks

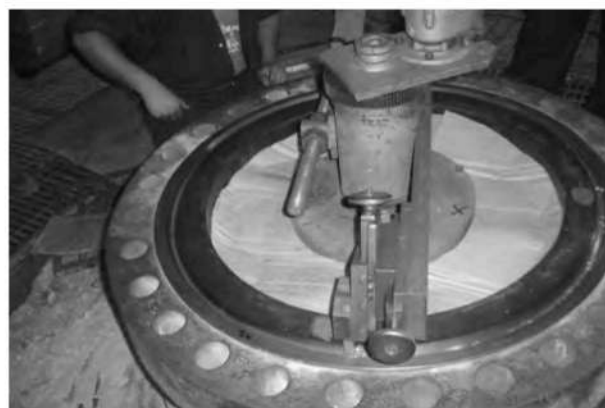
Fig. 3: In-situ machining at RTJ groove of man-way flange to remove cracks

- Then D. P. testing was carried out to assess the nature of defect.
- Progressive machining (maximum 0.5 mm metal removal in one cut) was carried out and subsequent DP test was carried out, after every 0.5 mm of machining, for removal of defects (**Fig. 3**).

- Progressive machining (maximum 0.5 mm metal removal in one cut) was carried out until DP test was clear.
- Checking with CuSO₄ solution testing was carried out to confirm the material (stainless steel weld overlay or low alloy steel) at the depth of cutting and measure accurate dimensions of balance groove at the grinding locations.

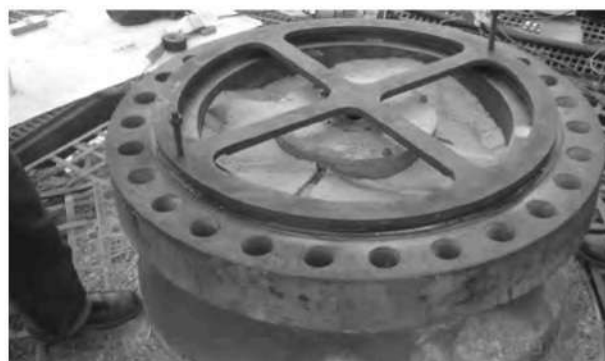
Fig. 4 : Final polishing with lapping

- After repaired by welding followed by grinding, final polishing with lapping was carried out (**Fig. 4**). At last, final D. P. testing was carried out to identify significant indications, if any (**Fig. 5**).

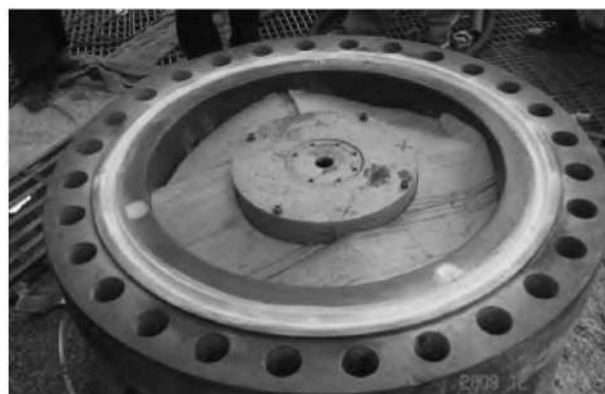
Fig. 5 : Final D.P. testing after lapping to identify significant indications, if any

No crack was observed (**Fig. 5**). After commissioning of the reactor, no leakage was observed from repaired RTJ flange. By employing this in-situ repair methodology, the repair could be successfully accomplished within the scheduled shutdown period of the unit.
