Root Cause Analysis of Failure in Hot and Cold Mixing Point in Hydrogen Generation Unit (HGU) due to Thermal Fatigue Phenomenon

Indian Oil Corporation Limited, Guwahati Refinery, PO-Noonmati, Assam, Guwahati -781 020

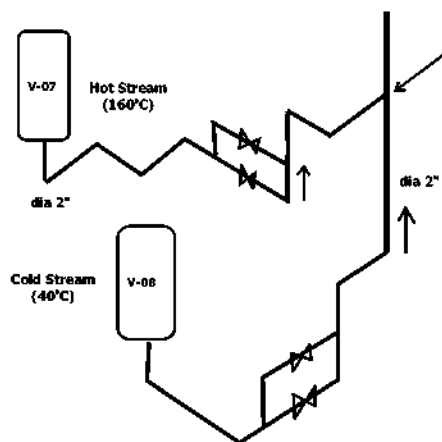
The dia. 2", SS-304 hot and cold mixing point, is located in the down stream of vessels V-07 (hot condensate vessel) and V-08 (cold condensate vessel). The temperatures of the streams are 160°C and 40°C respectively. The isometric sketch below (Fig. 1) shows the layout of the piping configuration and the location of the failed mixing point.

Fig. 1 : Isometric Sketch of Hot and Cold Mixing Point, showing the failed location

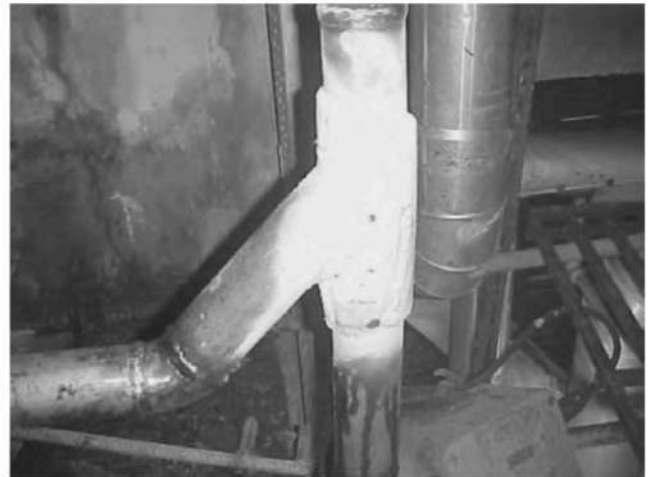
Since this was the first incidence of cracking, the original angle of 90° connection (Tee joint) was changed to 45° connection ('Y' joint) in June'06 turnaround (Fig.2). A reinforcing pad was provided at the 'Y' joint for strengthening the weld joint. The original dia. 2" Ø, schedule 40S (3.91mm thickness) pipe at branch and main header was replaced with higher schedule pipe, i.e. schedule 80S (5.54 mm thick). Thus by increasing the weld area in a 45° connection along with reinforcement pad than a 90° connection, the thermal stresses were minimized.

Fig. 2 : Photograph of Replaced mixing point modified to 'Y' joint, DP tested after replacement in 2006

Welding of SS304 pipe and RF pad was carried out after joint preparation with E-308 electrode. After completing the replacement job of the failed 'Tee' joint with a 45° 'Y' joint, final DP-testing of the reinforcement (RF) pad weld joint and radiographic inspection of butt joints (4 nos) was carried out. The condition was found satisfactory. As an improvement in the design it was recommended to change this welded 'Y' joint at the mixing point, with a dia. 2" Ø, schedule 160 (8.74mm thick), SS304 latrolet in the next opportunity. This forged latrolet will reduce the stress concentration produced at the mixing 'Y' joint.

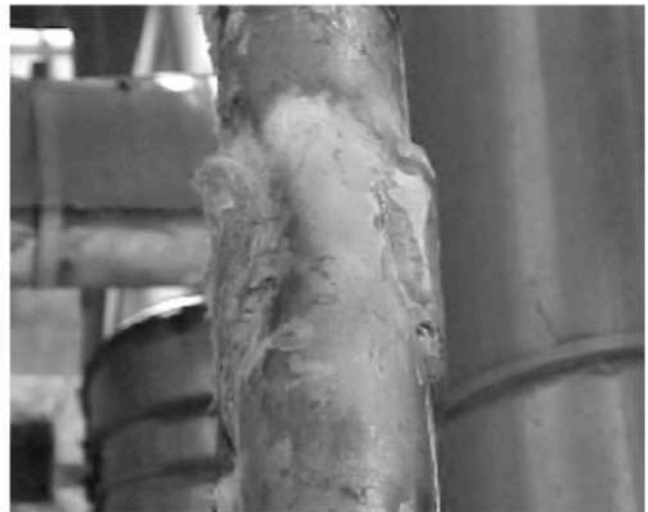
In July 2008, the mixing 'Y' joint failed once again after staying in operation for approximately 2 years. This time the leak was noticed from the weld joint of reinforcement pad to the 2" dia pipe in the hot and cold mixing point (see Figs. 3 & 4). Thickness survey of the portion in and around the cracked location did not reveal any corrosion/ metal loss.

Fig. 3 : Photograph of Leaking portion of the mixing 'Y' joint at RF pad weld joint in 2008

As the recommended latrolet was not available, the cracked mixing 'Y' joint was replaced with an available equal Tee of dia.

2", schedule 160 (8.72 mm thick) confirming to SS 304 material. The butt welds (3 nos) were inspected using radiography and were found satisfactory. An RF pad was provided at the 'Tee' portion for strengthening. The RF pad welding was DP tested, no significant indications were observed.

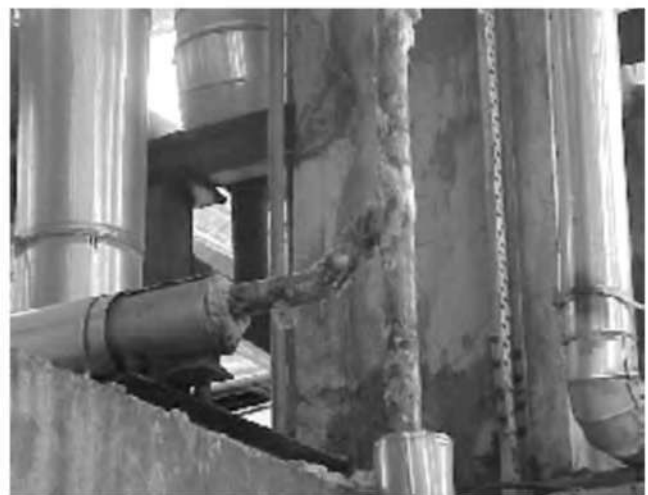
Fig. 4 : Photograph of Hot & cold condensate mixing Tee point after insulation removal

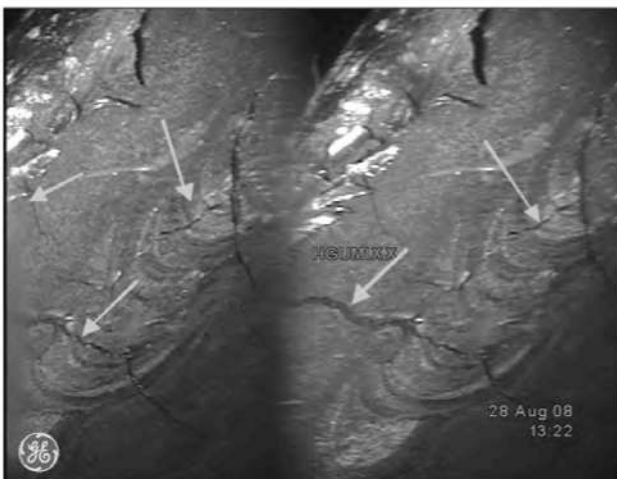
The replaced failed 'Y' mixing joint was inspected using a remote visual inspection video scope (RVI) to see the condition of the inner surface of the pipe/'Y' weld joint. Multiple surface cracks were noticed in the weld joint between the main header and branch pipe ('Y' joint) and also on the pipe surface upstream and down stream of the flow direction. (See Figs. 5 & 6). These cracks were both linear and branched cracks.

Fig. 5 : Photograph of Cracks noticed using remote visual inspection (RVI) instrument on the inner pipe surface at the mixing Tee location

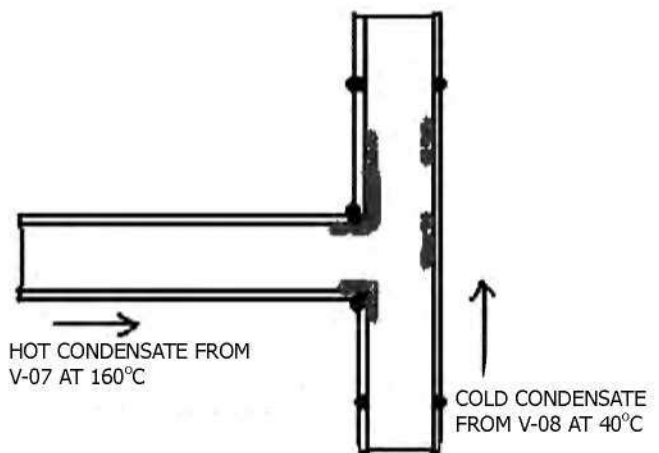
Fig. 6 : Sketch showing portion cracked by thermal fatigue

coming from V-07 vessel at 160°C meet at the mixing point where differential thermal expansion is experienced due to this temperature difference of 120°C. The calculated differential expansion is of the order of 2 mm in 1metre length of the pipe. As the unit is in continuous operation, this Tee/Y mixing joint is subjected to continuous thermal cycling. Thermal stresses are generated at this mixing joint due to the hindered expansion of the pipe causing crack generation. These cracks were noticed primarily at the weld joint between the cold and hot line and in the inner surface of the pipeline downstream of the flow direction, as shown in Fig. 6.

The 'Tee' weld joint and RF pad is a stress raiser and the cracks were initiated easily at the toe of the weld causing leakage from this point. This crack had further propagated to the main pipe also due to the thermal cycling. Therefore the combined effect of thermal cycling and stress caused thermal fatigue of the mixing Tee joint leading to its failure. As per API RP 571, section 4.2.9, cracking is suspected when the temperature swing exceeds about 200° F (93° C). In this case also the temperature swings are of the order of 120°C.

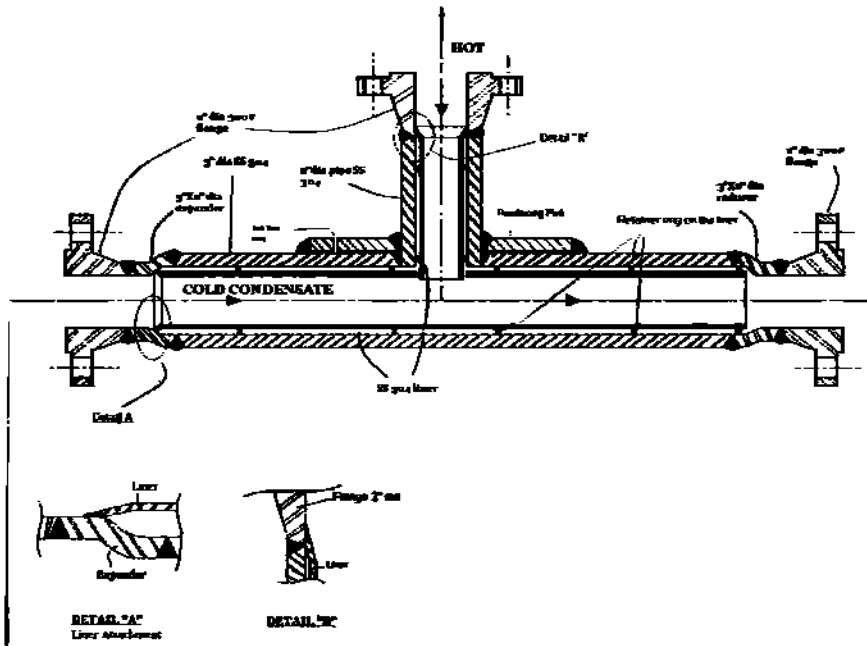
Fig. 7: Sketch of Proposed "QUILL" design for hot and cold mixing point

The remedial measures taken to combat the failure of injection points were:(a) upgrading the material of construction, (b) increasing inspection frequency, (c) upgrading the injection type i.e providing an "quill", (d) process change, (e) piping configuration change. Of the above measures the most popular ones are (a) and (c). Both these methods have given successful results. Therefore it was decided to go for a injection quill as it was tested at other locations will great success. The design of the quill was based on good engineering practice with provision of an SS304 inner liner and retainer rings as shown in Fig. 7. The inner liner prevents direct contact of the hot fluid with the surface of the pipe carrying cold fluid thereby preventing thermal stresses. Inspection, maintenance and repair of this quill will be easy after its installation as it can be easily dismantled. This will save time during shutdown and also increase the unit run length.

1. Both the liners may have perforations of 10 mm dia for reducing the thermal gradient on the pipe.
2. Length of the liner will be approx. 1000 mm with branch connection around 300 mm from the inlet side to maintain the same velocities. The OD at inlet will be maintained as 2" and main header dia will be increased to 3" to create annular space for minimizing thermal stresses.
