Case Study - Controlling Distortion During Welding of a Composite Joint where Post Weld Machining is involved

Devasis Paul Director Technical, Nextgen Plasma Pvt Ltd., 100A, Elliot Road, Kolkata 700016 Email: devasis.paul@nextgenplasma.com

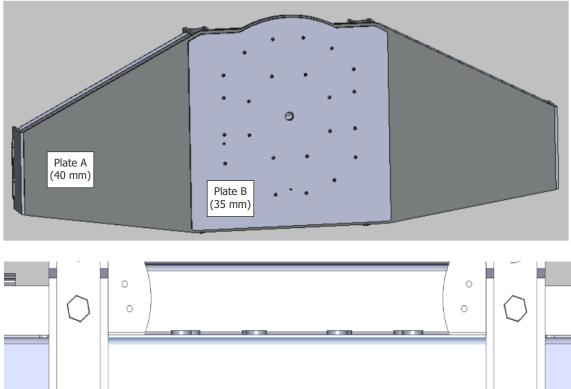
This is a case study where two Steel Plates, A & B with thicknesses of 40mm & 35mm respectively are welded together to increase the thickness for machining. Referring the drawing below **Fig. 1**, a plate 'B' having dimension of 1605x1650 is being welded to the other plate 'A' having dimension of 4400x1650. The plate B at the bottom will have to be machined along with several through holes for the whole structure to be mounted to another pre-installed faceplate. Hence, the flatness of the plate B after welding is of great importance.

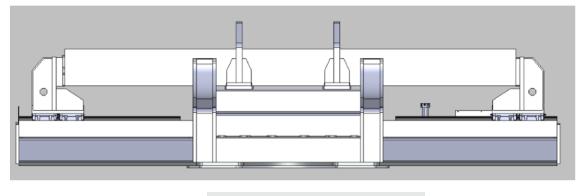
Figure 2

there was a bulging of 15 to 18 mm which originated from the centre of the fabricated structure. At this juncture, it is to be noted that the Plate had many other thicker steel plates welded at 90 to Plate A, which prevented the Plate to distort due to heat.

So, when machining was done, the thickness of the Plate B at the centre became almost 10 to 12mm due to machining while its edges remained 25 to 28mm. A Clear Gap of 5 to 8 mm between the Plate A and Plate B was created, which was not visible from the outside. In this state, the structure could not be mounted on the designated faceplate as it might bounce due to the gap created between the plates and also the alignment of the structure after tightening with the bolts would be disturbed and it would not be parallel to the mounting LM Rails fitted on the other side of the Plate A (**Fig. 2**).

During welding of the Plates A & B, there was enormous pressure generated between the plates, and the force was concentrated at the centre of the plates as a result of which the Plate B which was placed on Plate A, bulged due to heat distortion. The Plate A did not bend due to the other steel members placed at 90 to its base restricted it.
