Optimization of Parameters for Welding of Spark Plug Detector

ABSTRACT

Key words: Spark plug detector; extension wire; failure analysis; metallography; welding procedure qualification.

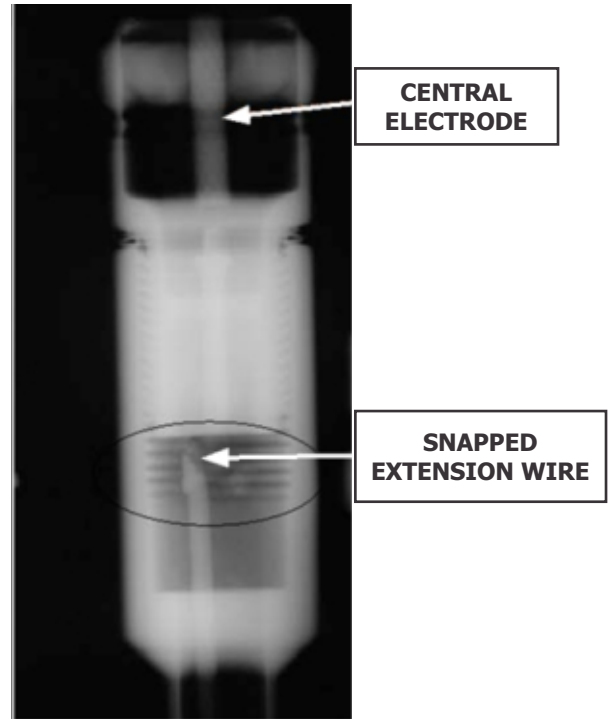
Fig. 2 gives the radiography of the snapped wire. Since there is no mechanical load involved, the exposure to high temperature or corrosive environment is likely to be a possible cause of the failure. Further the failed region is located in the weld joint [**Fig. 3**] which suggests the role of joining and its effect on the initiation of a failure. It is decided to identify the failure mode of the snapped wire in particular at the weld joint. Therefore careful study on the failed piece was carried out. Systematic

Fig.2 : Radiography image of snapped extension wire

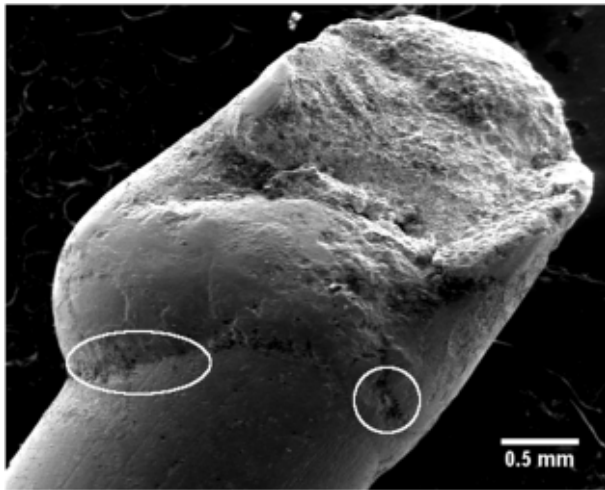
Fig.3 : Spark Plug wire-failed end with the weld region encircled

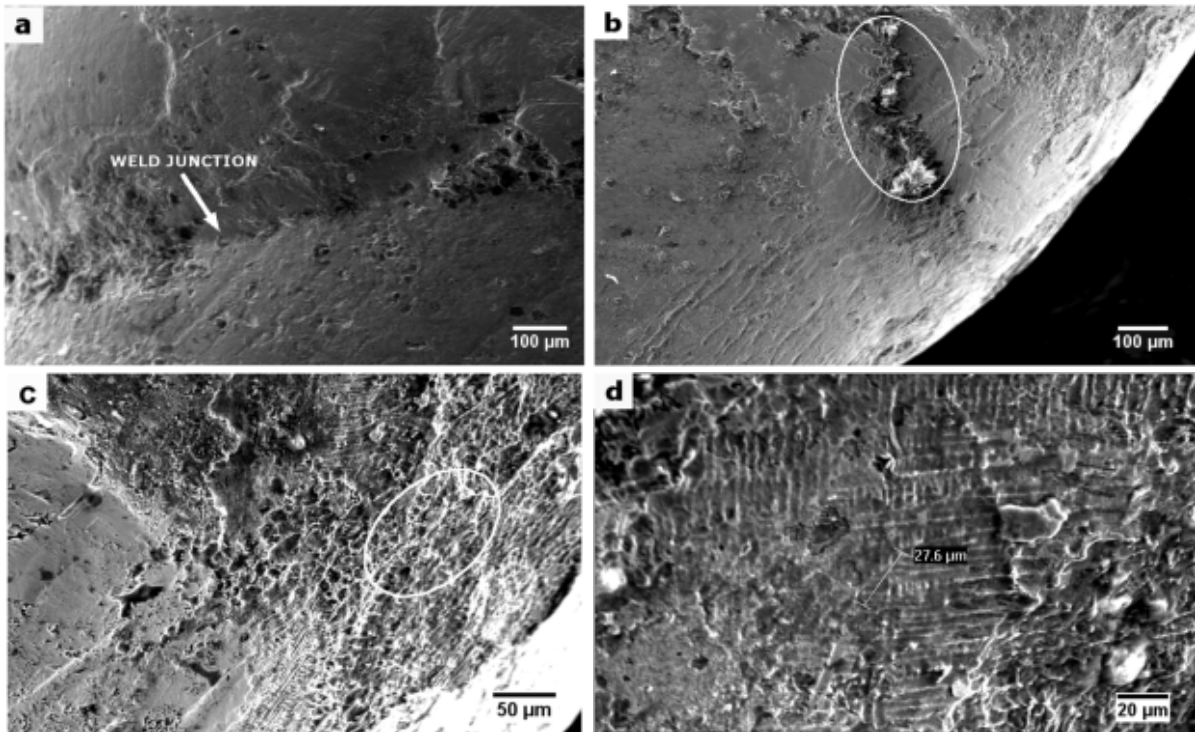
fractography of the failed joint has been carried out using Scanning Electron Microscopy (SEM) and chemistry of the wires was confirmed through Energy Dispersive X-Ray Spectroscopy (EDS) in SEM. **Fig. 4** shows the microstructure of the weld region. A few cracks [**Fig. 4-b**] were observed in the weld region. Further, microstructure consisting of dendrites in two different orthogonal direction were observed **Fig.4d** shows the nature of grains in the interfacial area which suggests corrosion attack as the grains have flaked out. Presence of dendrites in orthogonal direction suggests possible elemental segregation [2]. In order to examine on the elemental distribution across weld interface, EDS line scan spectra were gathered from representative regions. It can be observed from **Fig. 5** that the presence of oxygen, Cr and Fe vary distinctly suggesting the proneness to corrosion attack and oxidation during service. The operational log suggests the possibility of sodium ingress causing corrosive atmosphere around weld area. In order to confirm if the crack originated at the weld or at the interface, longitudinal section of the failed piece was prepared through conventional metallographic procedures.

- The extension wire has snapped resulting in non-performance of the detector. A few cracks from solidification of weld were observed in the weld. An initial leak from the cracks is likely root cause of the failure.
- Presence of oxides of Na suggests that the small amount of sodium that has leaked out has converted into oxide and further into alkali in the presence of moisture at high temperature. This could have attacked the area which is chemically prone, in particular the weld interface area.

Fig.4. SEM image of (a) weld interface with micro porosities (b) micro cracks carrying white debris of Na₂O (c) dendritic microstructure in weld close to interface and (d) magnified view showing orthogonal dendrites

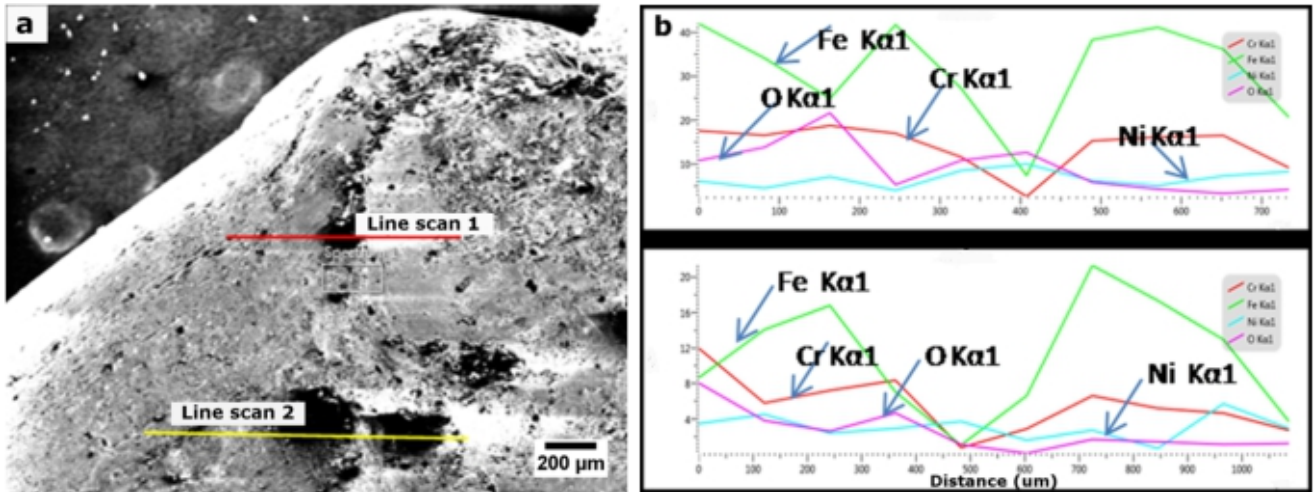
Fig.5. (a) weld Interface area; region of line EDS marked as line scan 1 & line scan 2; (b) spectrum acquired through scan 1 (above) & scan 2 (below) indicating the segregation of (Cr, Fe, Ni & O) elements seen at the interfacial area

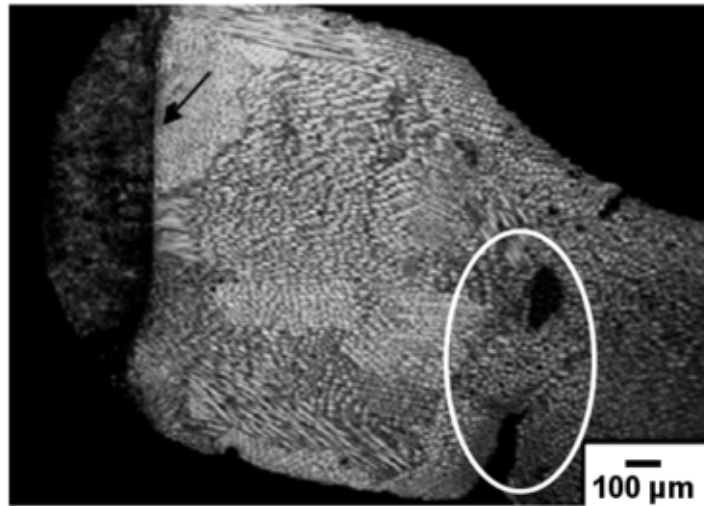
Fig. 6 shows the micrographs representing the section. It can be observed that the crack has originated from the weld region that formed between Ni base alloy and stainless steel and propagated intergranularly through the dendritic region. Hardness profile across the weldment was carefully assessed and is shown in **Fig. 7** as a schematic of the section with the representative hardness values

Fig.6 : Crack seen in weld (marked by a round); arrow marks interface with Ni spark plug wire

- Exposure to high temperature and corrosive atmosphere resulted in flaking of grains as observed in the regions around the weld.
- It is recommended that a systematic study of welding process of spark plug central electrode with stainless steel extension wire be taken up to optimize the conditions for a sound weld with (i) less chemical inhomogeneity, (ii) uniform hardness across the weldment (iii) uniform microstructure (iv) no microcracks and (v) no blow holes. Further accelerated corrosion tests can be carried out to ascertain the life.

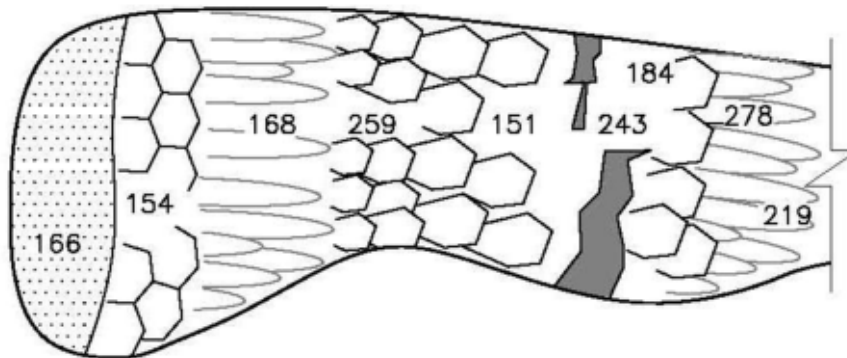
It can be observed that the hardness is quite varied in nature which can be understood considering the presence of dendrites of varying sizes in the weldment [2]. Further, the solidification cracks originated following cooling after welding can propagate easily across the soft zones present between hard zones during service life.

Fig.7 : Schematic figure with hardness marked on different regions; note that hardness around cracked region varies on either side distinctly

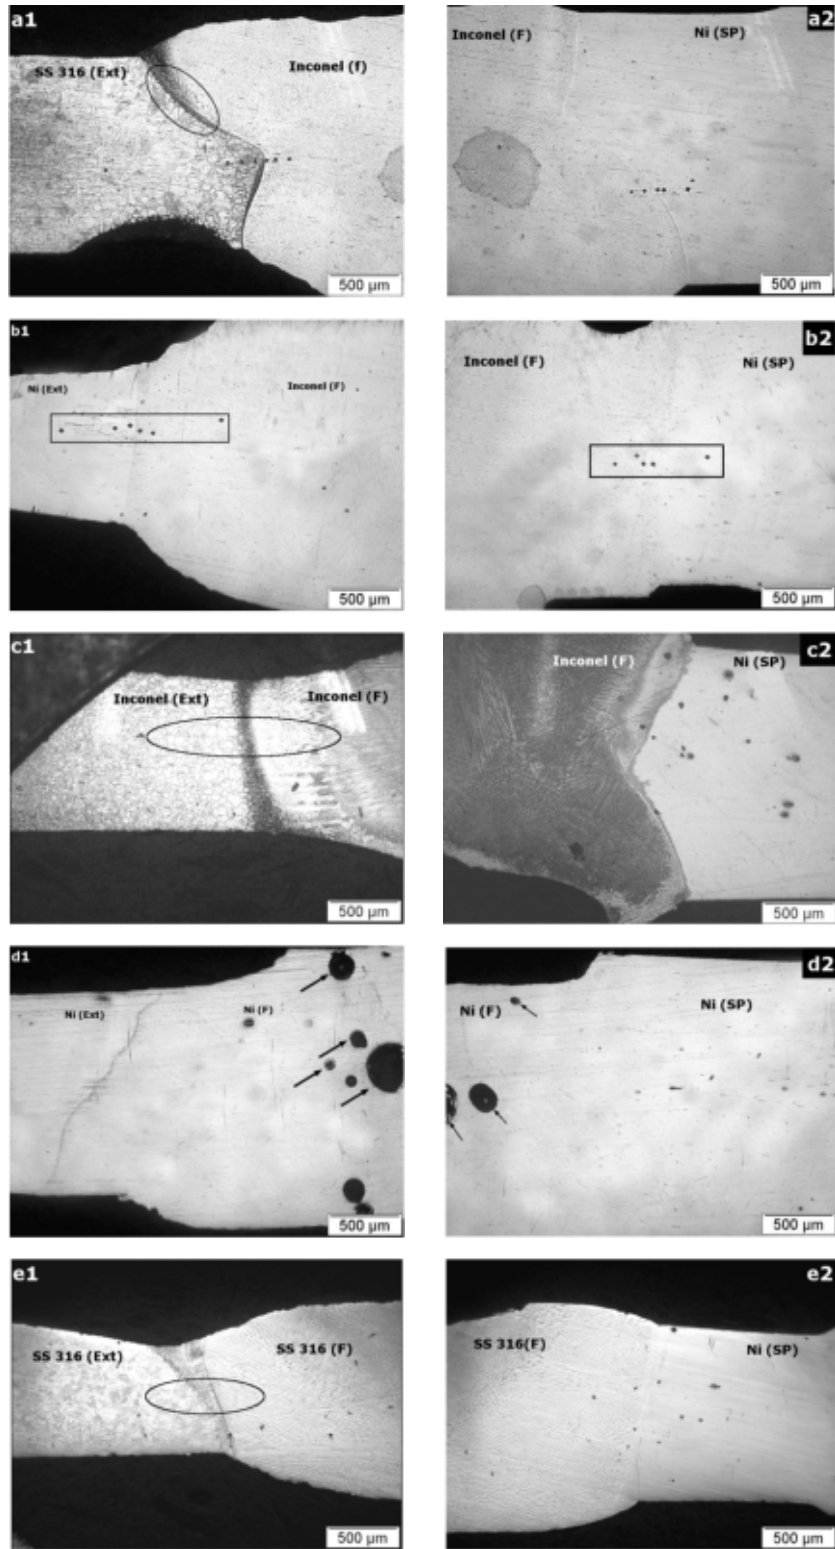
welding. Metallography results are shown in **Fig.8 (a-e)**. It can be observed that among the five different combination of filler and extension wire, presence of non uniform microstructure around the interface (encircled) dominates in case (a), (c) and (e) and though the microstructure was almost uniform in (d), several blow holes (shown by arrows) were observed.

Nonuniformity in microstructural features occurs if the alloying elements segregate at the boundaries. Since the duration of welding process was few seconds, the diffusion of elements is precluded and hence the heat affected zone exhibits a complex microstructure with associated hardness variation in the region. Porosity or blow holes in Ni and Ni –Cu alloys is reported [3, 4] when atmospheric gas contamination occurs during welding. Even though the studies have employed higher Ar gas purging, it is found inadequate to prevent the contamination in (d) which could have resulted in porosity.

In case of (b), the microstructure was found to be homogeneous and the hardness across the interface was found to be uniform as well. Based on the above results it was recommended to employ inconel filler wire for welding of Ni extension wire to the spark plug. This also matches with an earlier reported similar study on welding of 316LN stainless steel with alloy 800 [5]. While thermal expansion coefficient of inconel and nickel are found to be similar, thermal conductivity of nickel is five times better than inconel, weldments cools linearly by releasing heat to nickel wire, and hence the weld joint appears to be good [6].

Fig.8 : (a-e) microstructure at the weld interface of different combinations of extension wire and filler wire (left (a1 to e1) – interface of extension wire with filler wire; right (a2 to e2) -interface of spark plug with filler wire); arrows mark blowholes; non uniform structure rounded; hardness marks in (b) shown in round suggests uniformity in hardness; cracks seen in weld metal in (e)

Based on the results obtained from metallographic and micro hardness studies conducted on the cross sections of the different welds the recommended inconel filler wire is employed for welding of nickel extension wire to the spark plug. Accordingly welding procedure was derived to qualify the spark plug welding. This welding procedure (WPS) was adopted for all the bellows sealed valves in new experimental sodium loops.
