QUALITY IMPROVEMENT IN THE FABRICATION OF RAILWAY COMPONENTS - CASE STUDIES

N.K.Sarkar

Sr. Metallurgist, Konkan Railways Corporation Ltd., New Bombay

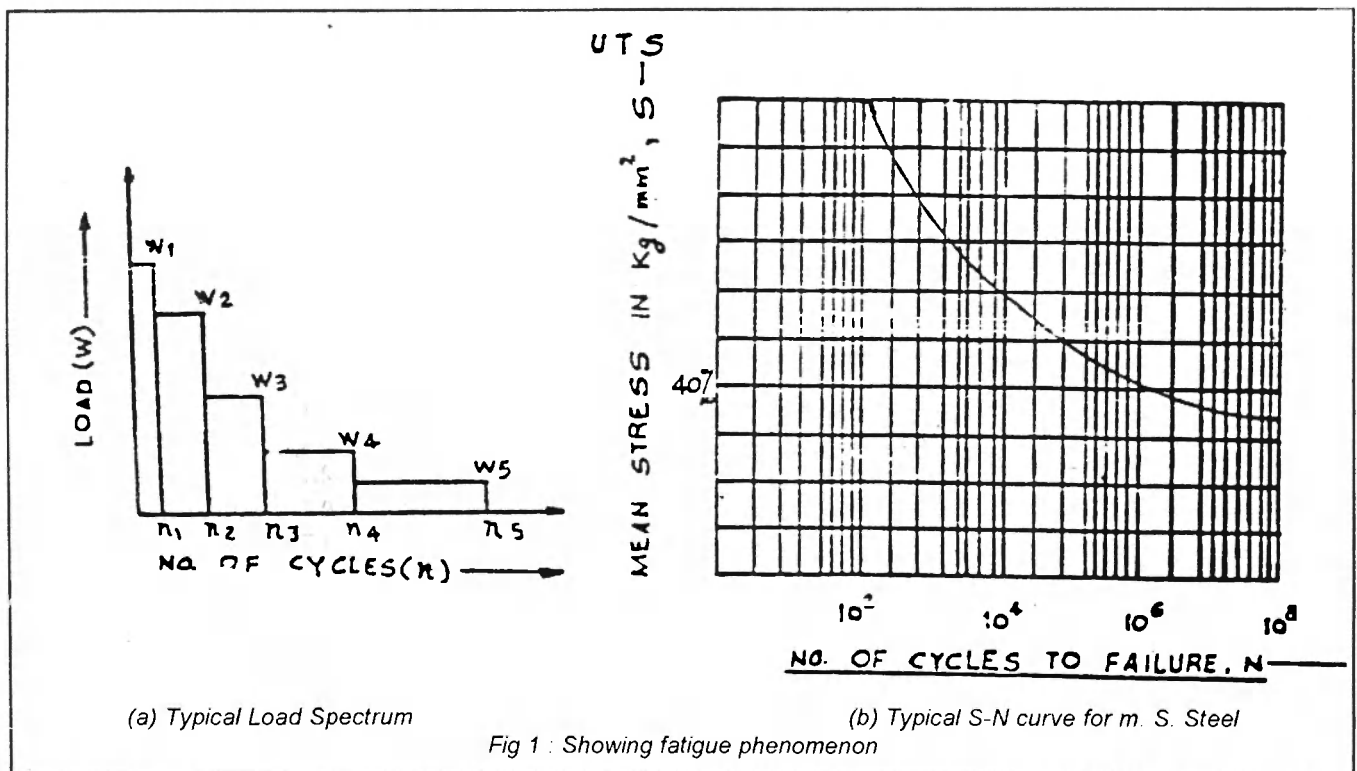
The designer's objective is to anticipate the sequence of service loading throughout the structure's life. The magnitude of the peak load, which is vital for static design purposes, is generally of little concern as it only represents one cycle in millions. Loadings are usually simplified into a load spectrum, which defines a series of bands of constant load levels and the number of times that

each band is experienced (Figure 1). In any welded joint there are few potential locations at which fatigue cracks may develop. These are at the weld toe in each of the two parts joined, at the two ends and in the root besides at the weld itself.

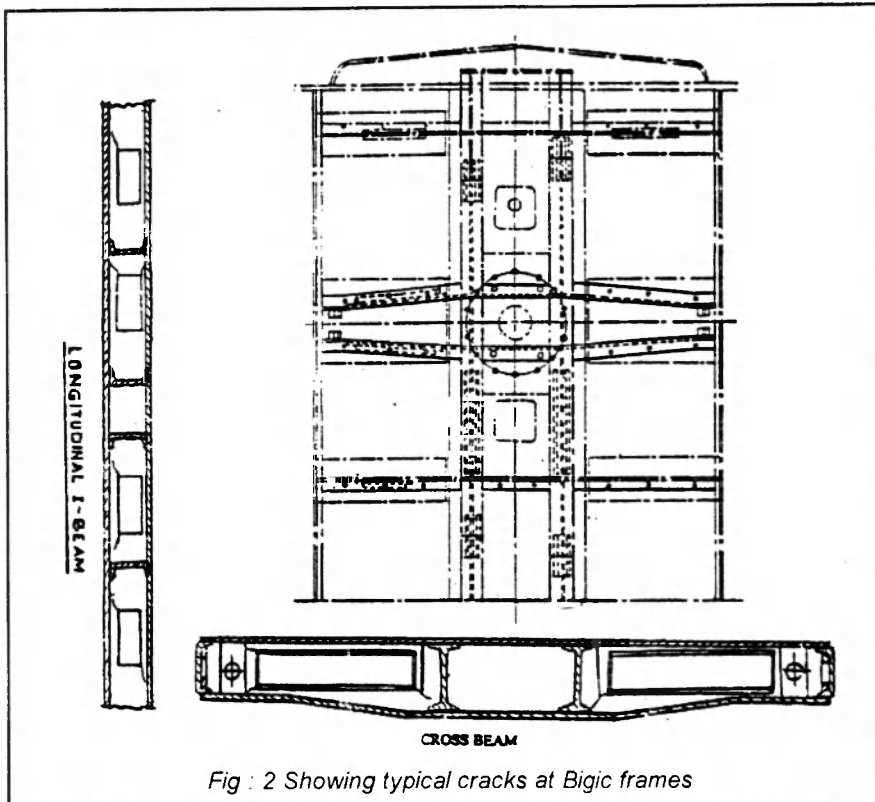
Fig : 2 Showing typical cracks at Bigic frames

DC electric locomotives are operated only in Bomaby Ghat sections. These locomotives, built by Chittaranjan Locomotive Works with indigenous designs were put into service in 1961. But after about twenty two years service, cracks were noticed at the airduct openings, longitudinal beams as well as at the cross members of the underframes at the centre point locations on both the cab

ends (Figure 2). Stiffener plates welded at these openings had also cracked. Few other deviations were also noticed in the openings for the air ducts made on the web plates which were too big with sharp fillet radius at the corners. These deviations therefore, had contributory effects towards the crack formation.

On investigation of the cracks after opening out, the failures were found to have originated at the corners where the stiffener plates were welded on the duct of the I-Beam. The fracture was progressive in nature and advanced towards the flange portion. The nuclei of the progressive zones were situated at the weld where welding defects like undercuts, void slag inclusions etc. were observed. Undercuts/voids of different degree were also observed on other welded are as of the stiffener plates.
