Salvaging of Large Bell of D Furnace of TATA Steel

Dip Narayan Koner*, Sanjay Kumar Jha

Spares Manufacturing, Tata Steel Limited, Jamshedpur - 831 001, India

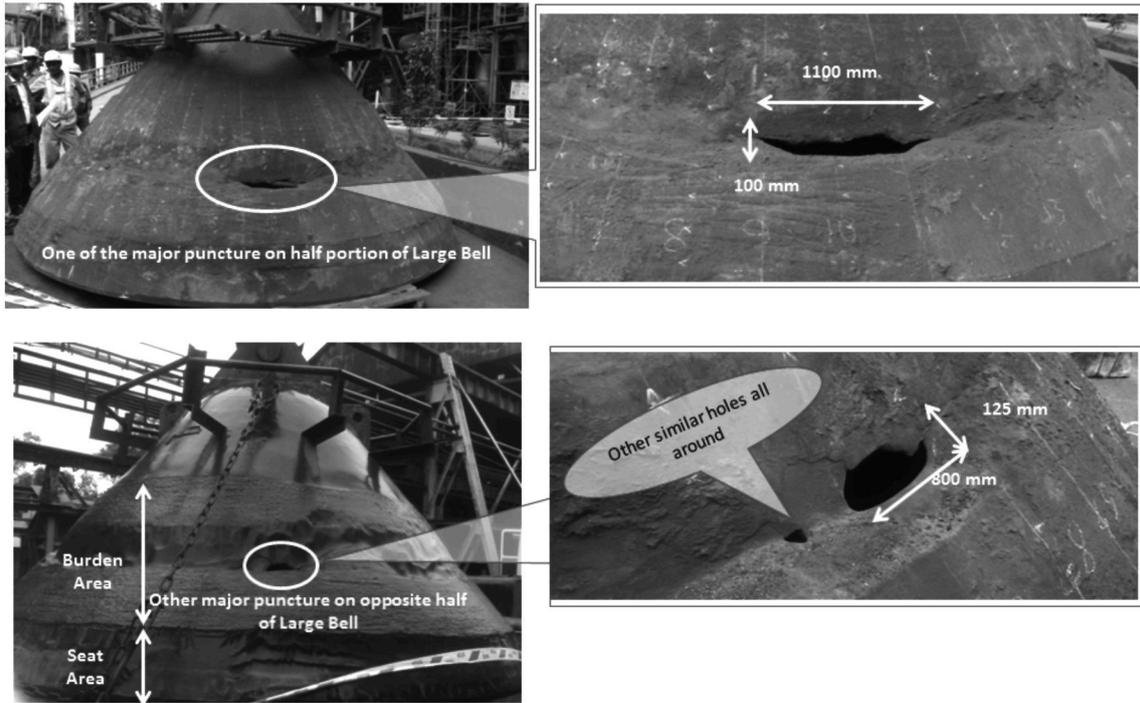
During midterm relining after opening of the top charging system it was observed that the large bell (shown in **Fig. 3**) was badly damaged in service. The extent of damage was varying in nature all over the surface area. Puncture was observed in the multiple locations in the burden portion. The magnitude of damage after measurement was up to 90% of the original drawing size. New procurement of the bell is a costly affair and the lead time of procurement is 8-9 month. The large bell is a single piece casting weighing approximately 20 ton. The major shut down was limited to 60 days only. The challenge was to salvage this existing badly damaged large bell within 60 days' time and make it as good as new one.

After dismantling the large bell was received at shops in highly damaged condition. Extent of damage was optimum at the certain area in the burden portion. Open cracks were observed in multiple locations of burden portion. Size of these open cracks ranged from 800-1100 mm in length and 100-125 mm in height.

Holes were also observed at multiple locations in the burden area. The seat area also was highly worn out. The extent of the

worn out seat was highly heterogeneous in nature. After visual observation of the bell the first remarks was "had it been in service for some more period, it would have been parted in two halves". The magnitude of damages is shown in the **Fig. 3**.

Fig.3 : Magnitude of damage of large bell

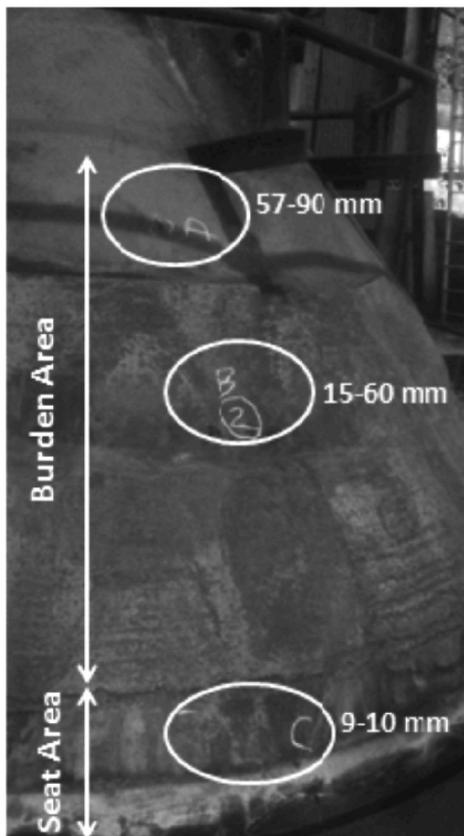
Fig.4 : Wall thickness measurement by UT

The required wall thickness as per drawing (Fig. 5) was 80 ± 6 mm and measured thickness varied from 9-90 mm. The variation in wall thickness was 15-60 mm in some portions of the burden area. The seat area wall thickness was 9-10 mm. Only 90% of the wall thickness of the seat area was worn out in service. From the measurement of the wall thickness at various locations, it was concluded that worn out magnitude does not have any pattern and the variation is too high across the large bell.

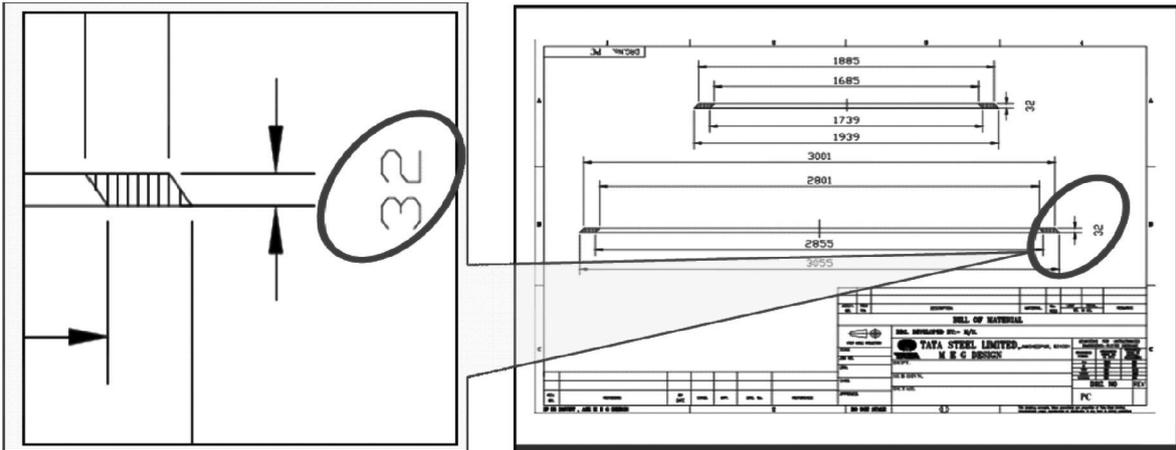
Fig.7 : Modified drawing of stiffene

With the circular ribs to be placed from inside. These circular members will be supported by number of vertical stiffener to be placed at equal space. These stiffeners were fabricated from 32 mm thick plate of IS 2062. These members after gas cutting and debarring fixed in inner wall of the large bell. The detail of the stiffener drawing is depicted in Fig. 7 and after erection of the stiffener is shown in Fig.8:

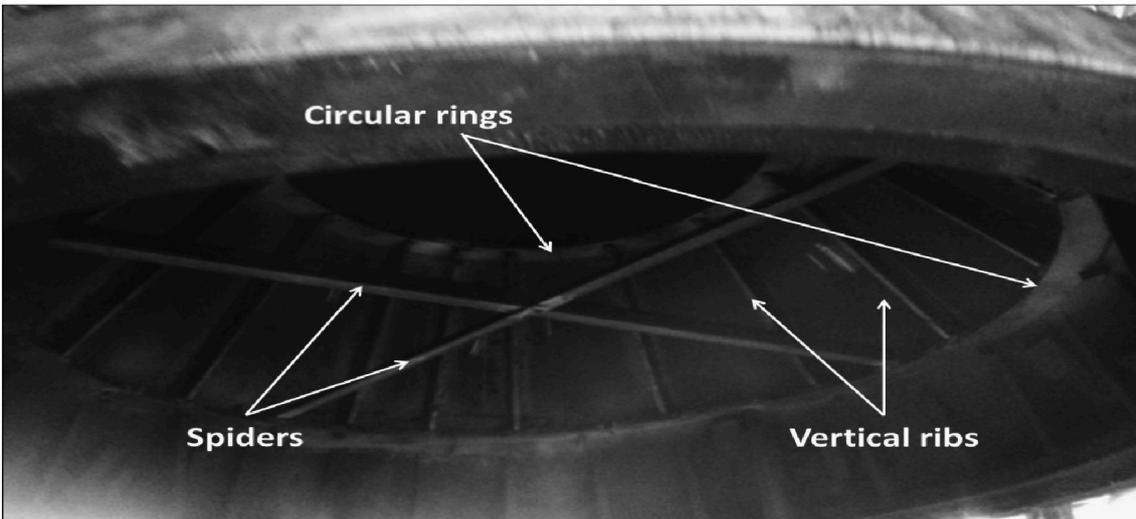
Fig.8 : Stiffener after fixing in the large bell

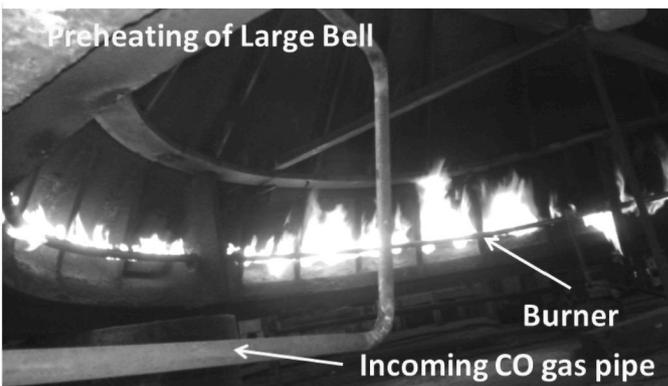
Fig.9 : Preheating of large bell

Preheating of the job and maintaining the inter pass temperature during welding is the fore most important parameter during salvaging. Circular burner in semi-circular shape was fabricated from the 1 inch dia mild steel pipe. One side of the pipe was made perforated for gas to come out. The circular parts fixed from inside to make in circular shape. Two pipelines were welded with the pipeline to give separate input of coke oven gas and oxygen. This is then ignited to start the preheating process.

The preheating process is depicted in the **Fig. 9**.

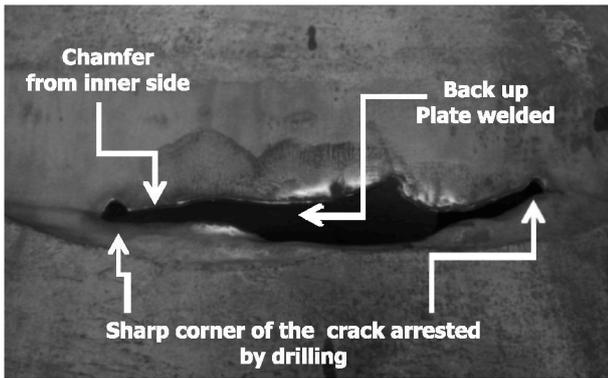
Fig.11 : Temperature measurement

Repairing of the highly worn out zone started with repairing of the punctured area. The punctured areas were regularized with gas cutting. The surface area is made chamfered in the direction of the inner wall. The sharp ends are rounded off by drilling to avoid sharp edges.

Back up plate made of 8 mm thick mild steel plate is welded

from inside. All the punctured area covered with back up plate. Details are shown in the **Fig. 11**.

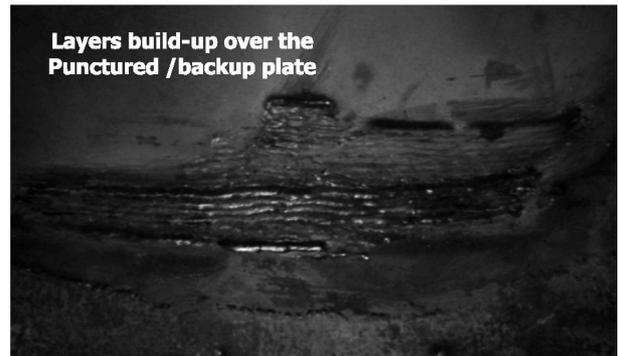
Fig.12 : Layers build up over the backup plate

After preheating, welding was started to fill up the punctured area. Welding started from the bottom base to the upward direction. This welding was carried out with 7018 electrode. Three layers welding was carried out in same manner to build up a solid bottom base. The details are shown in the **Fig.12**. After completion of the final welding these back up plates were removed by gauging. The solid integral weld pools now became the part of the large bell. Due to shortage of time span and the quantum of build-up on the damaged burden area, plates were cut into different sizes drilled at various length and then plug welded. These plates are made from 32 mm thick mild steel plate. Both ends are chamfered by gas cutting. After that final three layers of 17% Cr-4% Mn welded to make up the uniformity in the shape and also it is the buffer layer of non machinable hardfacing. The details are shown in the **Fig. 13 & 14**.

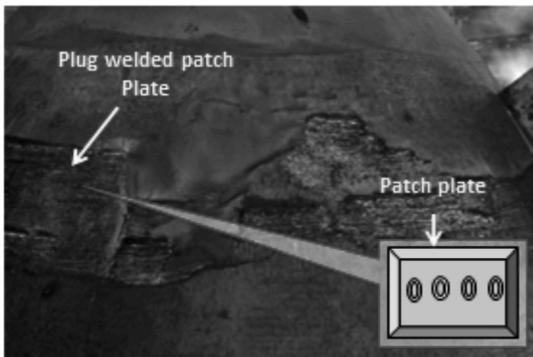
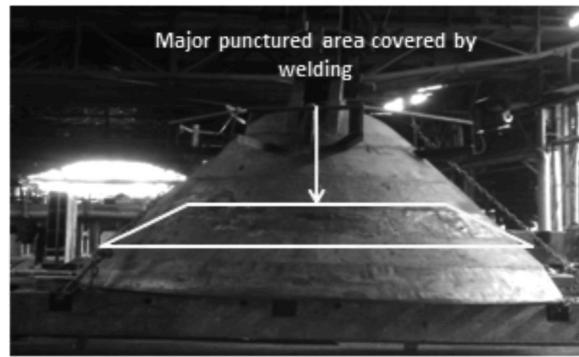
Fig.13 : Plug welded plates

Fig.14 : The major worn out area (after repairing)

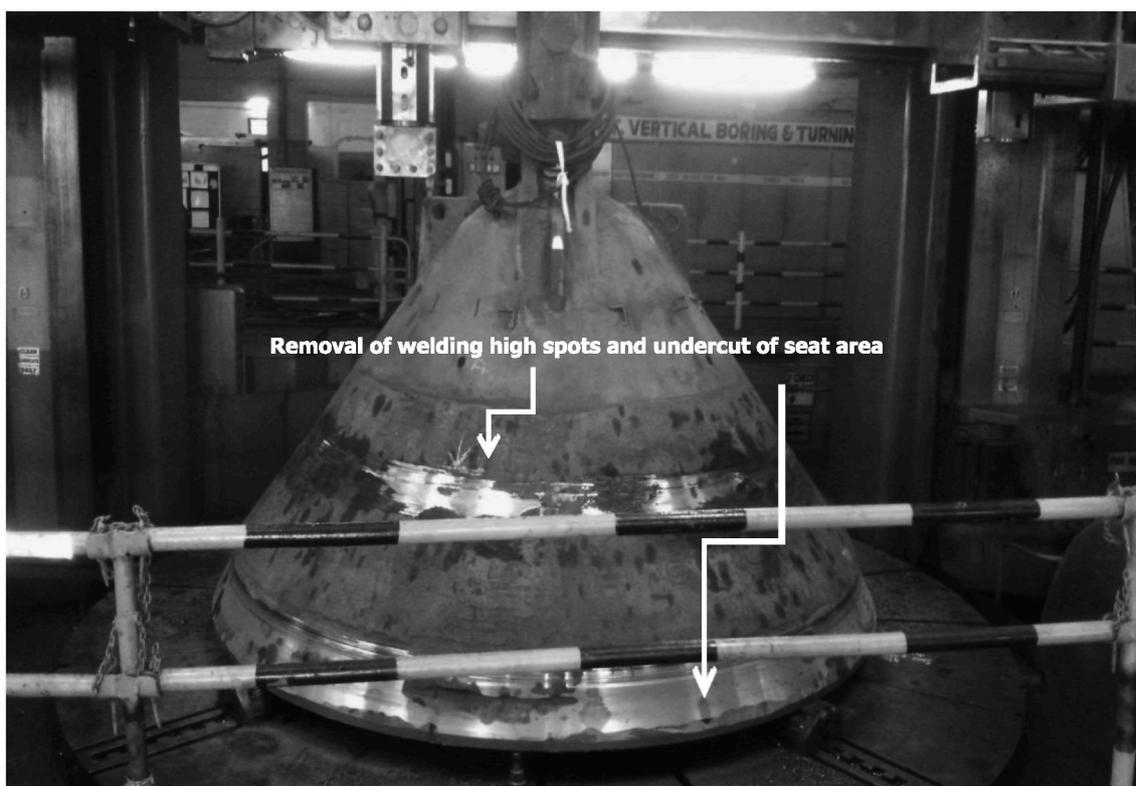
Fig.15 : Undercut and removal of welding high spots

The welding high spots in the major punctured area are removed by machining in vertical boring machine. Undercutting the seat areas are done in the same machine. The details are depicted in the **Fig.15**.

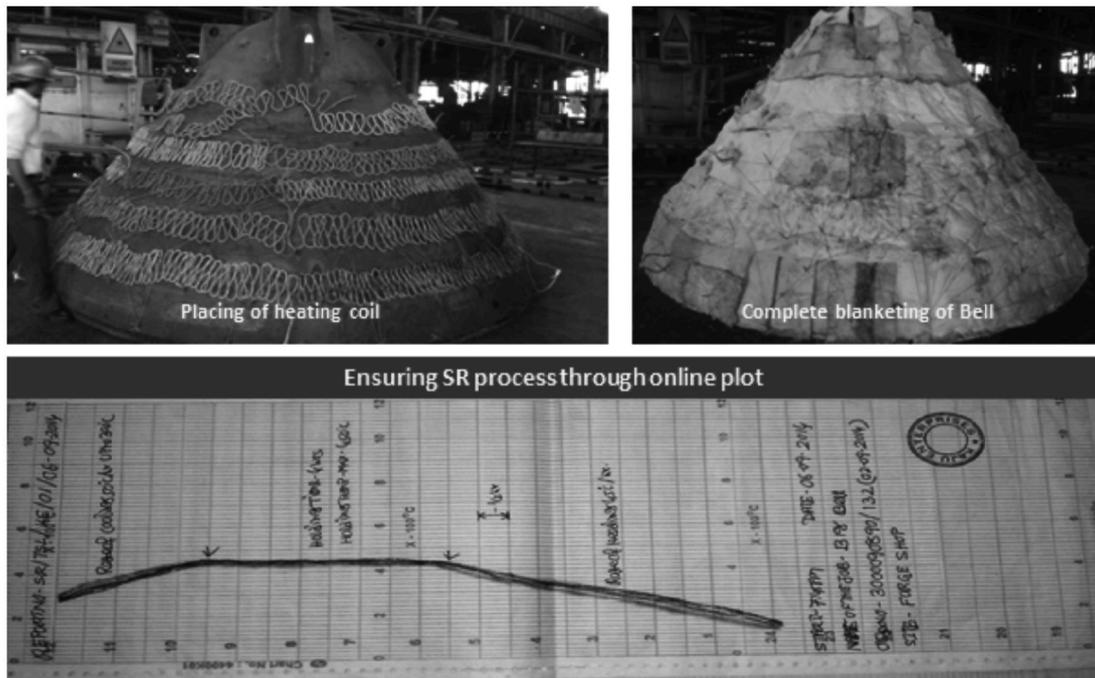
Fig.16 : In situ SR of Large bell

Since there was no in house facility available to carry out SR of such big job, it was decided to carry out in-situ. The process applied was at 450 ± 10 °C, 4 Hrs+15' (ST). slow cooling upto room temperature. The induction heating method was applied. The large bell was completely insulated by thermal blanketing both from inside and outside. Thermocouples were put at three different zones from outside to measure the temperature of each zone. These three thermocouple output were connected with the online plot and display. Slower rate of heating was adopted to avoid distortion in the job. The details of the process with online plots are shown in the **Fig. 16**.

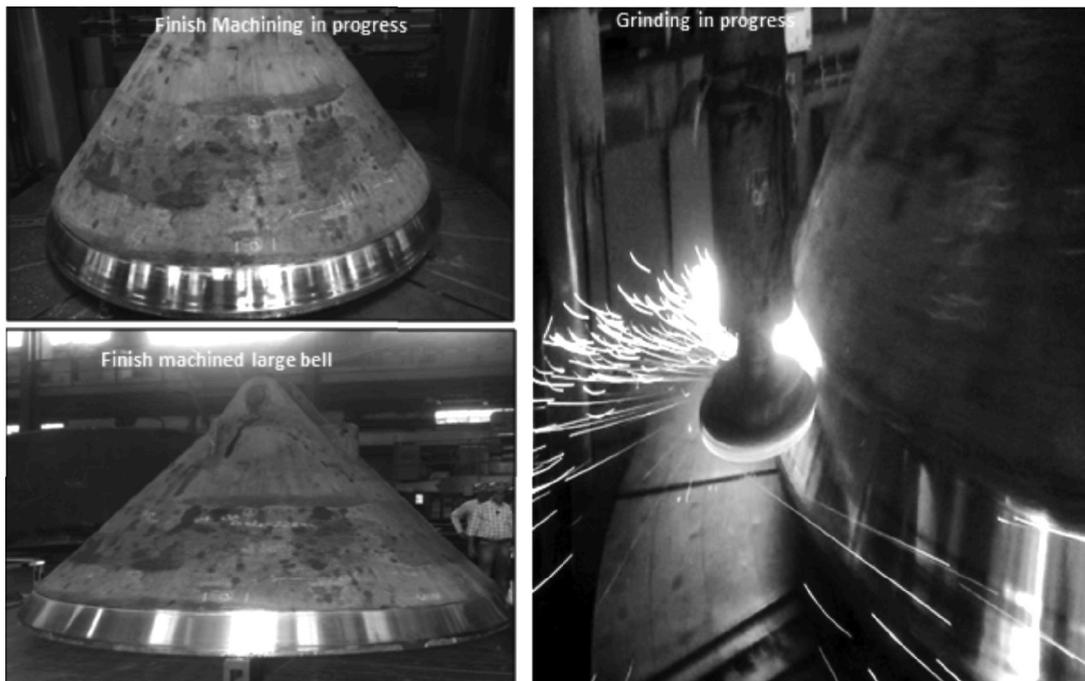
Fig.17 : Finish machining & grinding of large bell

After SR large bell is sent to machine shop for final machining. Finish machining is carried out at the seat area in vertical boring machine. This machine is unique in its nature to have unique gearing facility for taper turning. The requirement of machining at the seat area was to be at 600. The seat area of the large bell hopper was also grinded at 600 for better sealing. After taper turning, grinding is carried out in the seat portion with the same setting of finish grinding of large bell hopper. This has ensured to have same surface of large bell and hopper. Fig.18 shows turning and grinding operation of the large bell:

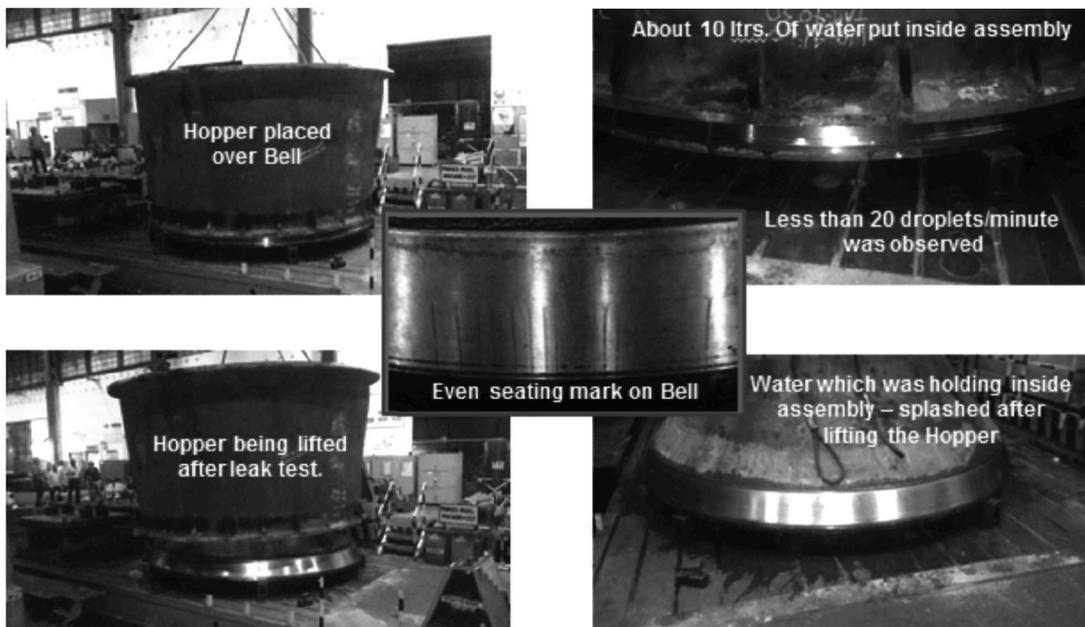
There was no surface defect detected in the process. Balancing operation is carried out of the large bell. It came within 1.0 mm against the requirement of ± 1.5 mm. After balancing the large bell hopper assembly is leak tested. The leak test is most important parameter as this eliminates the probability of gas leakage from the sealing area. In order to carry out the leak test, the large bell hopper is placed over the large bell. Ten litres of water was put inside the assembly and the results are as follows:

- Less than 20 droplets/minute of water came out from the assembly against the requirement of maximum 50 droplet /minute
- Even seating mark was observed in the bell as shown in the Fig.18.
- The length of seating portion was 225 mm from the bottom against the requirement of 223 mm

Fig. 18 : Leak test of large bell & hopper assembly
