Investigation of repeated economiser tube failures of a 135 tph cold cyclone CFB boiler – a case study

There were quick and successive failures of economiser tubes in a four years old cold cyclone circulating fluidised bed 135 tph boiler in a short span of three months. Advance inspection and failure analysis, change in operational practices were used to get the boiler running at full load at the earliest possible time. This paper presents details of the process of inspection, maintenance, operation and failure investigation carried out for the economiser tubes of the boiler. The failure of the economiser tubes was due to external corrosion of the tubes furnace fire side due to presence of sulphur in coal, accompanied by localised erosion by high levels of alpha-quartz in coal ash.

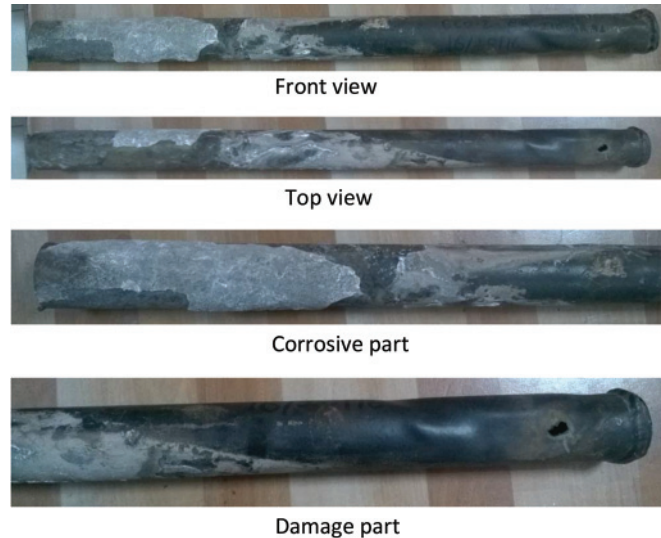
The boiler had tripped on low drum level caused due to water leakage from the economiser tube. On opening the boiler cyclone side economiser manhole, the chamber was found with water. Economiser tube facing the fire side of the chamber was found leaking. Two of the tubes were found ruptured opened up and two tubes were found with pinhole leak. Though damaged tubes were found with sticking ash, any significant bulging of tubes was not observed. The following figures and tables contain the analysis conducted on the two failed service-exposed economiser tubes. The primary objective is to find out the reason for failure of the cited tubes.

(a) Sample-1 : Failed service exposed economiser tube '1' (43 MW unit CFBC unit 135 tph)

Fig.3: Failed economiser tube 1

- (iii) Arrangement to shield fuel impinging tube surface: The arrangement of shielding of service exposed economiser tubes particularly towards the coal-ash impinging side with SA213 304H stainless tube halves of 2.5 mm thick and internal diameter of 38.1 mm (1.5 inch) may reduce the impingement linked erosion effect.

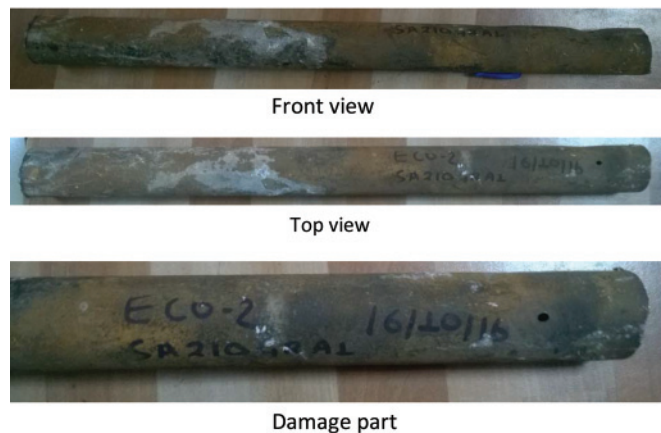
Fig.4: Failed economiser tube 2

(b) Sample-2 : Failed service exposed economiser tube '2' (43 MW unit CFBC unit 135 tph)

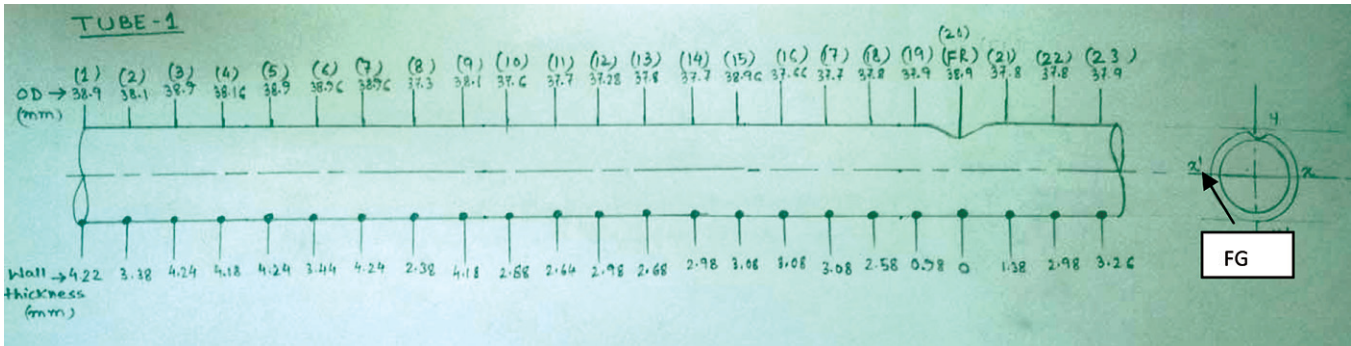
Fig.8: Measured readings of failed economiser tube 1
 (FR) – Failure region; OD – Outer diameter •→ Wall thickness flue gas direction
 OD corresponding to points 1, 2, 3, ... FR, ..., 23 in XX' and YY' directions.

•	Distance from right (in mm)	Along XX ¹ (in mm)	Along YY ¹ (in mm)	Thickness (in mm)
1	230	38.9	38.94	4.22
2	220	38.1	38.1	3.38
3	210	38.9	38.96	4.24
4	200	38.16	38.9	4.18
5	190	38.9	38.96	4.24
6	180	38.96	38.16	3.44
7	170	38.96	38.96	4.24
8	160	37.3	37.1	2.38
9	150	38.1	38.9	4.18
10	140	37.6	37.6	2.88
11	130	37.7	37.36	2.64
12	120	37.28	37.7	2.98
13	110	37.8	37.4	2.68
14	100	37.7	37.7	2.98
15	90	38.96	37.8	3.08
16	80	37.66	37.8	3.08
17	70	37.7	37.8	3.08
18	60	37.8	37.3	2.58
19	50	37.9	35.7	0.98
20(FR)	40	38.9	34.72	0
21	30	37.8	36.1	1.38
22	20	37.8	37.7	2.98
23	10	37.9	37.98	3.26

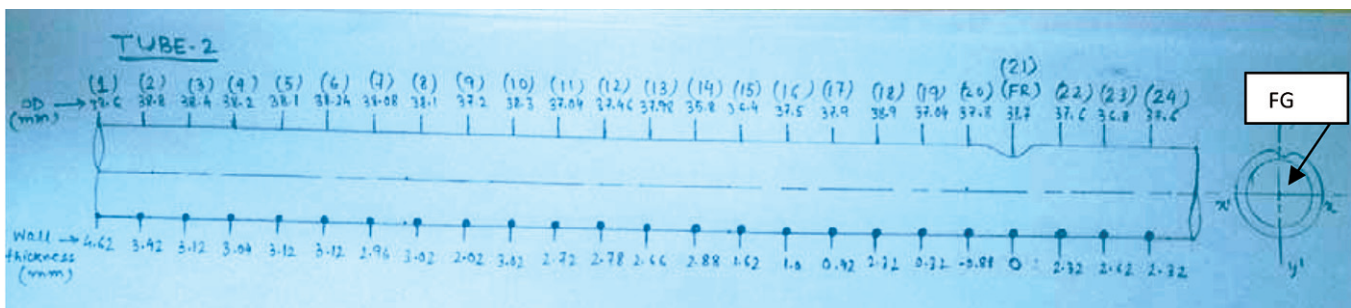
Fig.9: Measured readings of failed economiser tube 2
 (FR) – Failure Region; OD – Outer diameter •→ Wall thickness flue gas direction
 OD corresponding to points 1, 2, 3, ..., FR, ..., 24 in XX' and YY' directions

Distance from right (in mm)	Along XX ¹ (in mm)	Along YY ¹ (in mm)	Thickness (in mm)
1	250	38.6	39.7	4.62
2	240	38.8	38.5	3.42
3	230	38.4	38.2	3.12
4	220	38.2	38.14	3.04
5	210	38.1	38.2	3.12
6	200	38.24	38.2	3.12
7	190	38.08	38.04	2.96
8	180	38.1	38.1	3.02
9	170	37.2	37.1	2.02
10	160	38.3	38.1	3.02
11	150	37.04	37.8	2.72
12	140	37.46	37.86	2.78
13	130	37.98	37.74	2.66
14	120	35.8	37.96	2.88
15	110	36.4	36.7	1.62
16	100	37.5	36.08	1
17	90	37.9	35.5	0.42
18	80	38.9	37.4	2.32
19	70	37.04	35.4	0.32
20	60	37.8	34.2	-0.88
21(FR)	50	37.7	35.3	0
22	40	37.6	37.4	2.32
23	30	36.8	37.7	2.62
24	20	37.6	37.4	2.32
