Role of geological discontinuities during application of continuous miner technology in underground coal mines

3.0 Continuous miner technology in VK-7 incline mine, SCCL

4.0 Continuous miner technology in GDK-11 Incline, SCCL

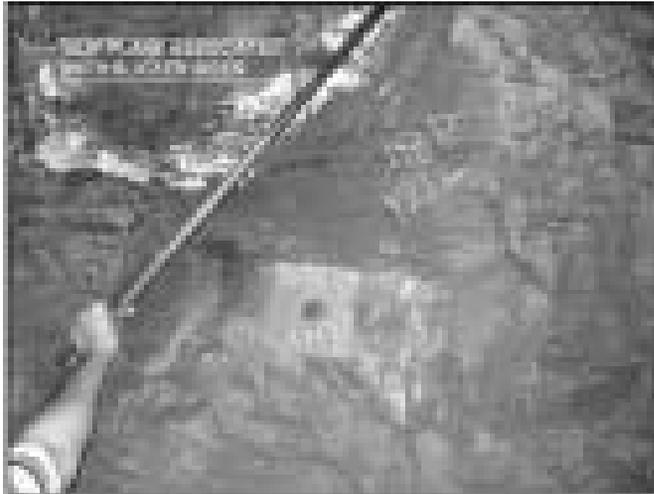
Fig.1a Slip plane associated with slicken sides

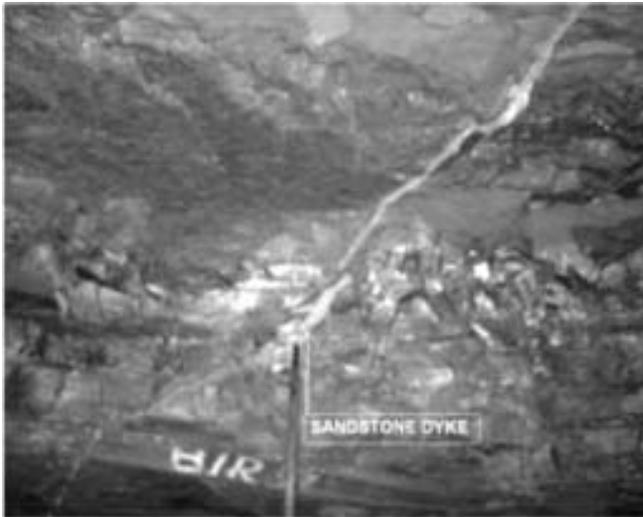
A clastic dyke is a tabular body of clastic material that has intruded into a fracture, joint or other zone of weakness in a coal seam, mine roof or floor. The clastic material may consist of sandstone, siltstone, clay or carbonate. The presence of clay veins in the roof of a coal mine creates hazardous condition. Sandstone dyke passing through a coal pillar causing pillar spalling is shown in Fig. 2 [3].

Fig.2 Sandstone dyke in the coal pillar, causing side spalling

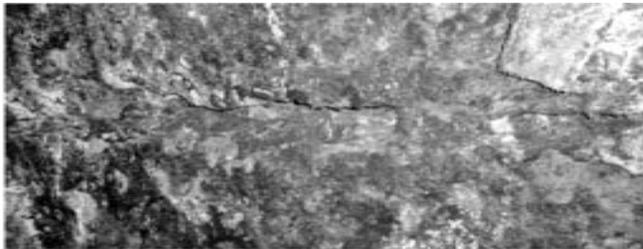
Fig.3 Fractures in roof

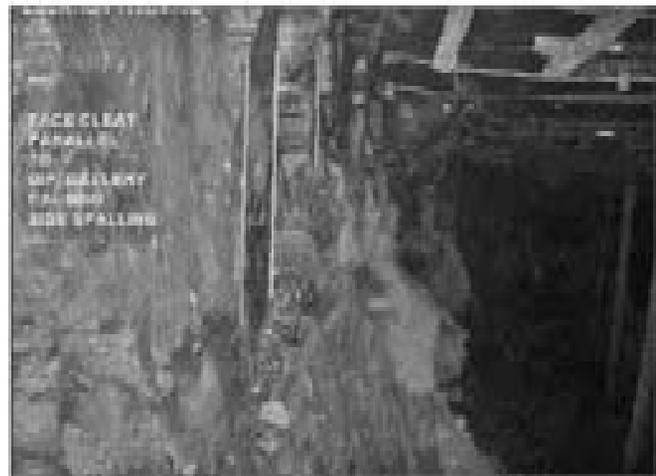
Fig.4b Side spalling in the dip galleries

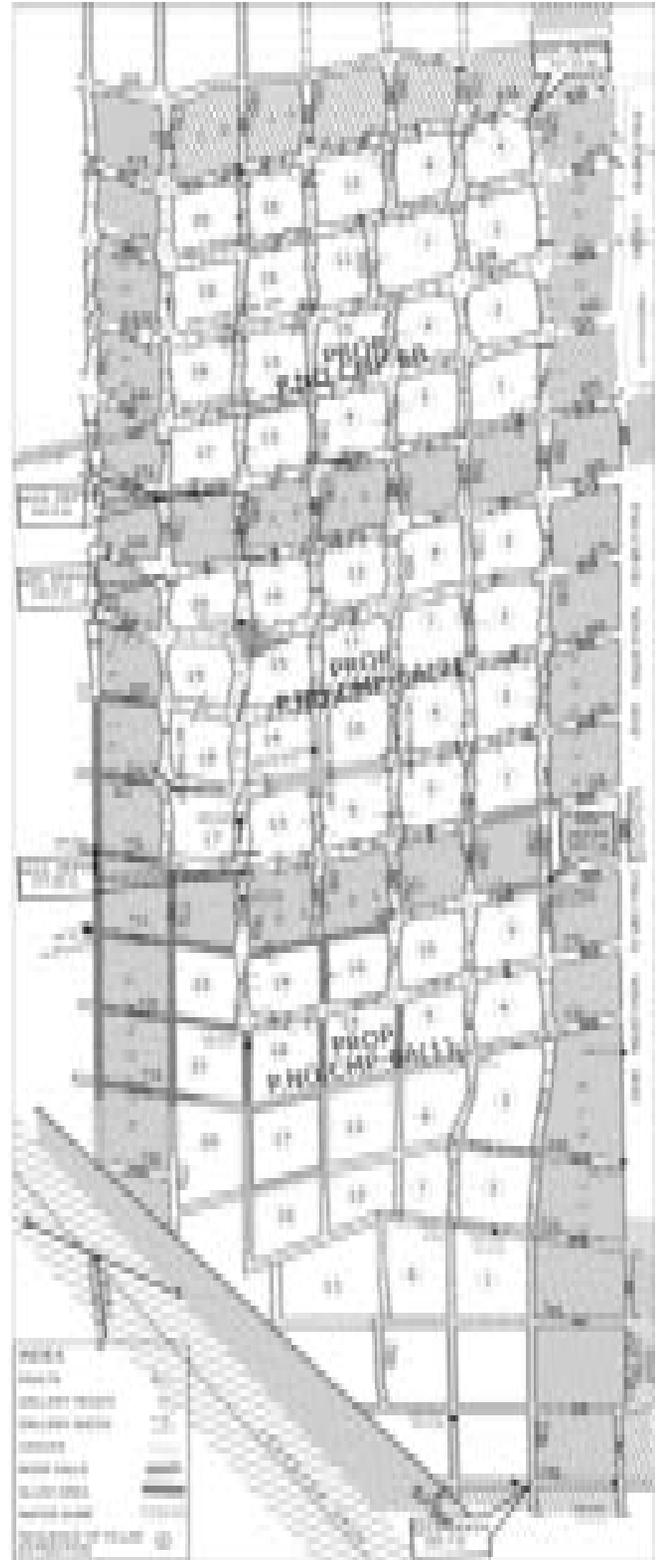
During extraction of CMP 6A(1), 6A(2) and 6B sub-panels at VK-7 Incline numerous faults, slips and fractures were encountered as shown in plan (Fig. 9). The RMR of the roof rock strata in the continuous miner district varies from 41 to 53. Interaction effects of top seam barriers have been observed in underlying king seam. Salient observations in underground workings were as follows:

- (i) The geological anomalies observed were mostly normal faults and slips with minor displacement. Faulting was prominent throughout the CMP-6 panel. The majority of the faults were minor with a displacement of less than 0.5m trending between N40°E and N70°E. Few major faults of throw ranging from 0.5 to 3.3m were also existed. A fault of 87m throw existed at the dip-most side in the area. In most cases, faults were oriented sub-parallel to the dip direction of the seam.
- (ii) The prominent joints sets were observed in these panels trending between N45°E and N75°E. The orientations of these joint sets were almost parallel to the corresponding faults and slip planes. Most of the joint surfaces were rough.

- (iii) Other frequently occurring features include thickly filled calcite joints, which are 0.03-0.04m thick and traversed both in the seam and roof causing weakening of roof in the panel. Trend of face cleat was in N 85°E direction while butt cleat was N5°W.
- (iv) Closed and open fractures were found throughout the panel. The fractures were oriented both along the dip-rise and level galleries. Fractures were more prominent below the left-out barrier pillars of overlying goaved out seam.
- (v) Some localised roof falls were observed and majority of which were associated with litho-logical anomalies (Fig.9). Localized spalling in the pillar sides and pillar corners were also observed at few places in the panels. Heaving of coal floor was observed in the roadways below the top seam barrier pillars.

Fig.9 Plan showing orientation of faults/slips, cracks, etc. in the sub-panels CMP-6A(1), 6A(2) and 6B

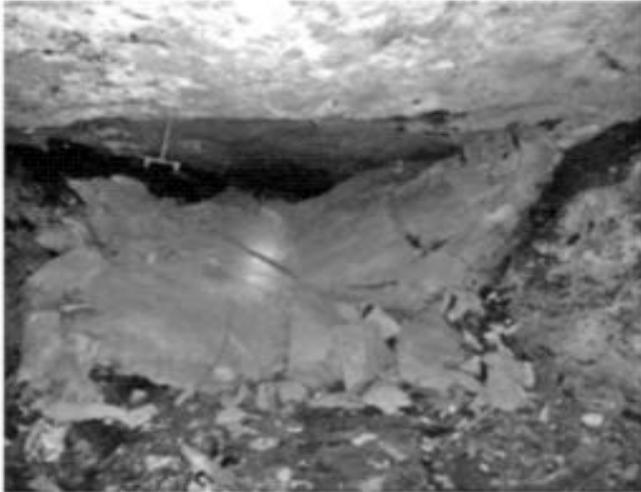
Fig.10 Roof fall at 24R/55L in VK-7 Incline

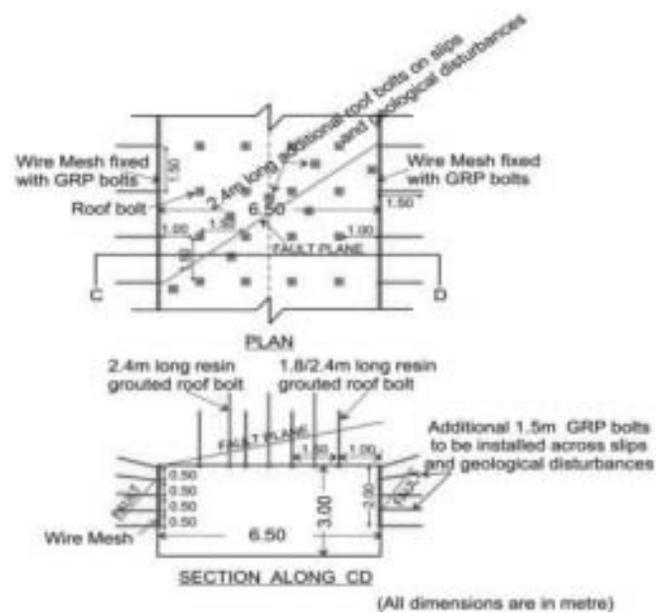
Fig.14 Support system for the area intersected with slips and faults

In case of slips and faults intersecting the galleries, supports of 2.4m long resin bolts were provided as shown in Fig.14 in addition to regular bolting in galleries and splits. Additional supports were also provided as per requirement in form of wire netting, roof bolts with W-straps, cogs or other supports in old and newly formed cracks, fractured roof, deteriorating roof, excessive wide roadways and junctions etc. During depillaring of CM sub-panels at VK-7 Incline, it was observed that falls were regular in goaf with extraction of pillars and occurred subsequently after fender extraction within a shift time. Stress build-up and side spillings were observed in the pillar under extraction and up to one pillar ahead only leaving all other pillars without any disturbances.

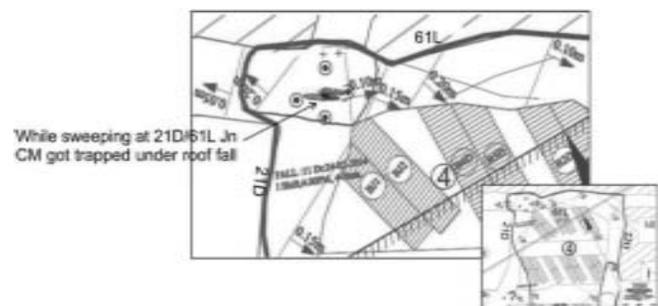
During the extraction of fourth pillar in CMP-6B subpanel, CM was trapped (Fig.15). It was found that this pillar was existed below top seam longwall barrier pillar. At the point of

trapping of CM, this pillar was encountered with several minor faults/slips and cracks. Slices were extracted normally. While extracting the last snook, auto warning tell-tale at the junction started flashing. Two slips that intersected formed an unsupported wedge was un-noticed. Therefore, while sweeping the junction, fall took place in the junction covering 80% area of the CM. Some damage had taken place in the CM and further extraction was stopped. Extraction was resumed after full filling the following measure steps:

Fig.15 Extraction of pillar No.4 with several minor faults/slips and cracks in 21D/61L junction

- (i) 5 numbers of 5m long flexi bolts were installed in all the junctions in addition to the 5 numbers of 10m long cable bolts. All the goaf edges were supported with 3 numbers of 5m long flexi bolts in addition to 2.4m bolts at $0.75\text{m} \times 0.75\text{m}$ grid pattern.
- (ii) All minor slips/intrusions/impressions and other geological disturbances were mapped and suitable support plan was prepared for securing the junctions. All sides were secured with plastic mesh.
- (iii) Faster rate of extraction was attempted to achieve for the better strata conditions and special strategy was

- (iv) Before extracting the last snook, careful marking of geological discontinuities in the roof rock strata was done and supported well with bolting.
- (v) No bottom sweeping of coal was recommended after extraction of snook and CM was withdrawn from the junction.

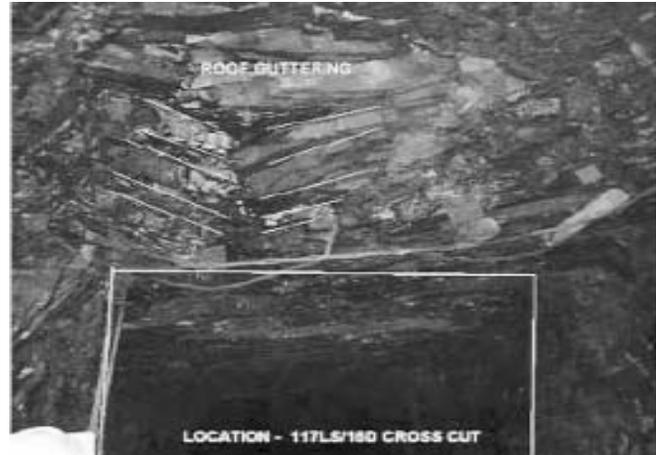
Fig.17 Roof guttering along level gallery

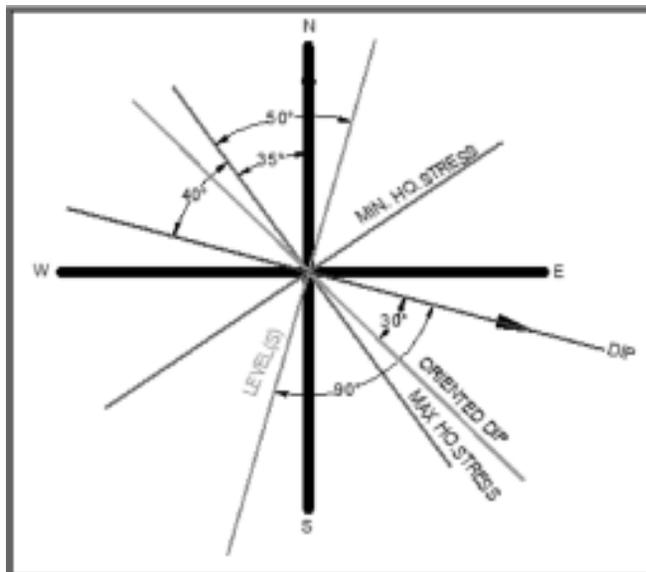
Fig.19 Oriented of dip galleries at GDK-11 Incline, SCCL

GDK-11 Incline of SCCL took place in dip galleries. Features like thinly laminated roof, cross stratification, washout, localized geological fractures present in the immediate roof might be responsible for the roof falls during development of the panel. During development of the pillar in square geometry, orientation of the dip-rise gallery was aligned unfavourably to the principal horizontal stress direction which was also responsible for the roof fall. So, the cut out distance in dip gallery was reduced to 4 to 6m causing frequent shifting of continuous miner affecting the production.

were drive with 60° instead of 90° which increased cut out distance from 6m to 12m. After re-orientation of pillar from square geometry to rhomboid geometry, frequency of roof falls in dip-rise galleries were reduced considerably [6-7]. Fig.19 indicates the original dip, oriented dip, level and horizontal stress directions.
