MAINTENANCE WELDING

By
S. Sankaran

The author is working as D/S, Boiler MTCF/ TSII, Neyveli Lignite Corporation, Neyveli

Paper presented at National Welding Seminar - 1995, Cochin

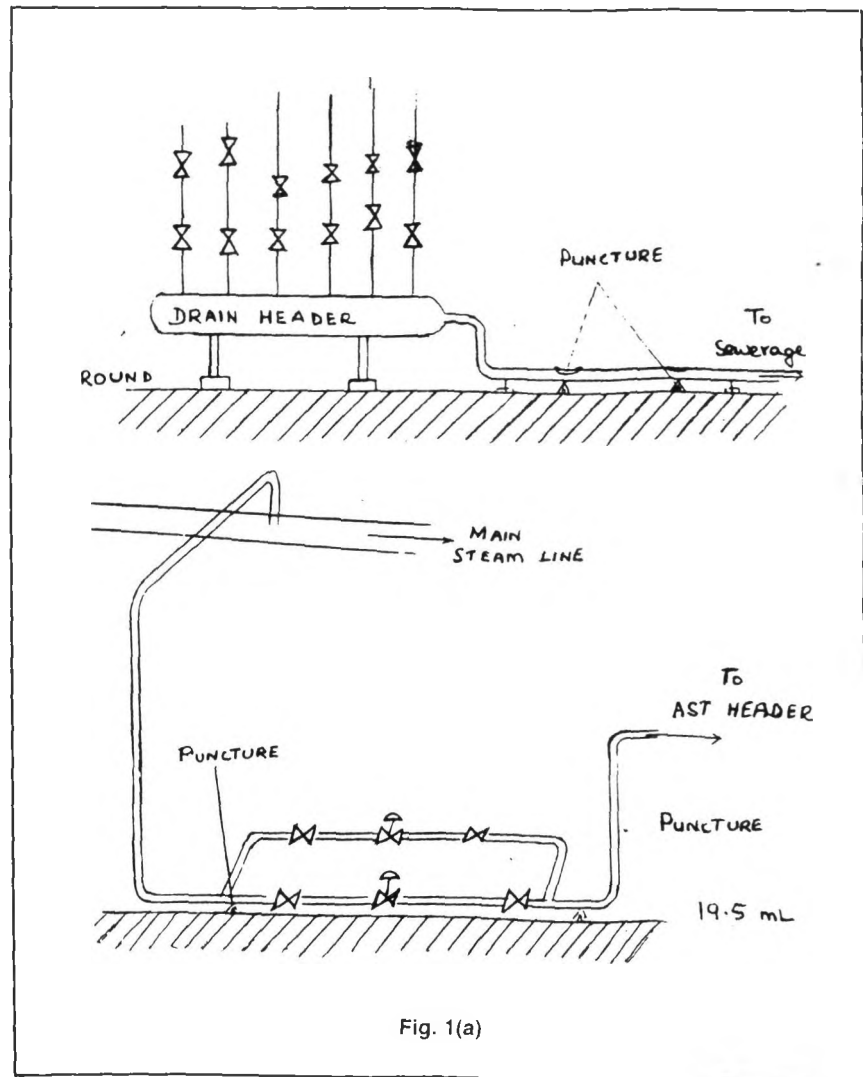
A sufficient size of opening will have to be cut in the pipeline above the point of defect and with the access available the defect is to be attended to. Then the window will have to be closed by a new piece cut from pipe of same size and materials. For high pressure application, use TIG welding for root run.

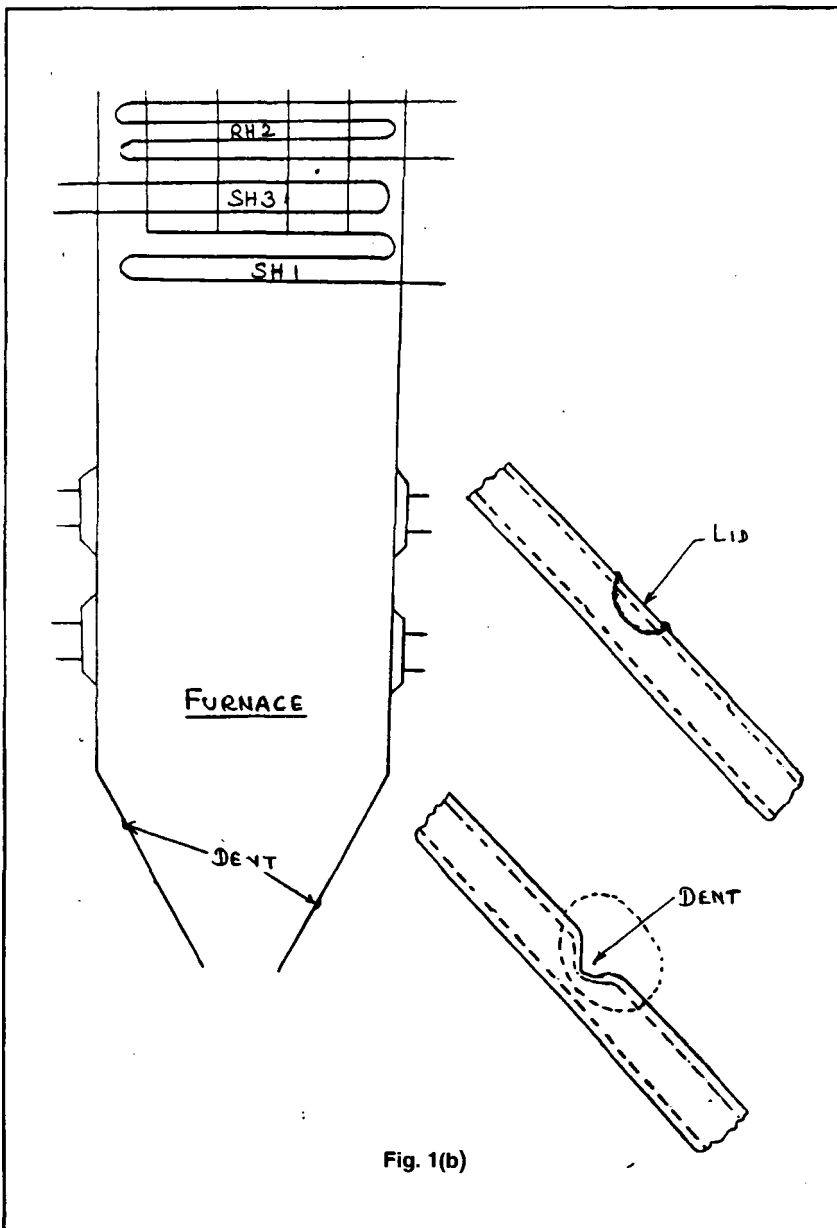
Fig. 1(b)

(b) Dents in Water Walls Fig.1(b)
Due to falling of clinkers or some such reasons sometimes dents oc-

cur in the bottom hopper portion of the water wall tubes inside the furnace. This may affect the circulation in the particular tube and that may burst open due to overheating. So they are to be replaced. Alternatively if the unit is to be taken back to service immediately the window technique can be made use of for replacing the dented portion instead of the whole tube.

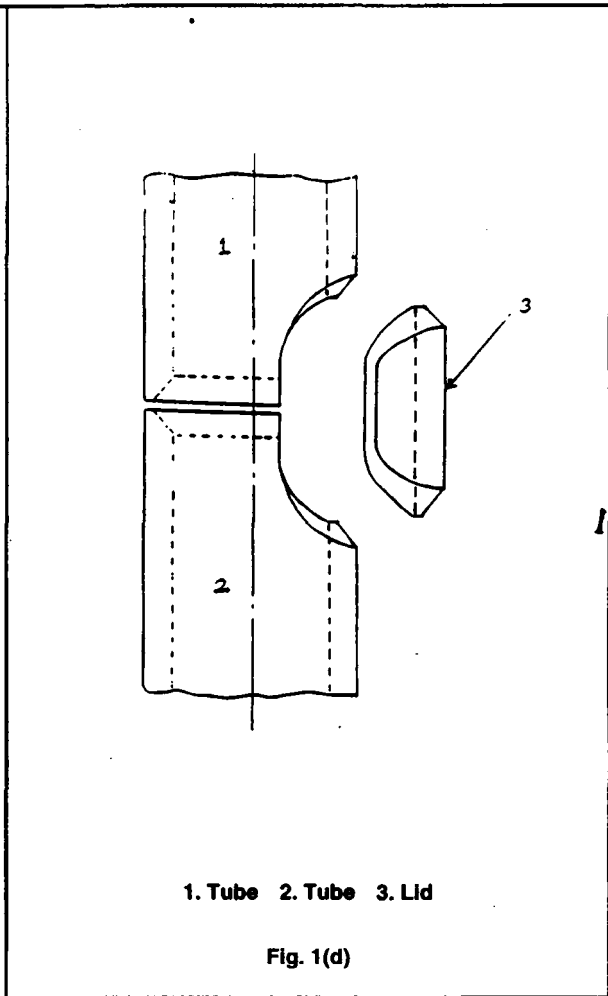
Fig. 1(d)

1. Tube 2. Tube 3. Lid

1. As Radiography of the joint could not be taken due to the inaccessibility of the other side, junction points [See points 1, 2

in Fig.1[d] are to be ground and Dye penetrant Test is to be carried out before and after welding of the window lid {part no. 3 in Fig.1[d].

8. Use TIG Welding for completing the inner half root welding.
9. Grind the junction points and cheek for slag inclusion or porosity. If in doubt use DP testing.
10. Now close the window by a suitable pieces of same configuration.
11. Complete the Fin Welding.

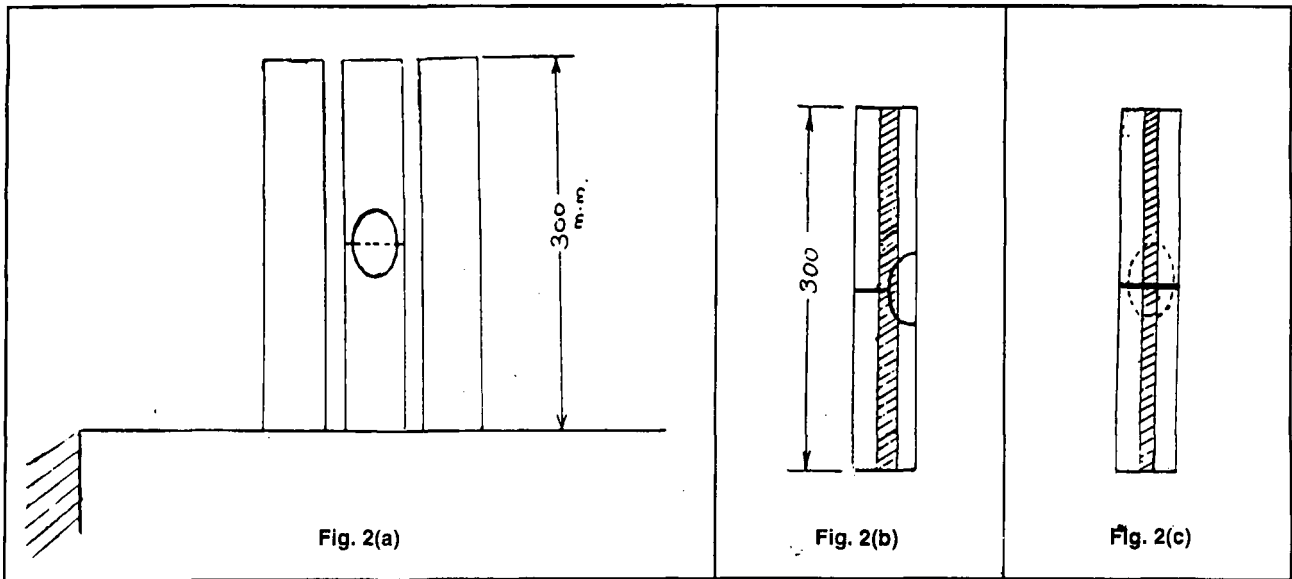
A test specimen of sizes as shown in Fig.2(a) shall be prepared and fixed vertical in 2 G Position. On either side of the test specimen, tubes of the same sizes and height shall be kept as close as possible as shown in Fig.2(a).

Also two specimen from the position shown in Fig.2(b) [each on other side] and one specimen as per Fig.2(c) shall be cut and bend tested. In all Bend Testing, angle of bend shall be 90 and the root under tension. If all the above requirements are satisfied a welder is fully qualified for performing the window type welding.
