Fatigue behaviour of Welded Joints of Structural Steel

By N. D. DAS*

ABSTRACT

The paper documents the results of fatigue tests carried out on welded samples of IS : 226 grade structural steel. The endurance limit of the welded joints under test conditions was found to be approximately 8.7 tons/sq. in.

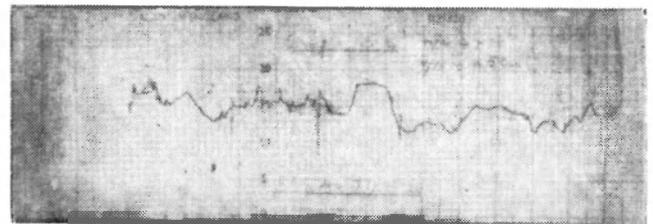
Fig. 3. Profile of the surface finish of the flat face of the specimen.

Measurement of surface finish of the specimens : Surface finish of the flat face of the specimens was measured with the Talysurf. The profile of the surface finish obtained is shown in the Fig. 3.

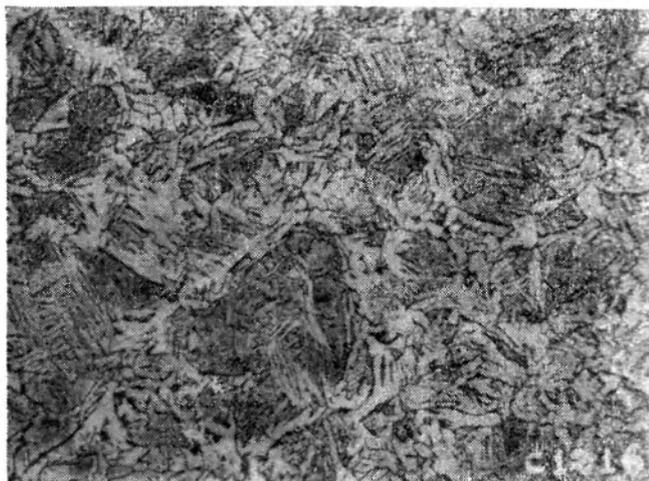
Magnification-300×

Fig. 9. Microstructure of welded metal. It shows the cast structure with dendrites.

tion. Fig. 9 is the micrograph of welded metal which represents a cast structure with dendrites.
