# A Numerical Study on the Fire Induced Collapse of a Real Life Warehouse Structure Based on Post-Fire NDT Results

Fires being a Low-Probability High-Consequence problem, can have a big impact on the structures due to their occurrence; irrespective of the construction materials. Even, the damage might lead to structural collapse. Such failures have warned to check the impact of fire on structural elements, which is frequently overlooked in popular design guidelines. Warehouses are used for the storage of different types of commodities; however, the vulnerability of these structures during fire event depends on the storage materials and other factors. Such a warehouse with steel roof trusses supported over Reinforced Cement Concrete (RCC) frame, located at Kolkata, suffered one of such severe fire-induced damage; and the roof truss system along with some portions of the brick masonry walls got totally collapsed. The information about the structure including its design data is presented along with the site observations after the fire incident, and the results of various Non-Destructive Tests (NDTs) performed over RCC frame elements. A severe fire of 8-hour duration led to a huge inc

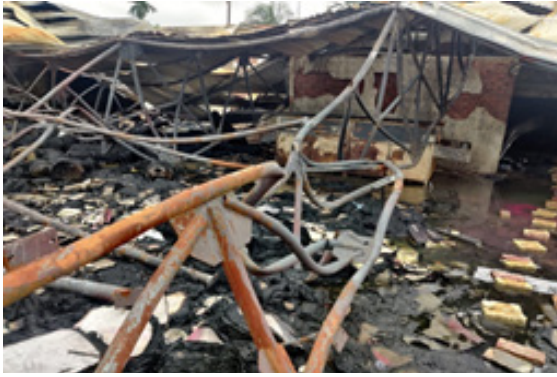
**Figure 1.** Failure of steel roof truss.

8 hrs.; and the roof truss system (Figure 1) along with some portions of the brick masonry (Figure 2) walls got totally collapsed. Although it did not claim any life loss; the inflammable storage materials were totally burnt out and caused a huge economic loss (Figure 3).

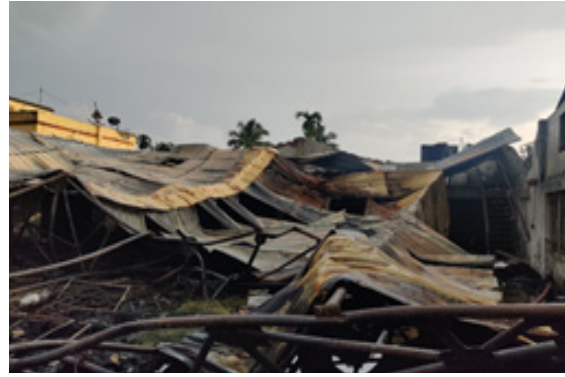
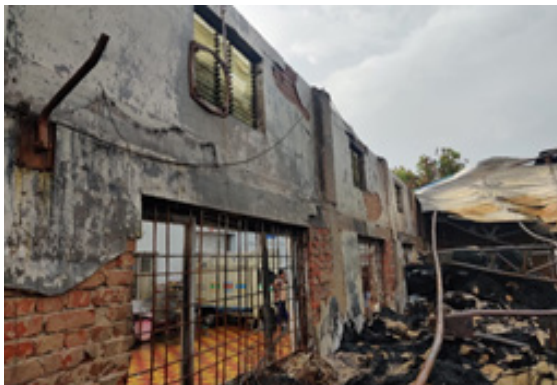
**Figure 2.** Collapse of brick masonry wall.

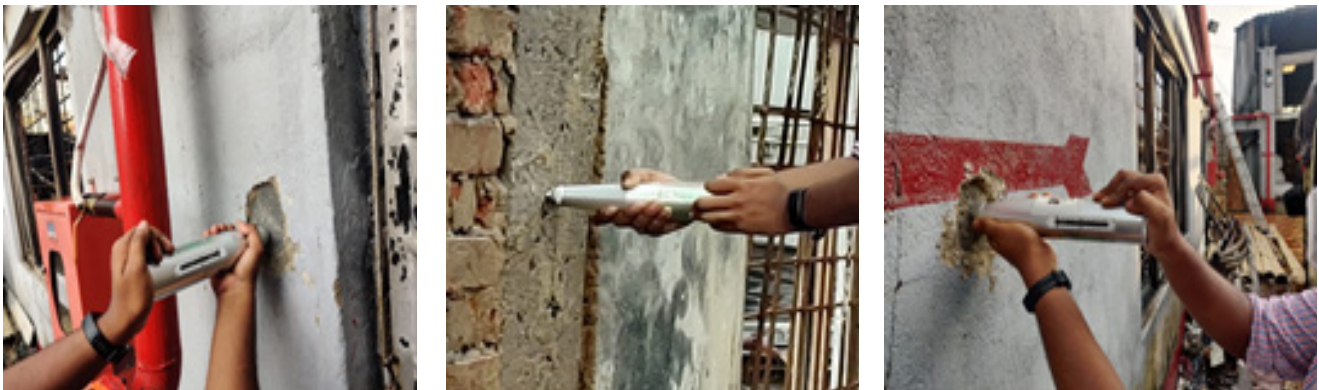
**Figure 5.** Rebound hammer test of the RCC frame members.

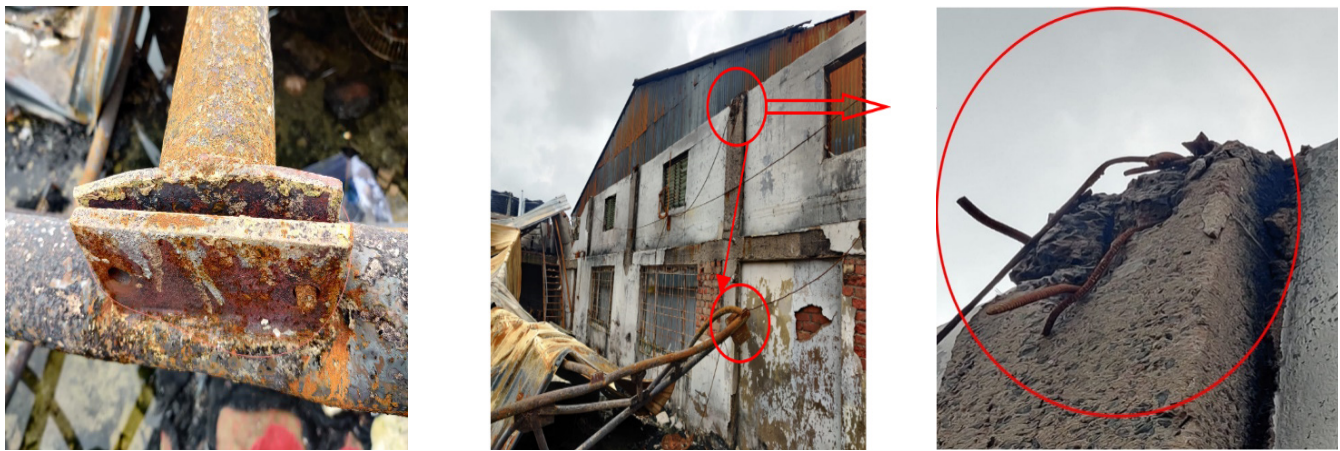
During visual inspection of the warehouse structure, considerable damage of truss joints and the connection between the roof truss and the columns were observed

**Figure 7.** Damage of the truss joint and connection between the roof truss and the columns.

(Figure 7); which is mainly due to the temperature load.

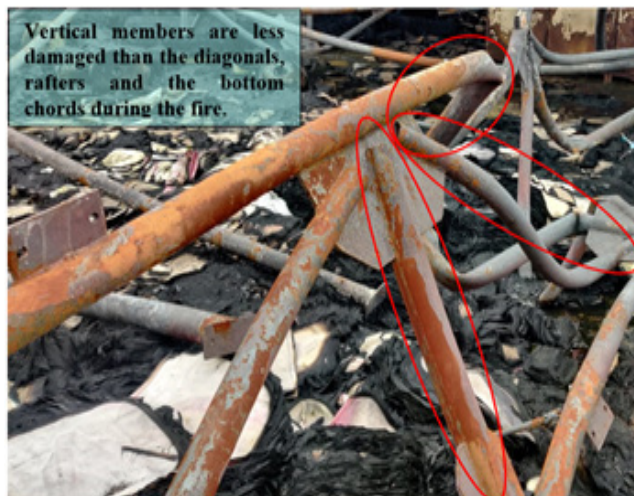
During visual inspection of the collapsed warehouse, it is observed that the vertical truss members are less prone to damage than the diagonals, rafters and bottom chords during the fire (Figure 16). From the present numerical study; it is quite evident that the interaction ratio of the vertical members is significantly lower than the

**Figure 16.** Damage extent of different truss members observed during visual inspection.

diagonals, rafters and bottom chords; when subjected to fire. The finite element analysis results are in tune with the observations of visual inspection; and thus are validated.
