INFLUENCE OF JOINT DESIGN & WELDING VARIABLES ON ETP COPPER

N.R. EDKIE* AND R.S. SOLANKI**

(Paper presented at the Workshop on "Joining of Copper and Copper Alloys" held at Kolkata on 24th September, 2003)

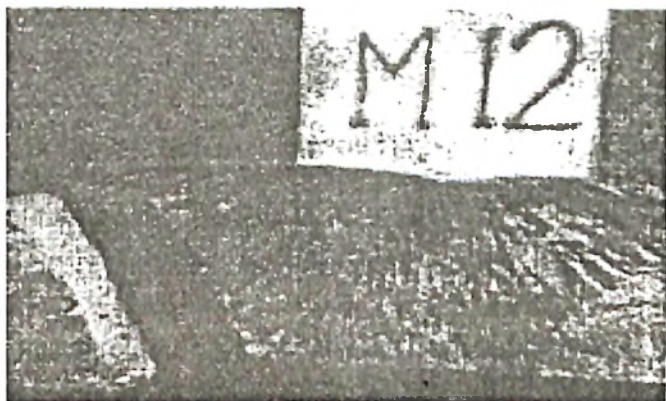
Fig. 6. A tensile tested specimen.

observed that both the weld joints of square butt type were fractured from the weldment, indicating poor quality of welding, but in the case of "V" groove weld all the specimens broke away from the joints as generally happens when the welding is sound. Fig 6 shows the tensile test fracture specimen with "V" groove of joint. It has been also demonstrated by tensile tests that scattered blunt flow (i.e., porosity, in this case) has no significant effect on the tensile strength of "V" groove type weld joints. This might have resulted from fact that the pores are not aligned in single plane.

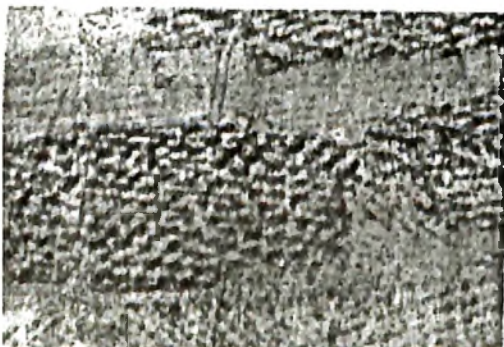
Fig. 8. Coarse - grained dendritic structure of weld metal (75X).

Some of the weld joints were cut and polished, and the specimens were then prepared for macro and microscopic examinations using the standard metallographic practice, to understand the changes that occurred in the weldment, HAZ and the parent metal due to the heat evolved during welding. Macrostructure of transverse cross-section at HAZ of defective welds M_{11} shows coarse-grained structure with gross porosity & copper oxide inclusions (Figs. 8 & 9).

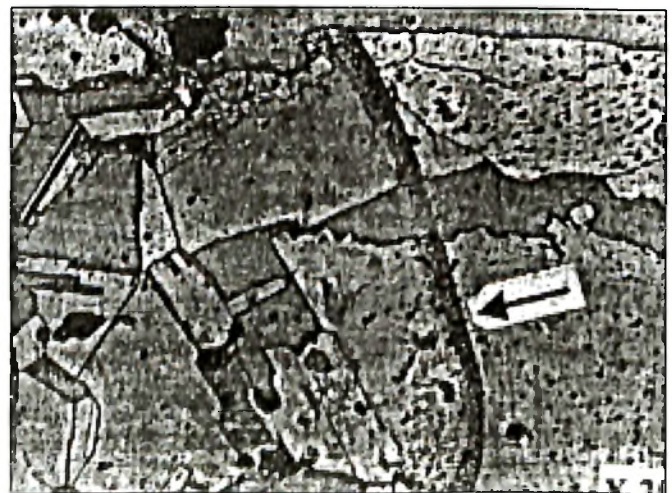
fusion boundary and equiaxial grains in the centre of the weld bead. HAZ could not be visually observed because ETP copper does not undergo phase transformations like steel. Fig. 10 shows a photograph of the fusion boundary. It is interesting to note the way in which the growth of columnar grains in the weld developed directly from the grains of the parent material adjacent to the fusion line. This type of grain growth is known as epitaxial. Up to a certain extent, such growth helps to improve the tensile strength of the material. The analysis also clearly reveals that the size and number of pores per unit area are more in the region that received less heat.

Fig. 10. Photomicrograph of fusion boundary.
