# Study on Weldability of EN 10025-6 S550 QT Steel

Cracks developed in the 90 mm thick EN 10025-6 S550 QT steel plates assembled to form a box unit. After assembly the surface cracks generated longitudinally along the elongated grains while preheating or performing root run. Root cause analysis was conducted to investigate the reason for the failure and also how to specify the "conditions of materials on delivery" during procurement is generated. Various tests such as visual test, chemical composition, inclusion rating, microstructure, dye penetrant test and hardness tests were conducted. The investigation revealed that the failure cracks could be due to temper embrittlement due to the segregations of impurities such as tin, arsenic, phosphorus and antimony, etc. in the grain boundaries and resulted in ductile to brittle transformation when exposed in the temperature. It is observed that, depends on the concentration of Ti and N in steel, coarse and cuboidal TiN particles of several micrometers in size act as potential sites for cleavage crack initiation. Furthermore, during the steel making process if sulfur is not properly controlled, then large MnS inclusions can also form duri

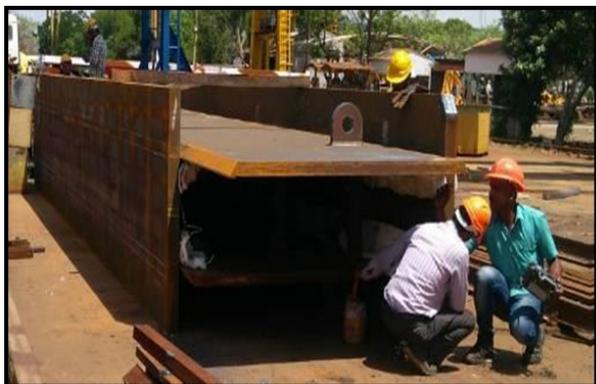
The 90 mm thick plate was assembled with 70 mm plate as shown in the **Figs. 1&2**. The thinner part was beveled and assembled with 90 mm thick plate as box section. The flange of the box section made with 90 mm and the web portion made with 70 mm thick plates.

Fig. 1 : Box section fit- up

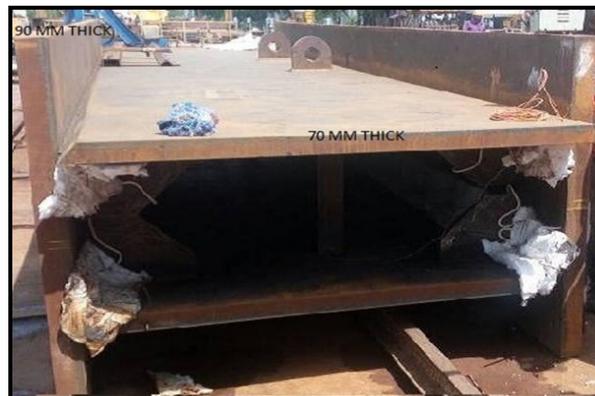
Fig. 2 : Assembled box with preheater

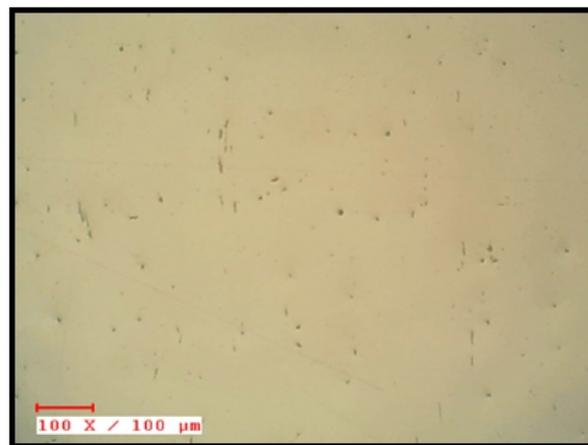
The inclusions test was conducted as per ASTM E-45-13 Method A. The inclusion rates for 70 mm and 90 mm thick plate is given in **Table 2, 3 & 4** and indicate that the inclusion rate in 90 mm plate is higher than that of the 70 mm plate and the photos of 90 & 70 mm thick plates are shown in **Figs. 3 & 4** respectively. The presence of inclusions leads to different thermal expansions of the steel matrix and of the non-metallic inclusions. The welding/ preheating induce stresses in the steel matrix near the inclusions and increase in stress result in strain as well as nucleation and/or propagation of cracks in the steel matrix. From **Table 2** it is observed that presence of higher inclusions result in an increase in the stress field proportionally to the size and the number.

**Fig. 3 : Inclusion in the 90 mm thick plate**

The values of these stresses depend largely on the difference in the thermal expansion coefficients between the steel matrix and the non-metallic inclusions. The additional stresses in non-metallic inclusions and the steel matrix that arises during heating and cooling create additional stress fields around Non-Metallic Inclusion (NMI) and steel matrix due to different thermal expansions during heating and cooling and resulting in the propagation of crack due to the stress field in the steel matrix around the inclusions.

The magnitude of the effect of non-metallic inclusions on increase in stress depends on coefficient of the thermal expansion of the NMI of the steel. Hence it divulges that, the presence of higher inclusion with heat resulted in originating crack in the base metal.

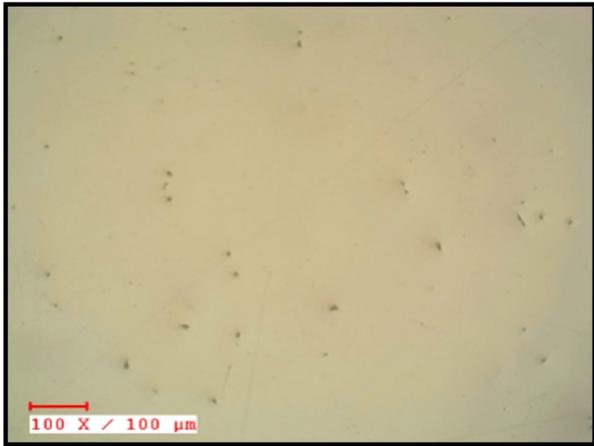
Fig. 4 : Inclusions in the 70 mm thick plate

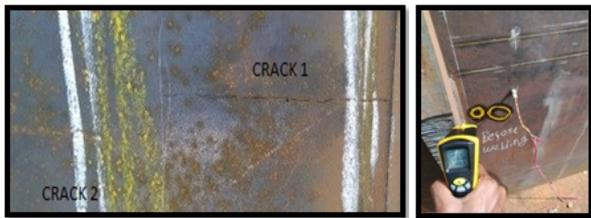
The defective job was subjected to visual, dye penetrant test and ultrasonic test. The cracks were observed in the longitudinal direction of the grains and the maximum length of the crack was 350 mm and the depth was 22 mm. **Figs. 5 & 6** show the presence of the crack in the 90mm thick plate in longitudinal direction and the cracks was originated away from the joint.

Fig. 5 : The longitudinal crack on the surface

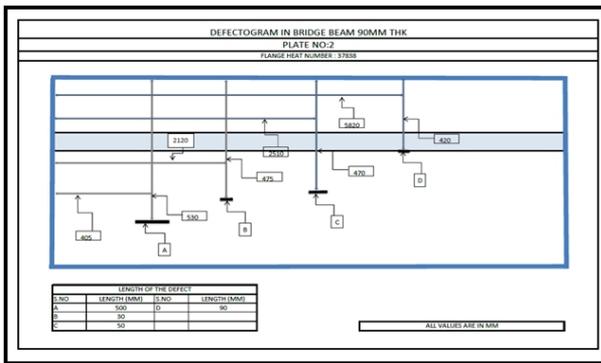
Fig. 6: The crack zone before welding (Stage: During preheating- Plate No: 2)

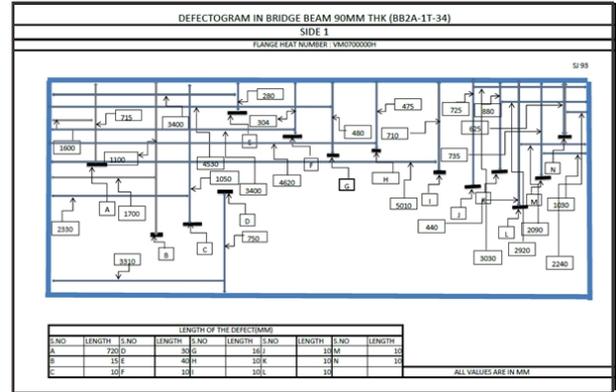
Fig. 7 : The crack zone during welding (Stage: After preheating, 6 layers Welding) - Plate No: 1

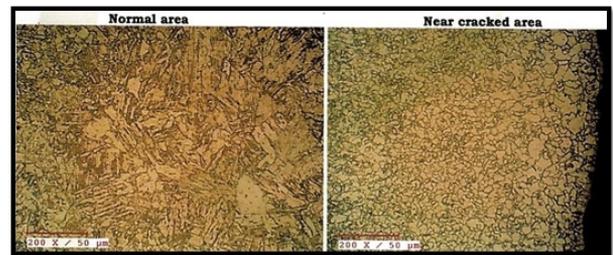
The microstructure of the 90 mm thick plate shows the low carbon martensitic structure and ferrite grains and also reveals non-homogeneity of the structure. The specimen was etched by using 4% Nital and magnified to 200 X. The standard reference used for this study is ASTM E3-11, ASTM E4-07.

The microstructure of the normal area (**Fig. 7**) shows low carbon martensite and ferrite grains in some location and it divulge non-homogeneity in the structure, whereas in the near crack area shows ferrite grain structure (**Fig. 8**). The microstructure of the 90 mm thick plate reveals (**Fig. 9**) fine grained low carbon martensite and coarse grained microstructure in 70mm plate is observed and shown in **Fig. 10**.

Fig. 8 : Microstructure of 90 mm plate (normal area), Microstructure of 90 mm plate near cracked zone

When carbon or low alloy steels are cooled slowly from 575 degree centigrade or tempered for extended times between 375 and 575 degree a loss in toughness occurs that manifests itself in reduced notched-bar impact strength resulting from tempering cycles and relatively fast cooling rates. The cause of temper embrittlement is believed to be precipitation of compounds containing trace elements such as tin, arsenic, antimony, and phosphorous along with chromium and

manganese. It suggest that the embrittlement occurs at prior austenite grain boundris. Although manganese and chromium cannot be restricted, a reduction of the elements and quenching from above 575 degree are the most effective remedies for this type of embrittlement [3].

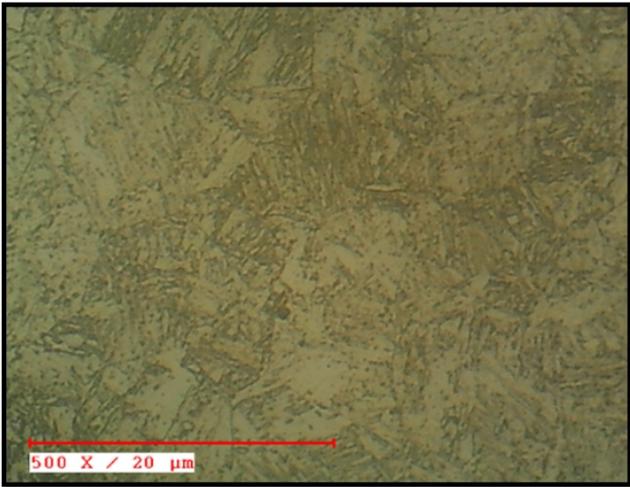
Fig. 9 : Microstructure of 90 mm plate

It is also observed that the grains are elongated in 90 mm plate. However, the 70 mm thick plates did not show any cracks though both materials are pertaining to the same heat. It could be due to that, during the reduction from the ingot due to multiple rolling the 70 mm thick plate grain underwent recrystallization and resulted in uniform grain size and inclusions are broken down.

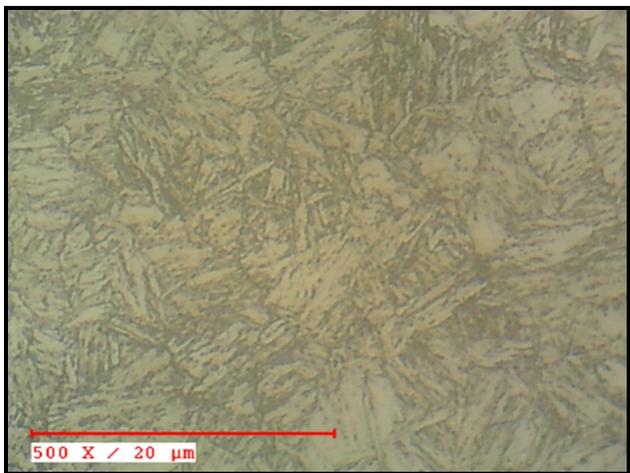
Fig. 10 : Microstructure of 70 mm plate

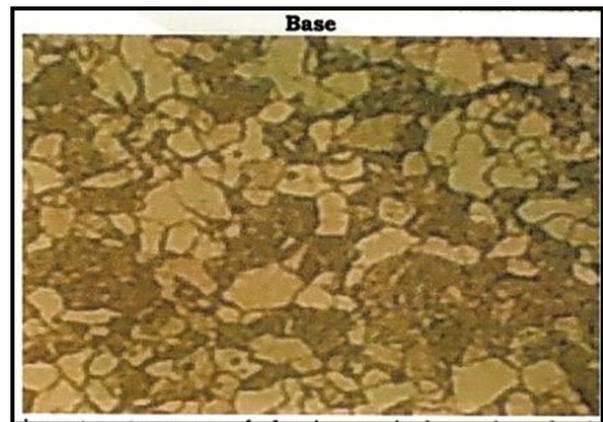
The 90 mm plate which cracked during the heating was subjected to stress relieving and shown in **Fig. 14**. The plates of 300 X 600 mm size were selected. The parameters for stress relieving are given in **Table 5**. The stress relieved plate was welded with restraint and found that the weldment, Heat Affected Zone (HAZ) and base metal are free from cracks (Visual & UT). The microstructure of base metal reveals ferrite and pearlite, The HAZ consists of bainite and ferrite and the weldment divulge veins of ferrite and shown in **Figs. 11, 12 & 13** respectively.

Fig. 11 : Microstructure of base plate

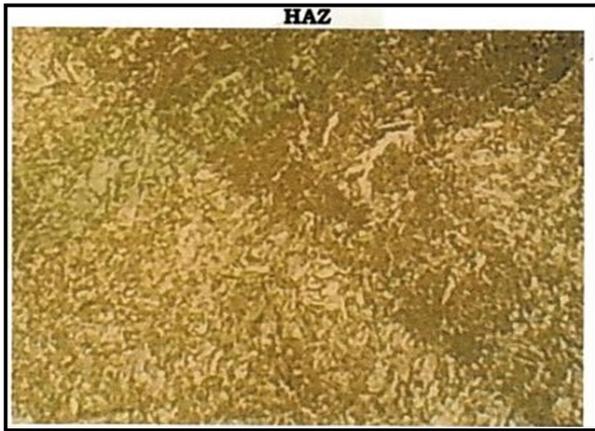
Fig. 12 : Microstructure of HAZ

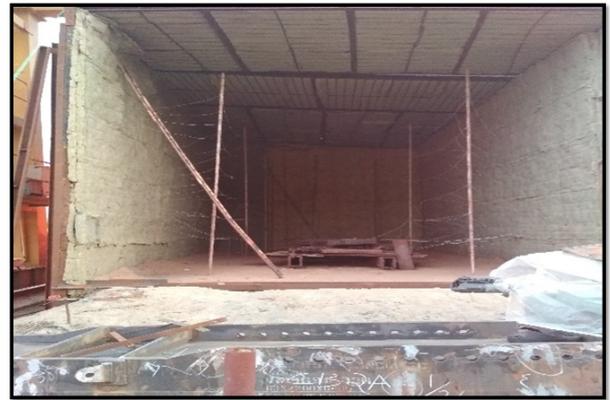
Fig. 14 : Stress relieving chamber

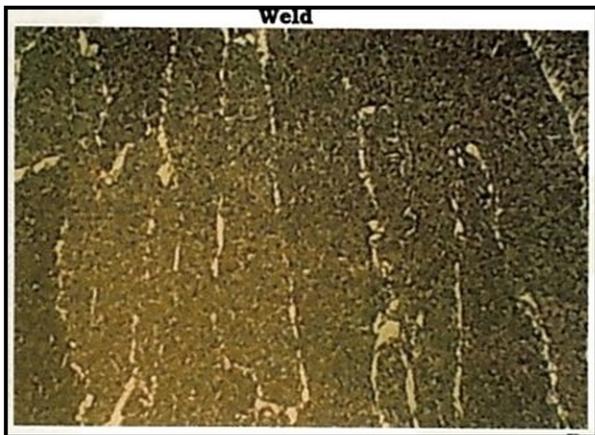
Fig. 13 : Microstructure of Weldment
