Repair of Cracks in High Thickness Quench and Tempered Steel

¹Indian Oil Corporation Limited, Panipat Naphtha Cracker, Panipat-132140, India
Email : banjaremayank@indianoil.in, kumarvimal2@indianoil.in, mudulibk@indianoil.in

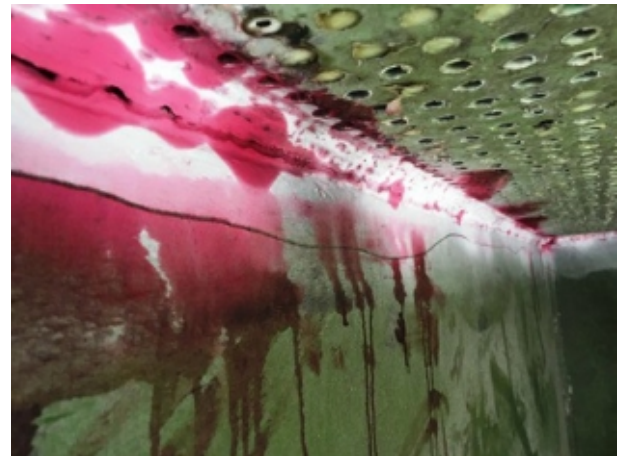
Earlier inspection of the equipment had not shown any significant observations. The intensity of longitudinal cracks (**Fig. 1**) necessitated removal of it; hence it was planned in August 2017 to repair the crack. Manual grinding machine was used to completely remove the crack and deposited weld metal in the fillet joint.

After cleaning the polymer deposits the cracks were observed on the edges of fillet weld toe region. It had spread longitudinally towards the weld junction with the vertical joint. On removing the weld deposits by grinding from toe area the crack appeared to have gone inside up to the root. Manual machine grinding resulted in un-even joint fit-ups of irregular root size varying from 3 mm to 7 mm along the length. The preliminary visual inspection after complete removal of weld deposit confirmed that there was no penetration in root in the earlier weld. The inherited stress concentration usually associated with the fillet welds and improper joint configuration in steels having yield strength 80Ksi and higher is quite detrimental.

Fig. 1 : Longitudinal Crack on Stiffener Fillet Weld of Sieve Plate can be seen.

Hard phases like martensite and high residual stress in the Quench and tempered steel accompanied with improper joint configuration and insufficient root penetration could be the cause of cracks.

Although a detailed fitness for service was not carried out, it was felt that the size, number and distribution of cracks were too severe to leave the cracks unrepaired. The final repair procedure that was established was as follows:

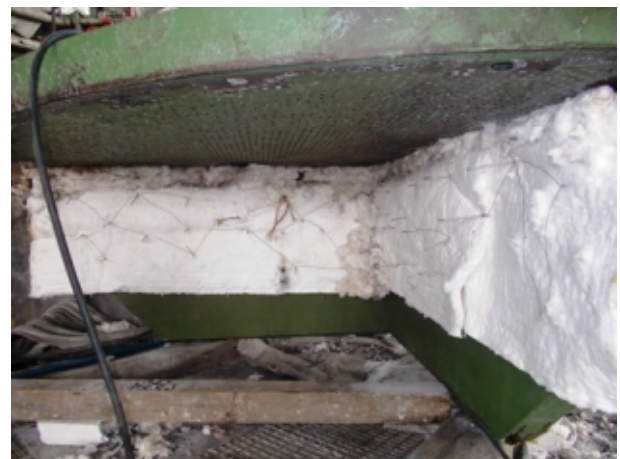
Fig. 2 : Showing Post Heating Arrangement of Sieve Plate after Weld

Post heating of the joints was done with heating elements (**Fig. 2**). To avoid high magnitude of thermal stresses coils were wrapped on alternate joints. Two 300mm wide band of heating elements centring the weld joint were applied soon after the welding job was completed with asbestos cover. At 350°C soaking for 4.5 hours were carried out as per thickness requirement of the code. The joints were allowed to cool under asbestos after post-heating duration as required as per approved WPS/PQR.

The chrome-moly quench tempered steel plates had a thickness of 114mm. Any welding on this thickness requires PWHT by ASME section VIII Division 1. However, with the approved WPS and PQR the PWHT was waived considering the inter-granular cracking which may take place in grain-coarsened region of HAZ of the base metal. The inter-granular cracking occurs by stress rupture, usually in the early stages of PWHT of quench tempered high strength steel. Post heating the weld at 350°C inch/hour was suggested as per approved WPS/PQR.
