Repairing and Welding Experience of LN₂ Cryogenic Transfer Line of 80 K Distribution System Of SST-1

*Rajiv Sharma, Hiren Nimawat, Gaurav Purwar and V. L. Tanna

*Institute for Plasma Research, Near Indira Bridge, Bhat, Gandhinagar - 382 428, Gujarat, India

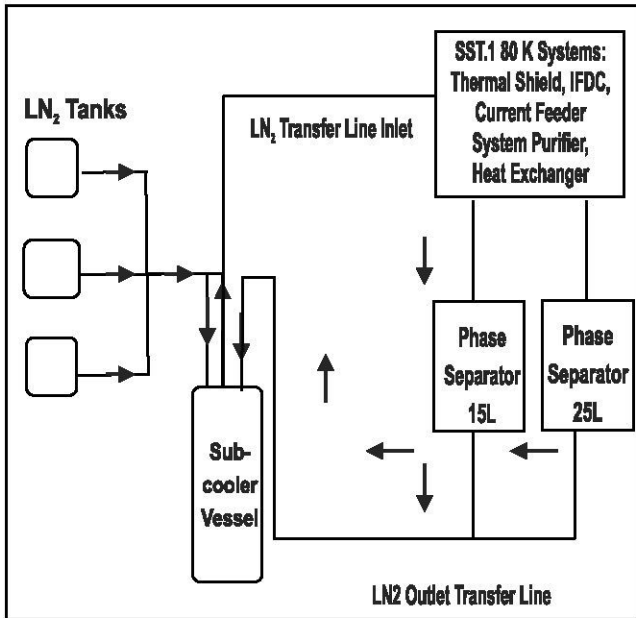
Fig.1 : Schematic of 80 K distribution system network

One mainly uses liquid nitrogen and liquid helium cryogens at IPR for SST-1 Tokamak cooling application. Specific to liquid nitrogen storage and distribution consists of three numbers of 35 m³ (each) capacity vacuum and perlite insulated storage tanks installed in warm gas management area, which is about 300 m far from the main application of SST-1 and Cryo installation. Vacuum and super insulation (MLI) jacketed cryo line is connected between internal cryo distribution and storage tanks as shown in Fig.1.

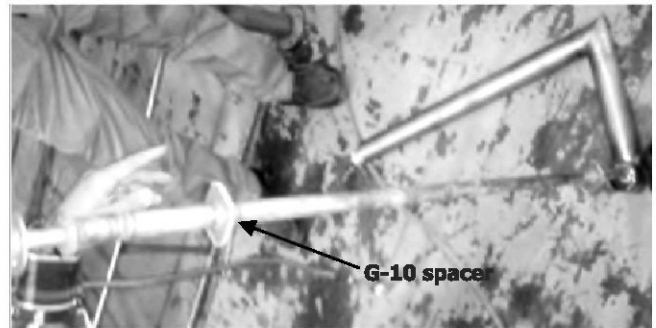
Fig. 6 : Assembly of LN₂ transfer Cryo line

Before welding the vacuum jacketed pipe sections together, slide the two sections over the inner process pipe which separate the vacuum in transfer line called vacuum barrier. The vacuum barrier pipe sections pre welded dish plate with both ends; the assembly is shown in the Fig. 6

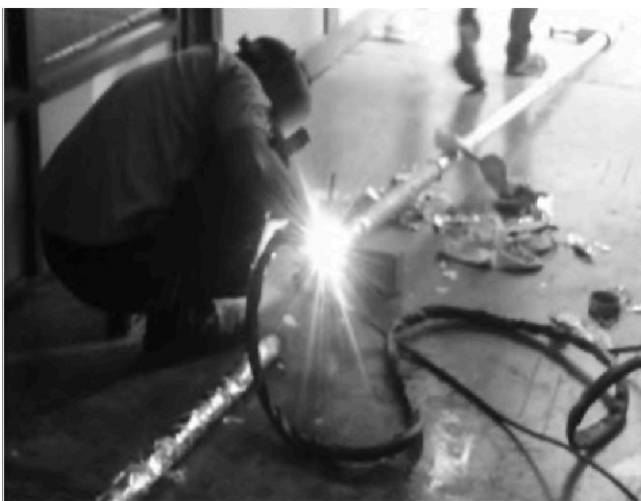
Fig. 7 : Welding of Bellows with transfer line

- (i) Tested cryogenic bellows [4] welded in the inner process line as shown in Fig. 7
- (ii) Test the sections for helium leak rate in vacuum and pressure condition as
- (iii) Apply multilayer of super insulation on inner process pipe.
- (iv) Move the two sections together engaging the inner line weld socket and weld the weld socket
- (v) Weld the one end of vacuum barrier pipe section with inner process line with dish end plate
- (vi) The outer pipe section of vacuum barrier welded with both end dish plate
- (vii) Slide the outer jacket pipe sections of both side of vacuum barrier and weld with dish end plate at actual location of transfer line as shown in Fig. 8

- (viii) The leaky sections were cut in two halves for ease the re-assembly and welding process.
- (ix) The joints which are to be welded clean with petroleum ether and cotton cloth. The TIG welding process as per ASME section IX procedure was adopted in pulse mode method to avoid burning of insulation material wrapped over inner pipe. The heat control during welding reduces the risk of hot cracking and distortion of cryogenic bellows.

- (x) The temperature was monitored ~ 70 °C by the digital thermometer, maximum 30 A current and 15 l/min purging with pure argon gas at 2 bar pressure were the desired/optimized parameters for welding of cryogenic transfer line. The welding joint preparation job was carried out in stress free condition of transfer line to prevent the generating of induced thermal stresses when line cooled is to 80 K.

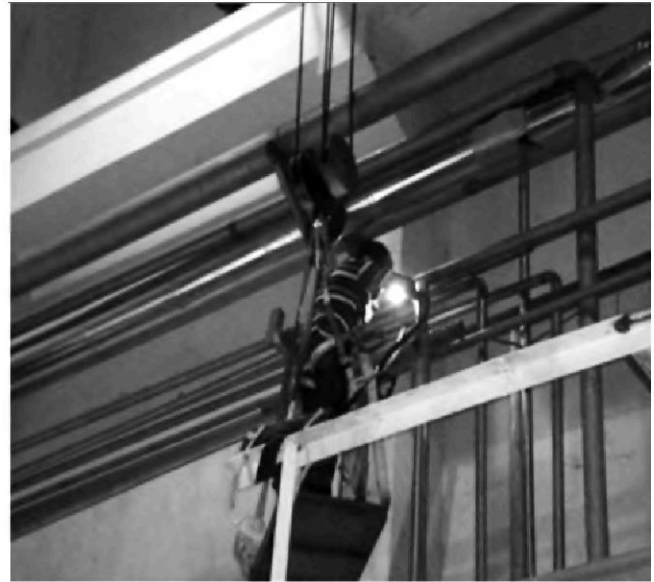
Fig. 8 : Welding of main LN₂ transfer line at 12 meter height

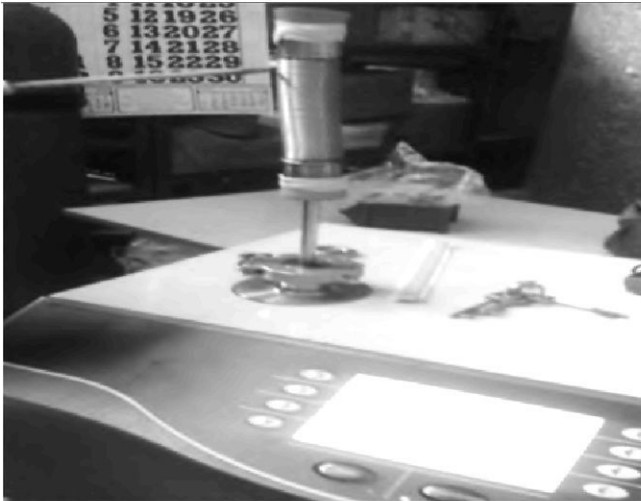
Fig. 9 : Helium leak test of cryogenic bellows

- (i) Leak testing of individual process pipe and cryogenic bellows [4] shown in **Fig. 9**, this assures elimination of any leaks in components before it is welded to the assembly as shown in **Fig. 10**.

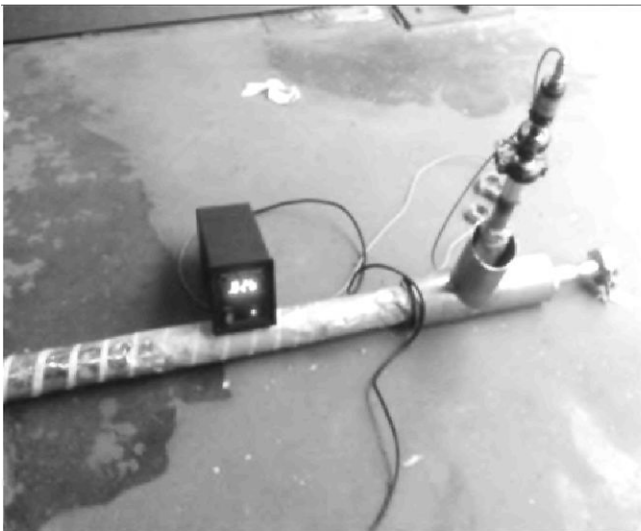
Fig. 10 : Vacuum and helium leak test of LN₂ transfer line

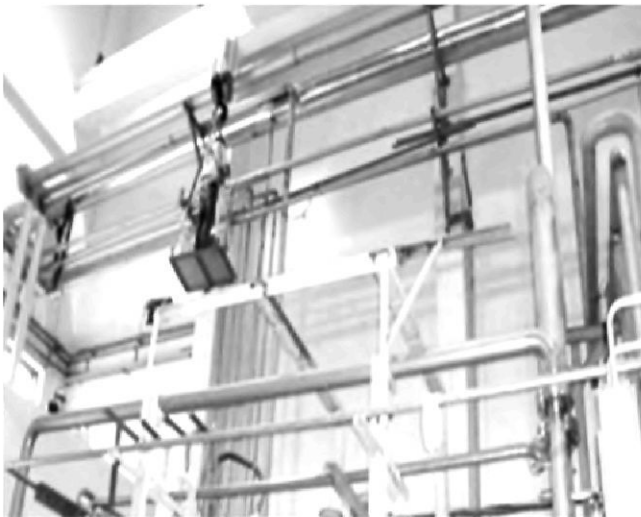
Fig. 11 : Repaired LN₂ line at 80 K

- (iv) The inner pipe is filled with LN₂ and annular space is connected to MSLD leak detector through the puppet evacuation port. Helium is sprayed externally on all outer surfaces of the outer jacket pipe including welded joints to check the failure of pipe/joint due to thermal stresses developed as a result of large temperature difference. Any drop in vacuum level of annular space indicates the failure of inner process pipe. The repaired line was validated by operating at 80 K as shown in **Fig. 11**.
