FRACTURE BEHAVIOUR OF Ti-6Al-4V WELDMENTS AND ITS RELATION TO MICROSTRUCTURAL FEATURES

K. KESHAVA MURTHY AND S. SUNDARESAN

Dept. of Metallurgical Engg., Indian Institute of Technology, Madras 600 036

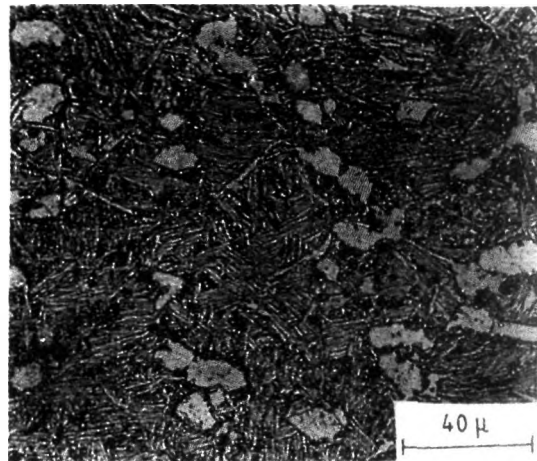
Fig. 3 : Light micrograph of the base material

The base metal microstructure shows a mixture of primary α grains in a transformed- β matrix (**Fig. 3**). In the as-welded condition, the fusion zone (FZ) exhibited fine acicular microstructures

The higher FT of the as-welded FZ in relation to the parent material is, no doubt, due to the fully acicular microstructure. On the other hand, the base metal microstructure consists of equiaxed α and transformed- β regions (Fig. 3). The relative superiority of plate-like microstructures, both for transgranular and intergranular fracture, is well known. The fractographs of the base metal, Fig. 10a & b, show a relatively flat fracture face with only little deviation in crack path. In contrast, the fracture faces of the as-welded FZ, in Fig. 11a & b, exhibit greater diversions in crack path, and many features of ductile fracture like tear ridges (Fig. 11a) and dimples surrounded by tear ridges (Fig. 11b). The rougher topography of Fig. 11a is consistent with the higher FT of the weld metal.

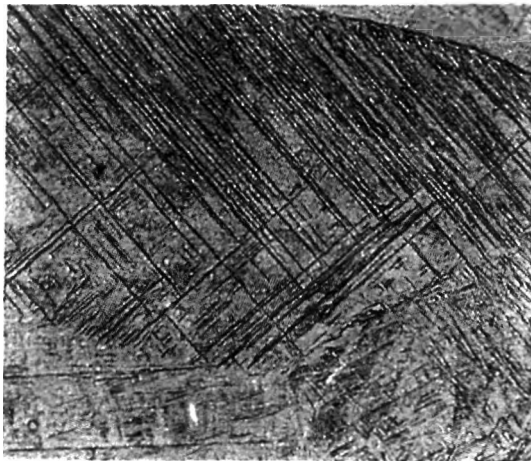
(a) : Electron beam weld

(b) : Manual GTA weld

Fig. 4 : Light micrographs of fusion zone, as-welded condition

for all three welding conditions, see **Fig. 4a & 4b**. The relatively slower cooling in M-GTAW in comparison to EBW is reflected in the greater intragranular coarsening in the M-GTA weld. The difference is also revealed in the transmission electron micrographs (TEM's) shown in **Fig. 5a & 5b**. The former is almost entirely martensitic, while the slower-cooled GTA weld exhibits a mixture of martensite and a colony structure consisting of α

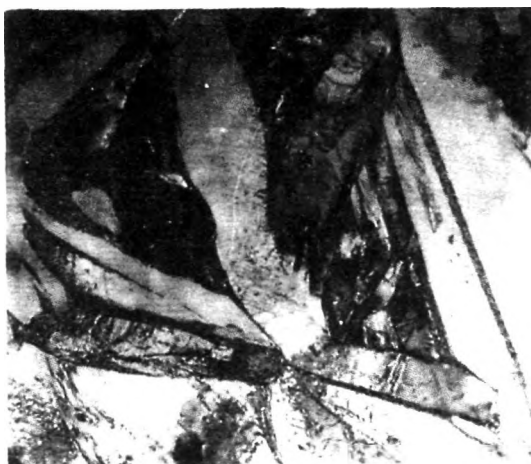
(a) : Electron beam weld

(b) : Manual GTA weld

Fig. 5 : Electron micrographs of fusion zone, as-welded condition

plates separated by thin strips of retained β , the latter confirmed by selected area diffraction. The A-GTA weld FZ showed features intermediate between those of EB & M-GTA welds. The microstructures after PWHT at 700°C and 900°C are shown in **Fig. 6a & 6b** and **Fig. 7a & 7b**, respectively, for M-GTA welds. Electron beam and A-GTA welds showed PWHT microstructures similar to these: a Widmanstatten α - β structure within the grains and a discontinuous α film at the grain boundaries. However, the coarsening effect was much less pronounced at 700°C than at 900°C, compare **Fig. 6a** with **7a**, and **6b** with **7b**. Some plates of martensite may still be observed in **Fig. 6b**, while in contrast the α plates in **Fig. 7b** are completely free of dislocations.
