# In-situ Weld Repair Of Cracked Shrouds Of Turbine And Characterization Of The Weld Joint

**M. Divya, C. R. Das, S. K. Albert, V. Ramasubbu, A. K. Bhaduri and P. Sivaraman**

Materials Joining Section, Materials Technology Division  
Indira Gandhi Centre for Atomic Research, Kalpakkam 603102, Tamilnadu

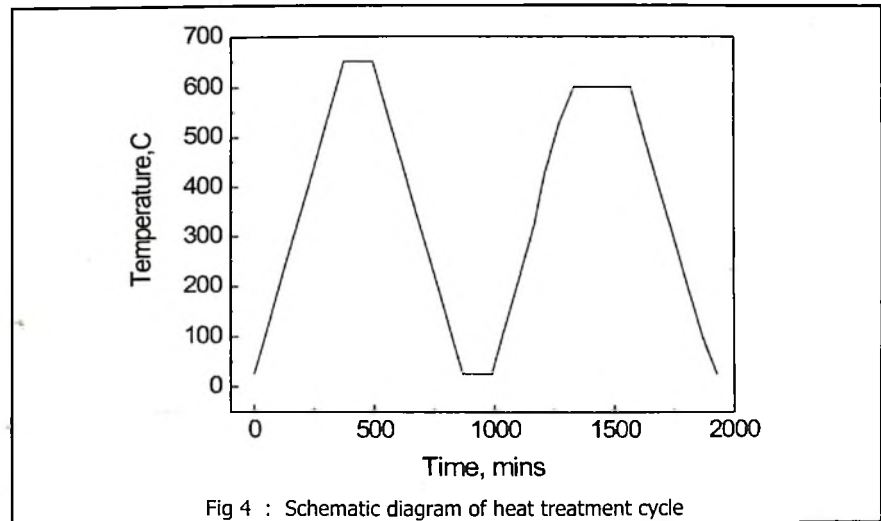
Fig 4 : Schematic diagram of heat treatment cycle

Two-stage PWHT used in the mock up welding would be incorporated in the actual repair welding. This heat treatment was carried out in situ using an indigenously fabricated furnace with built in temperature controller in which the entire heat treatment cycle can be pre programmed using constant heating rate of 100 °C/h. The heat treatment was carried out in two stages. In the first stage the weld was heated to 650°C and held at constant temperature for 2 hours and cooled to room temperature. In the second stage it was again heated to 600°C and held for 4 hours then cooled to room temperature. Figure 3 shows the PWHT carried out on the mock up shroud piece after welding was completed. The heat treatment cycle programmed during the mock up is shown in the Fig. 4.

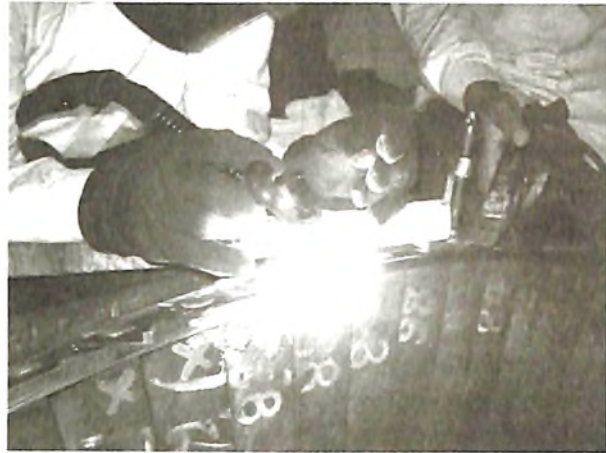
Fig. 5 : Photograph taken during welding of shroud piece

position and tack welded to the existing shroud as shown in Fig.5. A thermo couple was also tack welded to the shroud to measure and monitor the temperature progress during PWHT. Root gap was maintained 1.00 mm. The joint area was preheated to a temperature of 270-250°C using oxy acetylene flame. Welding was carried out using the same parameters used for the mock up procedure. The average heat input for the weld was estimated to be ~ 1 kJ/mm. The ridges present in the shroud were also built up by welding. Figure 6 shows the shroud piece after

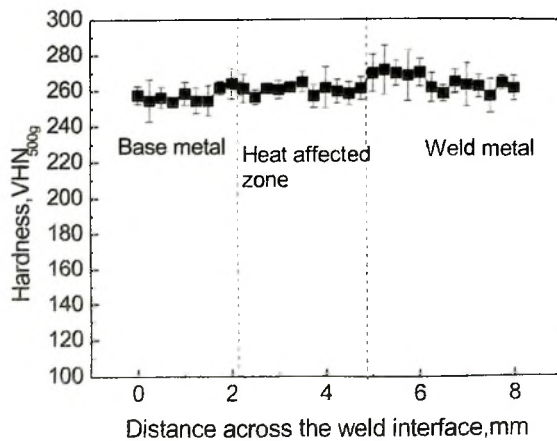
Fig. 11 : Micro hardness survey across the weldment

Figure 11 shows the hardness profiles across the weldment obtained from the mock up shroud piece in the post weld

heat-treated condition. The hardness of the weld metal in the as welded condition was  $\sim 400 \text{ VHN}_{500\mu}$  whereas after PWHT the overall hardness has reduced to 260VHN. This is an indication of adequate tempering of the weldment after PWHT. It is also important to note that there is no significant variation in the hardness across the weldment. The yield strength (YS) and ultimate tensile strength (UTS) of the weldment obtained from the tensile test conducted on the specimens obtained from the shroud piece welded in the laboratory are 655 MPa and 780 MPa respectively. The failure location was the base metal. The base metal YS and UTS are about 724 and 827 respectively. The difference in the UTS of weldment and base metal is only about 5% therefore; the strength of the weldment is comparable to that of the base metal. The weldment exhibits ductility 17.5 % elongation whereas the base metal ductility is 15%. This weldment also passed the 180 degree root bend test, one of the requirements for welding procedure qualification. Impact test was done on the samples extracted from the weld pads exclusively made using 12mm thick 410 martensitic stainless steel base plates and the 410NiMo filler wire. The toughness of the weld metal after this two stage heat treatment is 170 J, which is considerably higher than 13 J obtained for two-stage PWHT carried out at slightly higher temperature of 675 and 615°C. The fractographs taken from the fracture surface of the impact tested samples reveals dimple morphology indicating that the fracture mode is purely ductile (Fig.12).

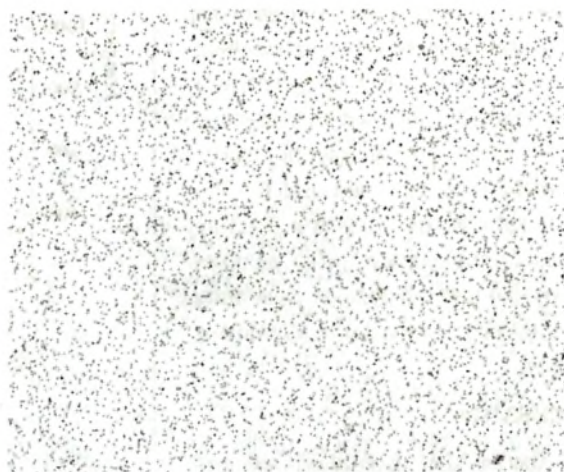
Fig. 15 : Ni element map shows enrichment of Ni along the lath boundaries

Retained austenite is normally present as thin films between the martensitic lath boundaries and it is difficult to resolve this phase in an optical microscope. Even at high magnification that is possible in SEM, differentiating martensitic lath and retained austenite is not easy. However, as retained austenite will be rich in austenite stabilizers like Ni, a compositional map using EDS can be used as an indirect evidence of retained austenite. Accordingly, Fig. 14 shows SEM image of the weld metal after the PWHT and Fig. 15, the distribution of Ni at the location of this image obtained by compositional mapping using EDS. Enrichment of Ni along the lath boundaries can be observed, indicating presence of retained austenite in the weld metal.

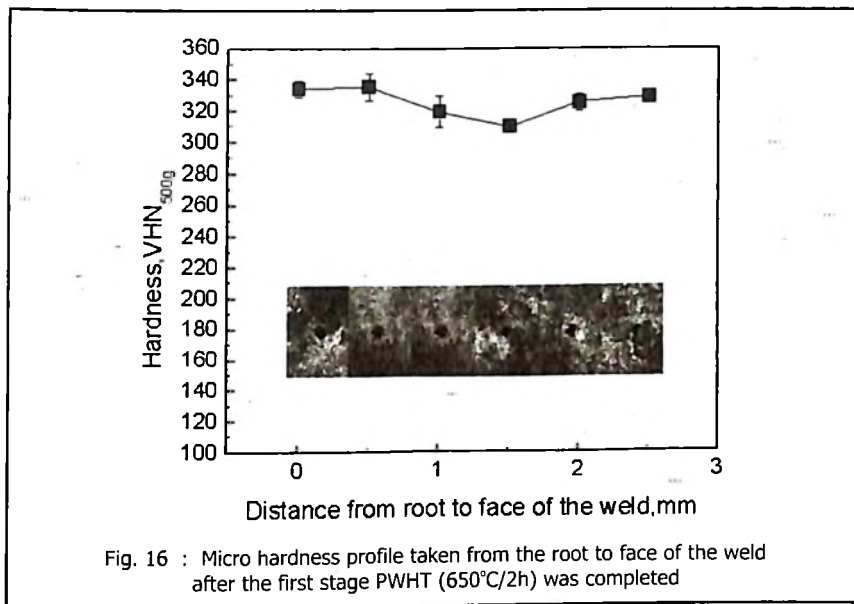
Fig. 16 : Micro hardness profile taken from the root to face of the weld after the first stage PWHT (650°C/2h) was completed

treatment temperature, 650°C is above  $A_c1$  temperature [8] which means some of the martensite present in the weld metal would retransform to austenite while the rest would undergo tempering. Hence, at the end of hold time at this temperature, the weld metal will have more volume fraction of austenite than that was present at the start of the heat treatment. During cooling most of it would transform back to martensite; but as the  $M_s$  temperature is expected to be below room temperature, complete transformation of austenite would not take place. Further it is reported that fresh martensite is formed on cooling only when the temperature interval between the heat treatment temperature and  $A_c1$  transformation temperature is high enough to produce at least 20% transformed austenite during this heat treatment [9]. Hence, at the end of the first stage of PWHT, the weld metal microstructure consists of tempered martensite, fresh martensite formed during cooling from the heat treatment temperature and retained austenite. Figure 16 shows hardness profile of the weld metal from root to face

on the weldment produced from shroud piece after the first stage heat treatment. Hardness, typically of the order of 320-340 VHN, which is higher than a fully tempered structure, but lower than that of fully martensitic structure, and variation observed in the hardness of the weld metal (Fig. 16) clearly indicate presence all the three phases mentioned above.
