**A STUDY ON THE WELDABILITY OF CAST NITROGENATED STAINLESS STEELS\***

**C.K.Vinod, G.L.Datta, A.K.Chakraborti**  
**IIT, Kharagpur**

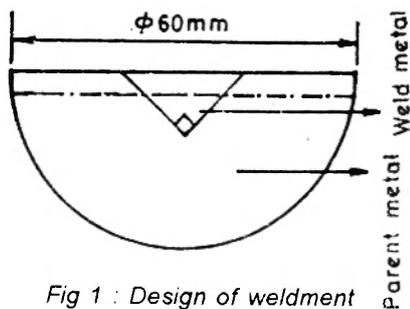
Fig 1 : Design of weldment

and a V-notch was made on each half (figure 1). The V-notch was welded with semibasic flux coated stainless steel electrodes of approximately 316 L grade in two passes at 28 volts and 110 amps alternating current. The composition of the electrode is given in Table 1. The microhardness (VPN) of the weld Zone, HAZ and parent metal of each welded specimen was measured after metallographic polishing and etching. Representative photomicrographs of the weldments were also taken. The welded specimens were cut into two equal pieces through the middle of the welded zone. Each welded sample was then subjected to corrosion test in 65% boiling nitric acid and the weight loss was de-

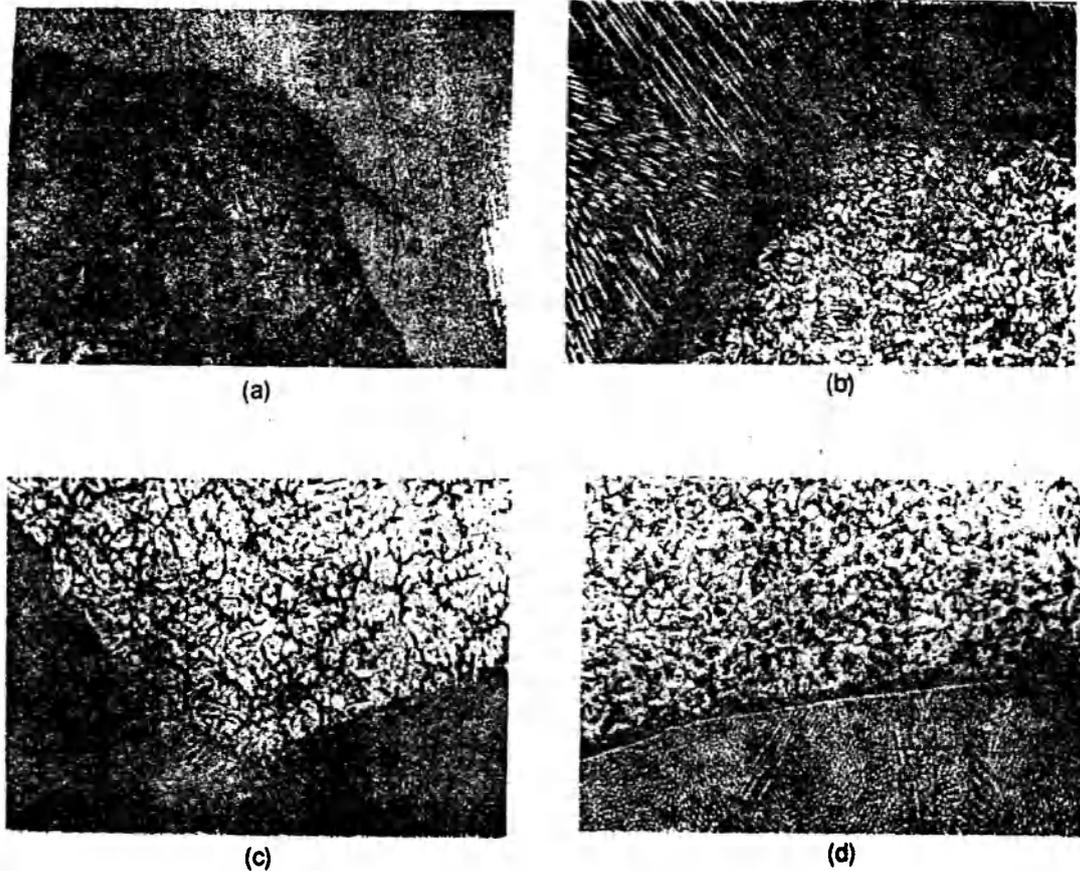
Fig 2 : Photomicrographs of the weld deposit, HAZ and parent metal; (a) alloy 1, (b) alloy 2, (c) alloy 3, and (d) alloy 4.

features: Microstructures of the welded specimens are presented in Figure 2 (a-d) to highlight the effect of composition on the HAZ width. The darkened layer at the weld-deposit parent metal interface marks the heat affected zone. The HAZ was fairly wide in alloy two three, but it was quite narrow in alloy 4. The microhardness data given in Table 2 suggest hardening of the HAZ relative to that of the martix in alloys 1,2 and 3. The results of the corrosion test are reported in the form of mass loss ( $\text{gm}/\text{mm}^2$ ) versus time plot in Figures 3 and 4. The weldment of alloy 1 was conspicuously lower than that of the weldment (figure 4). The SEM photographs in Figures 5 and 6 compare the corrosion pattern in

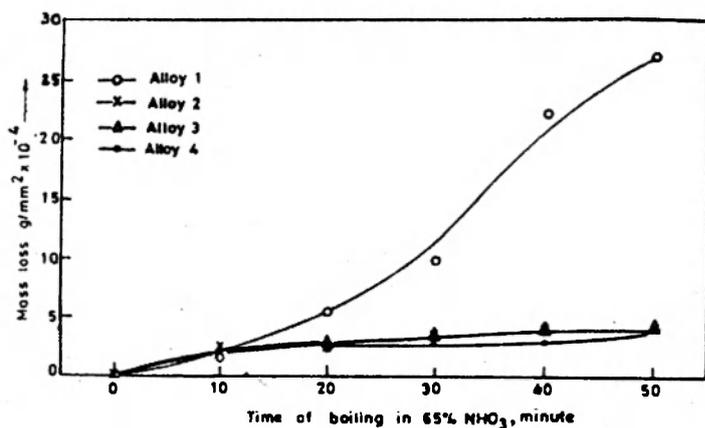
Fig 3 : Mass loss from weldments Vs Time in alloys 1 to 4

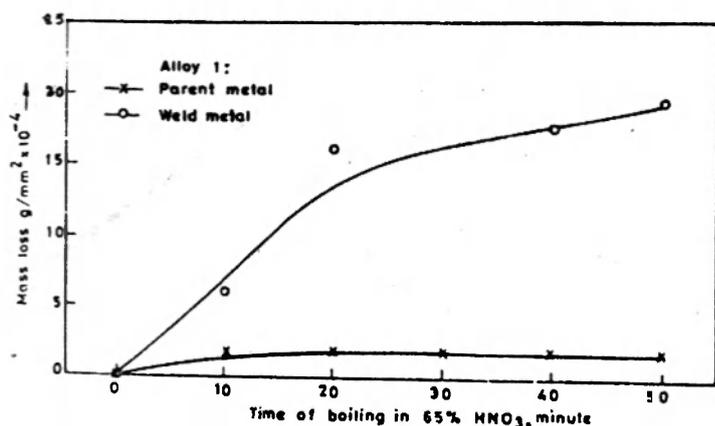
Fig 4 Mass loss from weldment and parent metal
