Damage to surface structures due to blasting – a new criteria

This paper describes effect of blast produced ground vibration on damage potential to residential structures to determine safe levels of ground vibration for the residential structures and other buildings in mining areas. Impacts of 341 blasts detonated at two mines were monitored at the test structures and 1871 blast vibrations signatures were recorded on or near the test structures. Cosmetic cracks in a native brick-mud-cement house were detected at peak particle velocities (PPV) between 51.6 and 56.3 mm/s. The reinforced concrete and cement mortar (RCC) structure experienced cosmetic cracks at PPV's of 68.6 to 71.3 mm/s at the first floor, whereas at second floor it was detected at PPV levels of 71.2 to 72.2 mm/s. Minor damage in brick-mud-cement house was recorded at PPV levels of 81.0 to 89.7 mm/s. The RCC structure at first and second floors experienced minor damage at PPV levels of 104 mm/s and 98.3-118 mm/s respectively. The brick-mud-cement house experienced major damage at PPV level of 99.6 to 113.0 mm/s, while major damage was recorded in RCC structure on first floor at PPV of 122 mm/s, the second floor at PP

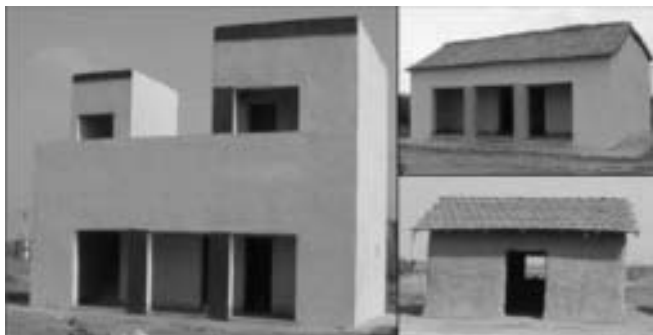
Fig.1 Newly constructed test structures for study purpose at Kusmunda mine

of test structures. Three types of test structures viz. (a) Mud house with Raniganj tiles, (b) Brick-mud-cement plaster house with Raniganj tiles and (c) Double storey three rooms RCC structure were constructed at both the sites. The view of the newly constructed test structures at Kusmunda mine is shown in Fig.1. The physico-mechanical properties of the construction material of RCC structure is presented in Table 6.

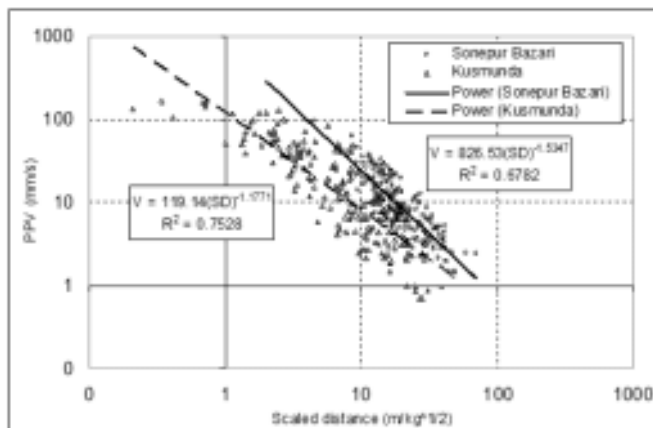
Fig.3 Propagation plots of recorded PPV at ground surface near the foundation of structures at respective scaled distances

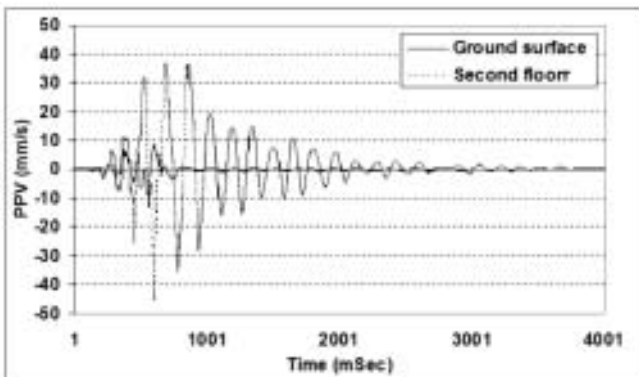
Fig.5 Peak structural response and forcing ground vibration (L-direction) for the second floor of the RCC test structure due to blasting at Sonepur Bazari mine

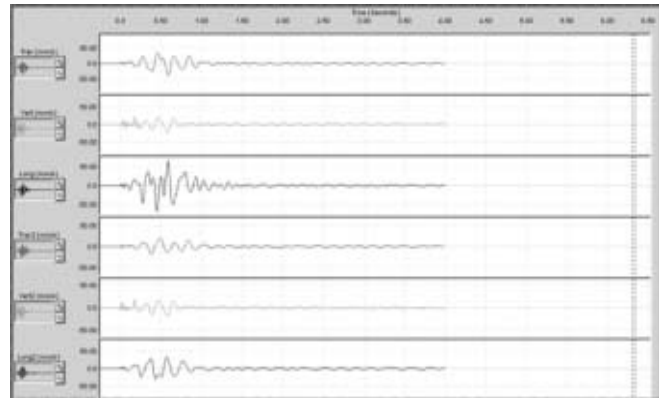
Fig.10 Blast wave signature recorded in brick-mud-cement house near the window (Trans, Vert, Long) and near the foundation (Trans2, Vert2, Long2) which caused minor damage in brick-mud-cement house at Sonepur Bazari mine

frequency, 5.6 Hz. The minor damages were observed within the structures for the corresponding vibration and frequencies mentioned above are shown in Fig.9. The same blast produced only cosmetic cracks in the first floor of RCC structure at vibration level of 71.3 mm/s with dominant peak frequency of 5 Hz. Cracks were located near the windows in the first floor. Fig.10 depicts the blast vibration signature that caused minor damage in brick-mud-cement house.

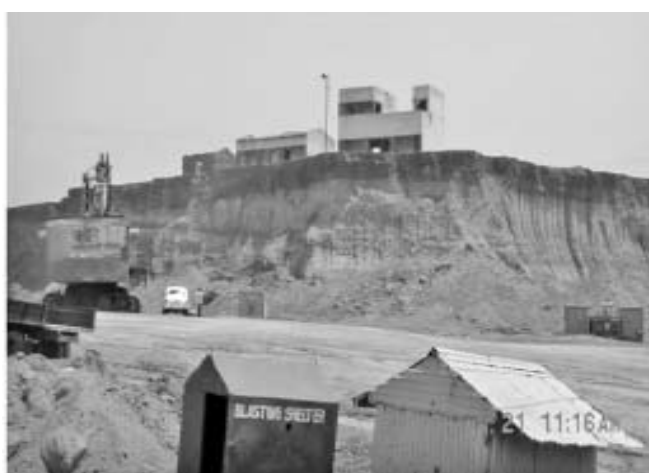
Fig.11 The view of the location of the test structure indicating working benches at 20 m from structures at Sonepur Bazari mine

The study was carried out to document the effect of repeated blasting on the collapse of test structures. It was recorded that when blast face was only 20 m from the structures (Fig.11) the mud house collapsed but the brick-mud-cement and RCC structures were standing with major damage in the plaster. At the end the measurements of cracks with crack monitor gauge showed width of cracks up to 35 mm, while the width of detached parts of the plaster ranged between 1 cm and 40 cm. Details of excitation motion and corresponding response motion which caused different levels of damage to the test structures at Sonepur Bazari mine is presented in Table 12.

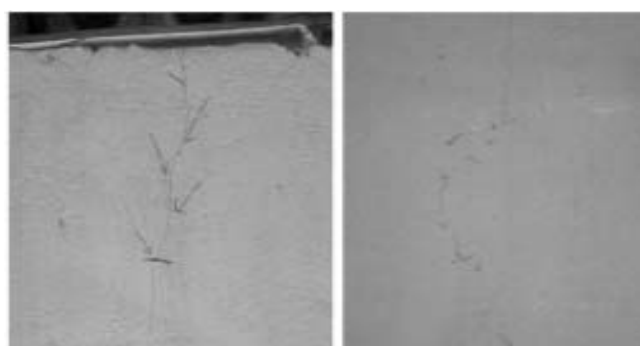
Fig.12 The view of cosmetic cracks developed in the brick-mud-cement house at Kusmunda mine

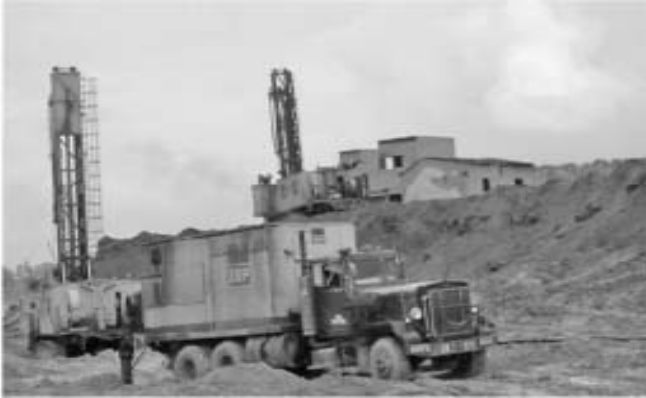
Fig.13 View of blast face at 55 m from the nearest test structure at Kusmunda mine
