Stability evaluation of highwall slope in an opencast coal mine – a case study

3. Analysis of highwall slope failure – case study

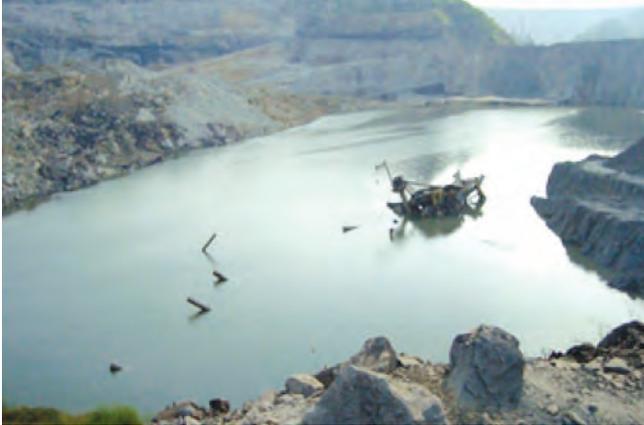
Fig.2 Regional failure of benches at Umrer OCP, WCL

It refers to large volumes of materials which come down the slopes due to large rotational type of shear failure and it involves deeply weathered rock and soil (Fig.2). In India, regional failure of coal benches occurred at Jayanth opencast project of NCL and Umrer opencast project of WCL.

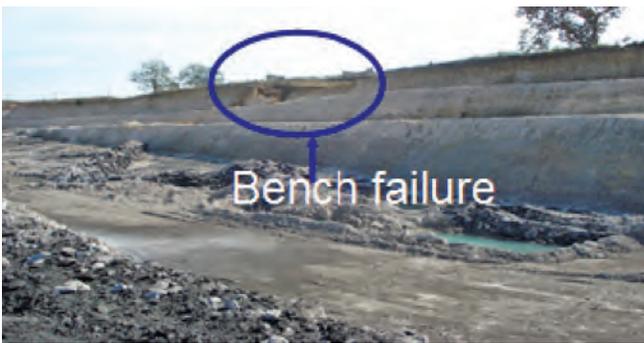
Fig.3 Local failure of bench at Dorli OCP-I, SCCL

This problem which refers to much smaller volume of material and these types of failure effect one or two benches at a time due to shear plane jointing, slope erosion due to surface drainage. Most of the pit slope failures occurred are local in nature. One example of bench failure at Dorli OCP-I of SCCL is given in Fig.3.

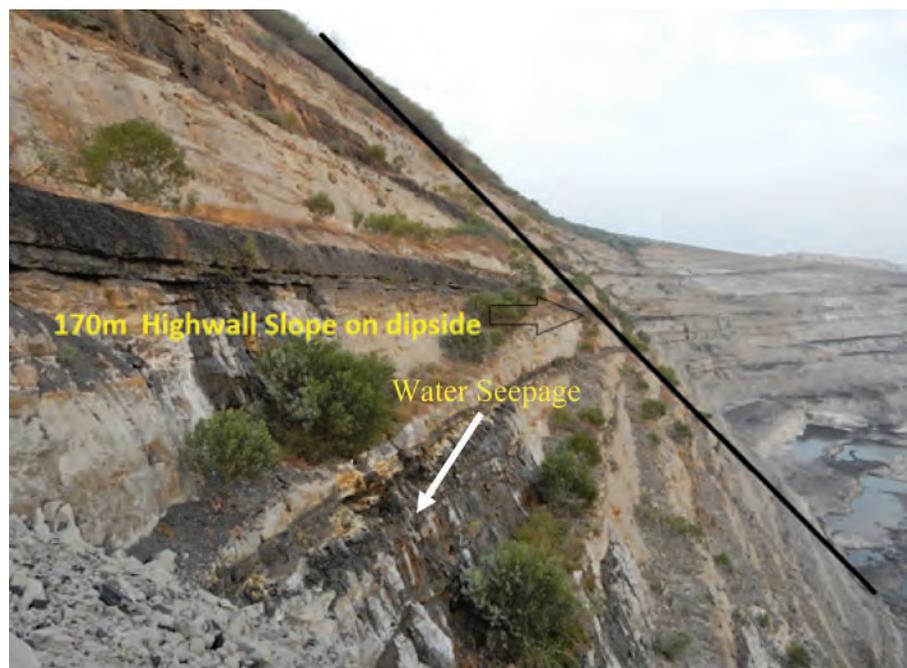
Fig.5(b) Photograph depicting the ultimate slope of 170m highwall of Medipalli OCP

The ultimate slope of 170m highwall of Medipalli OCP towards dip side of the quarry along flood protection bund is given in Fig.5(a) and (b).

observed due to improper drainage of water (Fig.5(b)). Erosion brought about by flowing water could also result in reduced strength (Morgenstern, 1971; Sage, 1976; Sharp et al., 1977; Hoek and Bray, 1981). Mining personnel were subsequently withdrawn from the area for safety reasons and provided proper drainage system. The mining resumed from 20.11.2015 when the cyclops information indicated that the slope had stabilised (Fig.10). Till date, there is no problem of slope failure. From simulation analysis, it is found that the simulation predictions are closer to the field data and show much better accordance with the field results.

Therefore, it is recommended to maintain proper drainage system and continuous intensive slope monitoring. There should not be any flow of water or garland drains in and around the pit which reduces the cohesion and angle of internal friction of the friable strata leading to the slope failure. Additionally, dewatering of potentially unstable zones is also important to minimize hazards related to highwall failures. Conduct of slope stability assessment in Indian coal mines is mostly based on empirical and observational approach. Hence, efforts should be made by statutory bodies to have more application of analytical numerical modelling in this field to make slope analysis and design scientific.

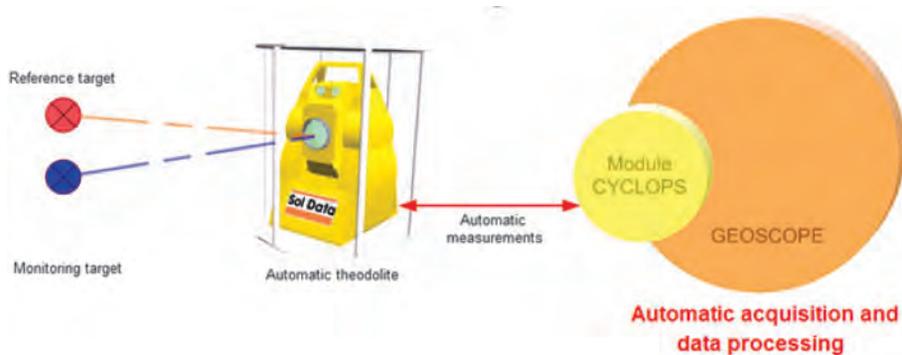
Fig.8 Principle of operation of slope stability real time monitoring by Cyclops
(Source: www.soldatagroup.com)

A comparison of numerical simulation results with the actual results obtained from the field is presented. Cyclops is a fully automated monitoring system

comprising a motorized total station with video target acquisition under computer control. Total 50 targets were fixed on the highwall slope of Medipalli OCP for monitoring. The information of slope movement is visualized in real time. The principle of operation of slope stability real time monitoring by cyclops is shown in Fig.9. The cyclops will be connected to software GEOSCOPE. The system GEOSCOPE manages three levels of alarm for every prism in XY and Z directions. GEOSCOPE will set off alarms in case of movement. These alarms (EX: flashing light, beacon, SMS, e-mail, etc) will instantly alert the people in charge of the site. A visualization of the results in real time on a PC will immediately render a state of the deformation or of the movement, as well as a description of the deformations.
