# Design and application of remediation plan for heading slope landslide in Feilongshan tunnel entrance

*In order to effectively solve the hazards of heading slope landslide of tunnel entrance project in fractured strata, the geological conditions, human activities, meteorology, hydrology, and other factors of Feilongshan tunnel entrance are analyzed; by comprehensively taking into consideration of factors such as the environment, project duration, and safety of the landslide area, this paper proposes comprehensive control measures centered on anti-sliding, and systematically studies the effectiveness of slope-brushing protection, pipe-shed support, counter-pressure backfill mortar rubbles and other measures for controlling heading slope landslide of the tunnel entrance. The on-site monitoring results shows that the change trend of the vector displacement and plane displacement at each measuring point after the remediation is relatively stable, all within the allowable deformation range; the comprehensive remediation plan has clear construction process flow, obvious technical effects, and high construction efficiency and safety. The research results provide a technical basis and r

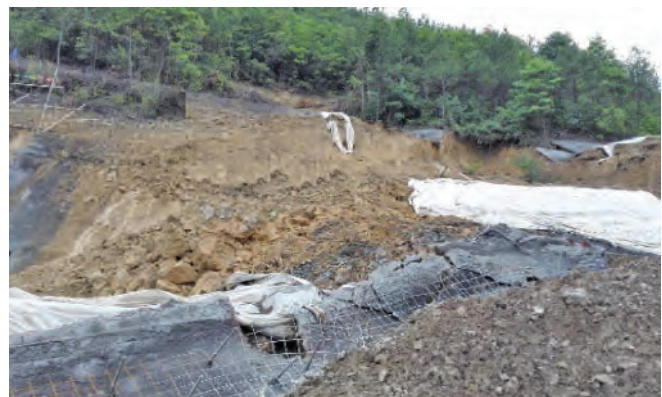
Fig.4 The third-time landslide in the entrance section

about 60m, landslide amount is about 15000m<sup>3</sup>. On May 18th, 2015, during the construction of slope-brushing protection of the right tunnel of Feilongshan tunnel entrance, landslide happened for the third time, the lateral width of the collapsed body is 35m, landslide amount is about 1000 m<sup>3</sup> (Figs.3 and 4).

4.2.2 Remediation of third-time landslide of heading slope: the construction process is: clear cavity of the landslide body → erect anchor bolts to the slope surface after landslide + flexible net protection → excavate the retaining wall platform → drill holes, stick pipes → construct retaining walls → backfill the cavity behind the walls → construct intercepting ditches → thick-layered base material protection.

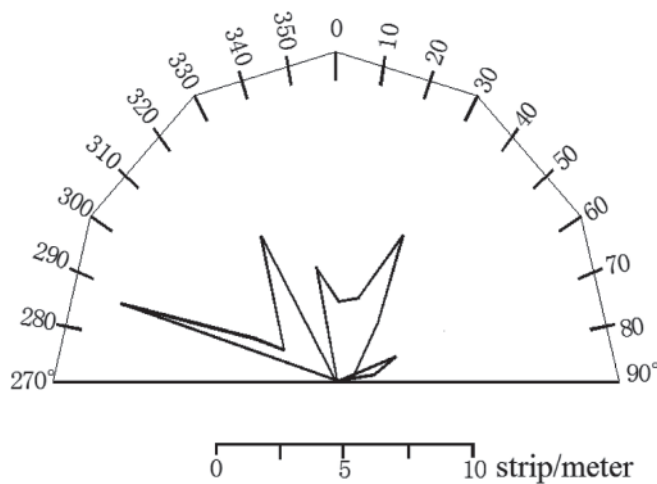
obvious, namely in the Cretaceous fine sandstone formations, they are more developed and most developed, and in Jurassic tuff formations, they are less developed or not developed. Joint fractures mainly develop in two groups, with the occurrence of  $320-350^{\circ}/75-80^{\circ}$  and  $210-230^{\circ}/50-75^{\circ}$ . The inter-laminar fractures mainly develop into two groups. In tuff the occurrence is mainly  $65-70^{\circ}/25-40^{\circ}$ , and in Cretaceous fine sandstones and glutenite the occurrence is mainly  $80-110^{\circ}/16-22^{\circ}$ . Most of the joint surface are flat, mainly micro tension joint, and a few are semi-closed. The extended length of the joint surface varies greatly. The extended length in the Jurassic strata is large, most are longer than 1.0m, usually 2.0 to 3.0m; in Cretaceous strata, most extended length is less than 1.0m, shorter ones are only a few centimeters to tens of centimeters. From Fig.5 we can see that, the IV-grade structural plane is the most developed along the N-W-W trend, the second most developed is along the N-N-E trend and N-N-W trend.

Fig.5. Rose diagram of strike joint

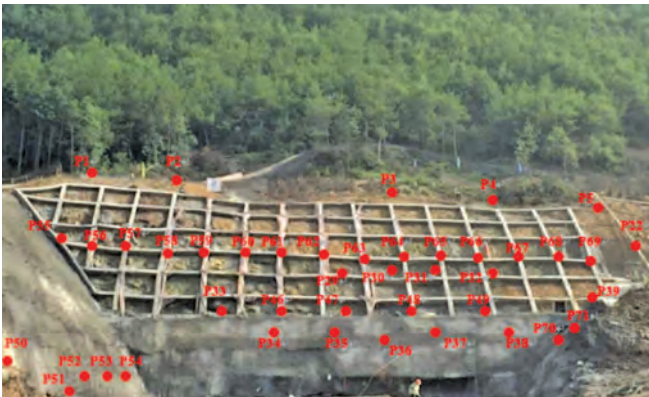
Fig.8 Diagram of surface subsidence measuring points at the entrance of Feilongshan tunnel (part).

After remediation of heading slope landslide of tunnel entrance, set 58 new measuring points on the protection grid beam or the anchor bolts of left and right tunnel entrance section heading slope, together with previous reserved points, there are 62 measuring points in all, as shown in Fig.8, respectively monitoring the surface subsidence in measuring points' X direction (longitudinal displacement of the measuring point along the axis of the tunnel), Y direction (lateral displacement of the measuring point along the axis of the tunnel) and Z direction (vertical displacement of the measuring point, i.e., the settlement of the measuring point), the monitoring results are shown in Table 1.

According to the analysis in Fig.8 and Table 1, no obvious plane displacement (maximum of 1.7mm) and vector displacement (maximum of 22.2mm) are observed at the measuring points, and both the vector displacement and the plane displacement trend are relatively stable. The measuring point displacement changes are within the allowable deformation range (accumulated displacement is not significantly increased). The monitoring measurement results show that the remediation measures for the heading slope of the tunnel entrance are feasible and the remediation effect is good.
