Study to Ascertain the Efficacy of the Bag Filters Attached to Various Locations at a Calcining Plant

Biswajit Samal, Kumar Raja Vanapalli, Sankalp Raj*, Ravish Dubey and Jayanta Bhattacharya

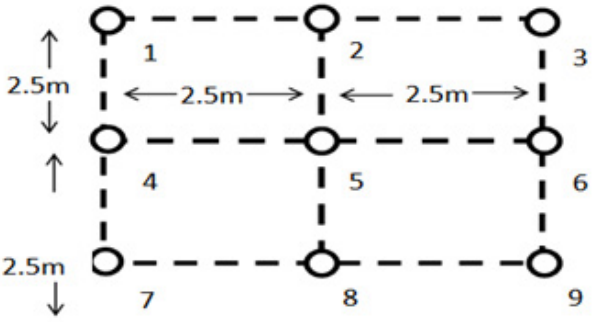
Figure 7. Points of measurement near the operating bag filter (Point 1 is the safe closest position near the bag filter).

the standard prescribed limits by CPCB)[7] inside the plant premises when the bag filter was not in operation (Table 3). Even with the bag filter running at full capacity the indoor air pollution, especially of particulate matter near the Bag filter was very high (Table 3). But with the operation of the bag filter the particulate matter concentrations drop significantly, but still higher than the AAQ standards, at the stack (Table 5) indicating the efficiency of the bag filter installed in reducing the pollution. The high particulate matter concentrations inside the plant may be attributed to improper handling of finished CPC being stacked inside without proper covering and fugitive dust. Even the conveyor belt and sections, which transfer the finished CPC after cooling also is not properly covered, contributing to indoor air pollution. Air pollution is associated with an increased risk for cardiovascular events. Many of the biological pathways involved could also promote diabetes mellitus[8,9].
