# Recovering a Legacy of Old Iron Ore Consolidated Fines Dump on a Mountain Side and Working out a Method of Mining: Conservation of Minerals and Freeing Space

**B. B. Mandal*, Sujeet Bharti, Kaushik Dey and Jayanta Bhattacharya**

*Department of Mining Engineering, Indian Institute of Technology Kharagpur, Kharagpur - 721302, West Bengal, India; bbmandal@mining.iitkgp.ac.in, sujeetiit@gmail.com, kausdey@mining.iitkgp.ac.in, jayantaism@gmail.com*

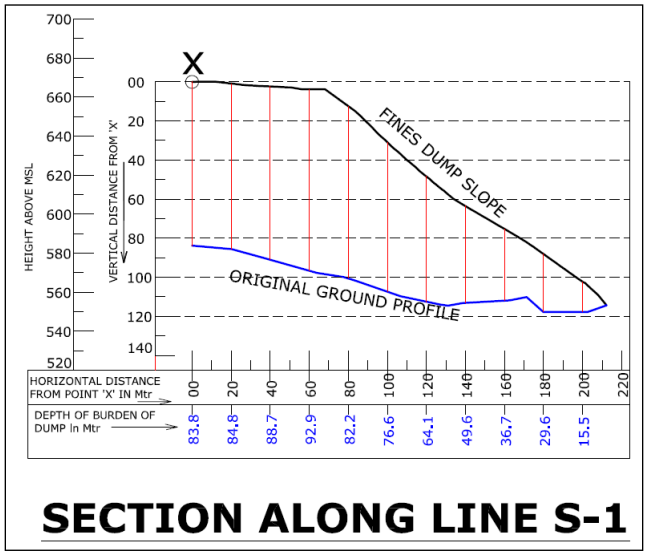
**Figure 5.** Section along line S-1.

| Sl. No. | Section Name | Factor of safety (without load) | Factor of safety (with load) |
|---|---|---|---|
| 1 | S-1 | 1.26 | |

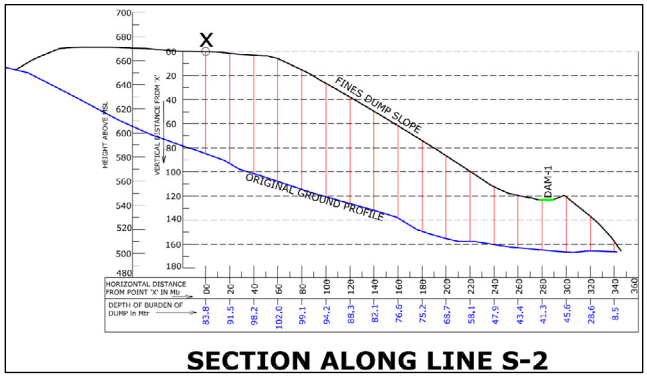
**Figure 6.** The section along line S-2.

| Sl. No. | Section Name | Factor of safety (without load) | Factor of safety (with load) |
|---|---|---|---|
| 2 | S-2 | 1.40 | |

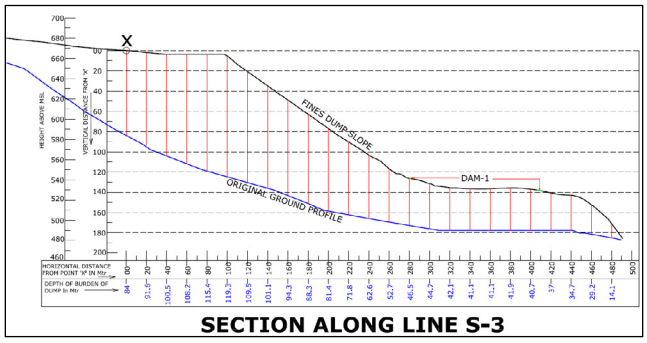
**Figure 7.** The section along line S-3.

| Sl. No. | Section Name | Factor of safety (without load) | Factor of safety (with load) |
|---|---|---|---|
| 3 | S-3 | 1.40 | 1.40 |

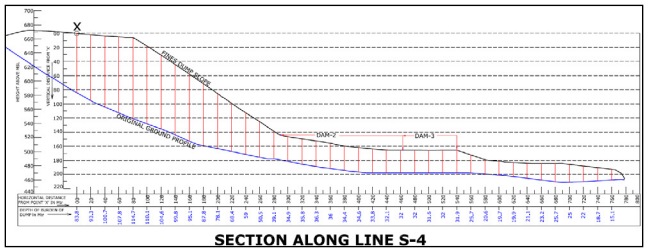
**Figure 8.** The section along line S-4.

The above results as in Table 6 show that for sections S-4 and S-5, factor of safety was only 1.24 and that of S-7 was 2.59. Another major area of interest is S-3 and S-4 that didn't show any change in factor of safety with 100t. Of course, the FoS (1.4 was 1.24) are not acceptable for engineering design. A minimum FoS of 1.50 at all times

| Sl. No. | Section Name | Factor of safety (without load) | Factor of safety (with load) |
|---|---|---|---|
| 4 | S-4 | 1.24 | 1.24 |

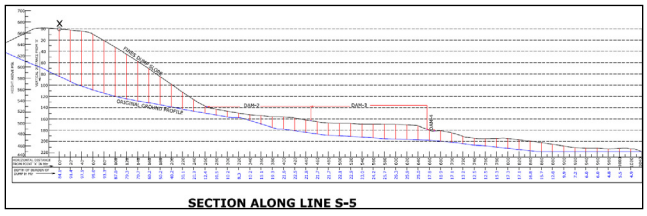
**Figure 9.** The section along line S-5.

| Sl. No. | Section Name | Factor of safety (without load) | Factor of safety (with load) |
|---|---|---|---|
| 5 | S-5 | 1.24 | |

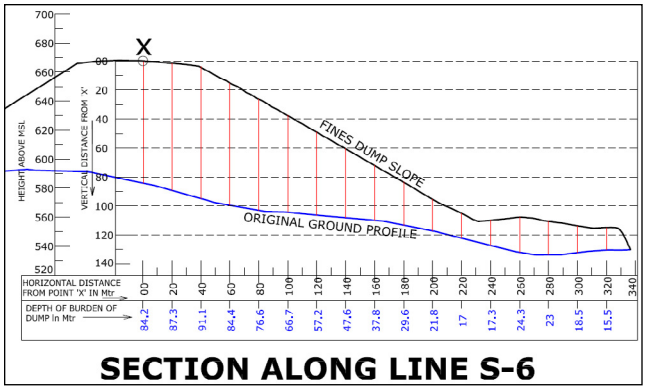
**Figure 10.** The section along line S-6.

| Sl. No. | Section Name | Factor of safety (without load) | Factor of safety (with load) |
|---|---|---|---|
| 6 | S-6 | 1.71 | |

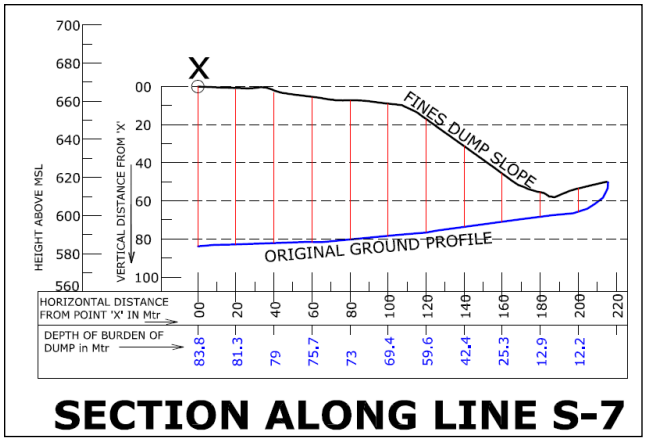
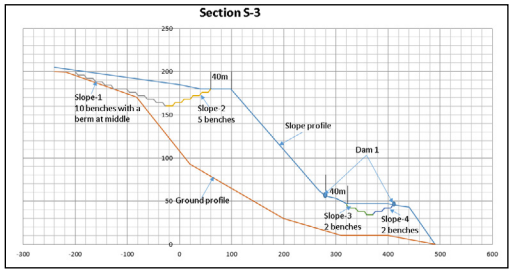
**Figure 11.** The section along line S-7.

| Sl. No. | Section Name | Factor of safety (without load) | Factor of safety (with load) |
|---|---|---|---|
| 7 | S-7 | 2.59 | |

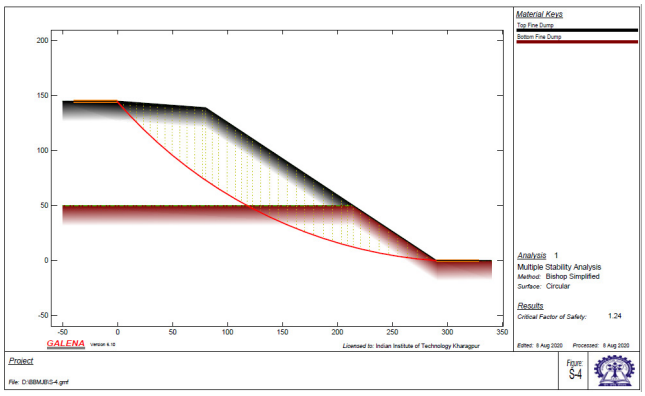
**Figure 13.** The factor of safety of the existing slope along the S-3 section.

of operation is always desirable. This is the reason it was decided that the dumps cannot be worked with one large pit.

1. The designated top fines dump and the bottom fines dump cannot be worked out as a single mine pit because of the low factor of safety as found in most of the sections. The combined F.O.S. was below 1.5 and hence cannot be allowed to mine as a single pit.

2. It is advised to work out two pits, one at the top and another at the bottom, with a minimum horizontal distance 240 m between the internal boundaries of the working.

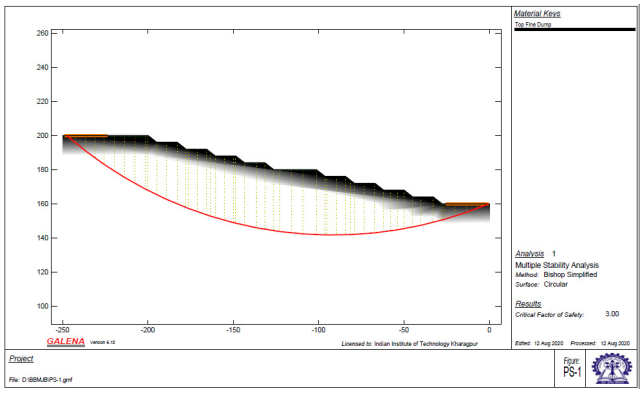
**Figure 14.** The factor of safety of proposed slope-1 along S-3 section.

| Sl. No. | Slope Name | FoS without load | FoS with Load |
|---|---|---|---|
| 1 | Slope-1 | 3.00 | 2.75 |
