Total Quality Control Approach for reduction in percentage repair for new water conductor system khopoli

V. P. Amodekar

ABSTRACT

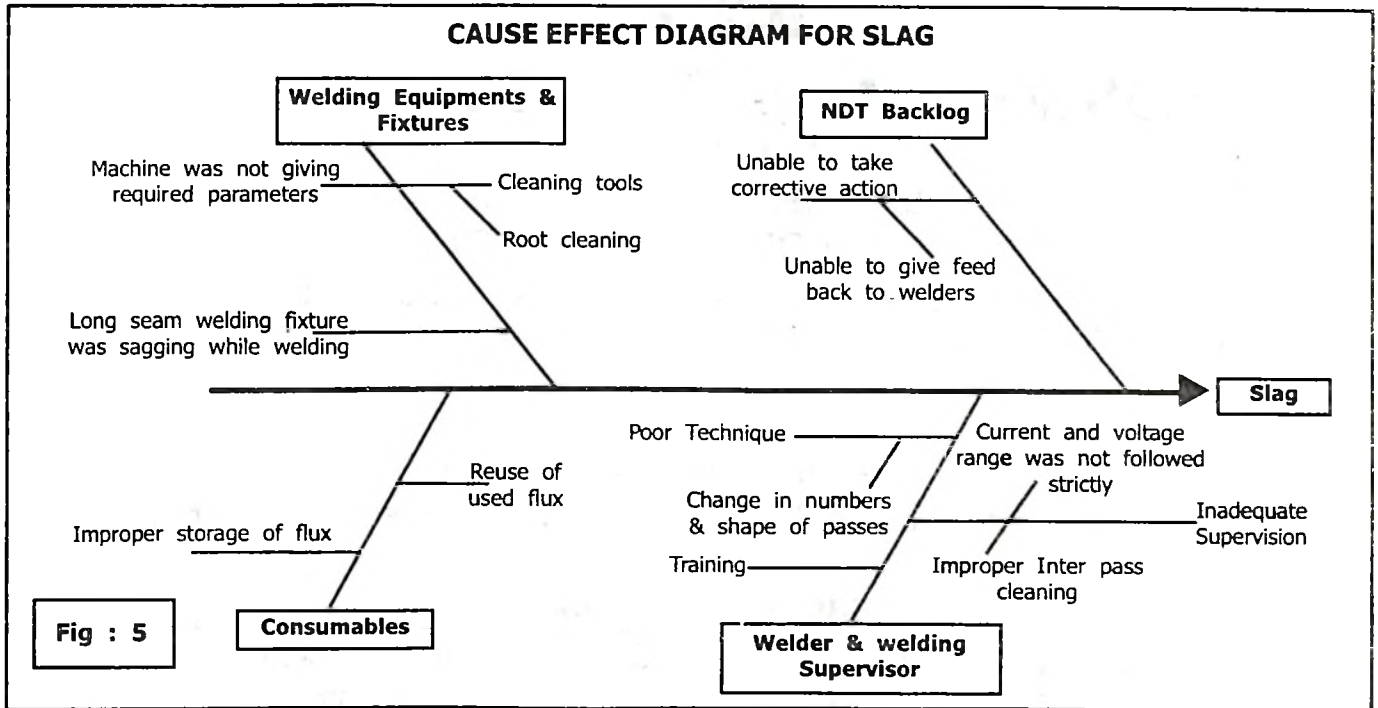
Fig. 6

The repair percentage was reduced from 16% to within 4% for following months as shown in figure 6. The before and after pareto diagram was drawn and as shown in figure 7. Similar exercise was done for erection repair percentage and monitored Below 4% as shown in figure 8.

- a) Additional NDT contractors were mobilized to get the NDT done in time for immediate corrective action
- b) Old Welding machines were replaced with new machines
- c) Flux storage procedure given by manufacturer was followed with more care.
- d) Quantity of flux was increased while welding joints so that arc cover was increased.
- e) Long seam at the rotators were made flush by grinding to avoid jumping of pipe while welding circular seam.
- f) Additional welding supervisor were employed for night shift.
- g) Welder performance report was prepared monthly. Welders were warned if percentage repairs exceeded satisfactory level. The welders were disqualified if they were not able to improve performance even after repeated warnings. Feedback was given to welders, some times welders were warned and some welders disqualified on the basis of poor performance.
