# HARD FACING WITH COBALT BASE ALLOY - STELLITE-1

Central Workshop, Indira Gandhi Centre for Atomic Research, Kalpakkam - 603 102

(This paper, presented at the National Welding Seminar-1995 at Cochin, has received the K.C.P. Award for the First Best Paper on Fabrication)

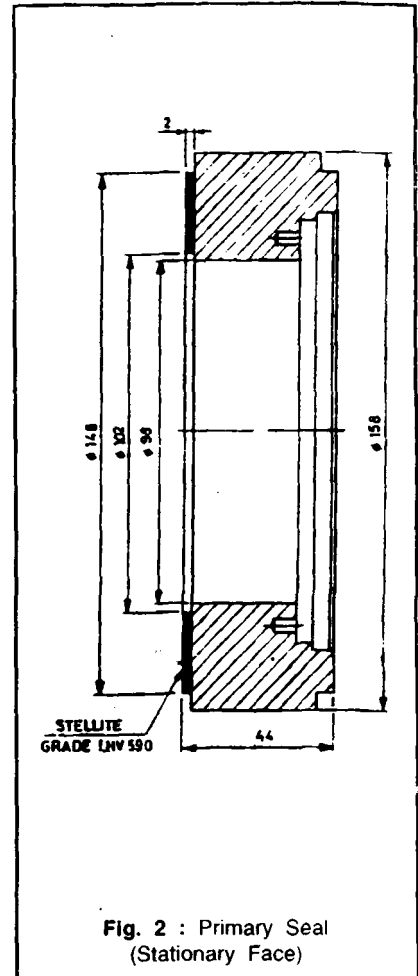
Fig. 2 : Primary Seal  
(Stationary Face)

The primary seal rotary and stationary faces of PHT circulating pump are made out of 44 mm thick S.S. of dia 158/98 mm. One face each of these seals is deposited with Stellite-1 providing a clear hard thickness of 2 mm after machining. The pump seals are shown in Figs. 1 & 2.
