Optimization of Parameters for Welding of Spark Plug Detector

ABSTRACT

Key words: Spark plug detector; extension wire; failure analysis; metallography; welding procedure qualification.

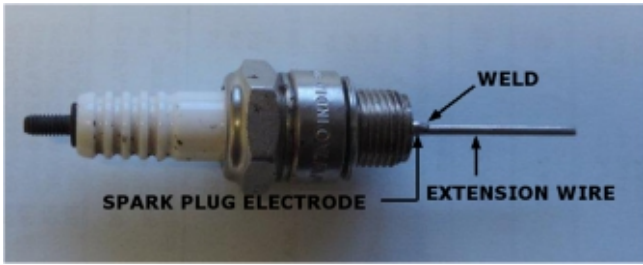
Fig.1 : Spark plug type Leak detector

Gas Tungsten Arc Welding (GTAW) process was carried out to weld the spark plug electrode (2 mm diameter) with extension wire (1.5 mm diameter). **Fig. 1** shows the spark plug welded with extension wire. Special fixture was fabricated to hold the spark plug and extension wire in line and welding was completed within few seconds. It was recommended to use filler wires of smaller diameter to reduce the size of the filler material deposit at the weld joint as it may otherwise lead to stress concentration at the weld joint. During the welding process, it was also recommended to increase the Ar gas purging flow rate (from 1lit/min to 3 lit/min) to reduce oxidation of the weld metal.
