Salvaging of Large Bell of D Furnace of TATA Steel

Dip Narayan Koner*, Sanjay Kumar Jha

Spares Manufacturing, Tata Steel Limited, Jamshedpur - 831 001, India

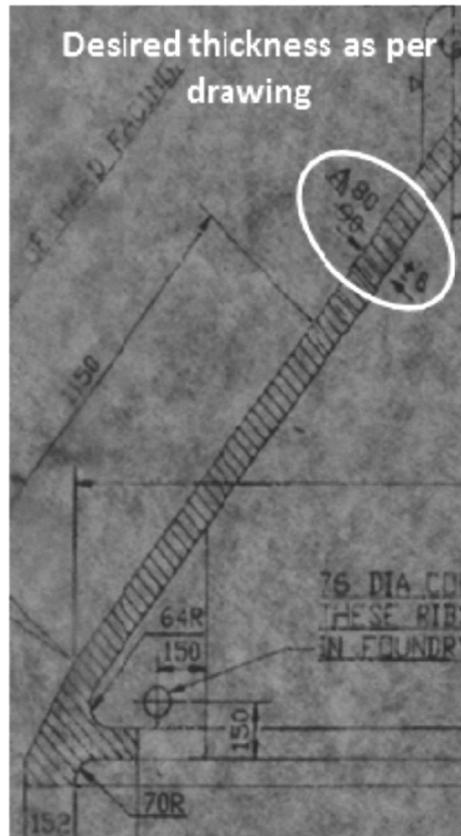
Fig.5 : Wall thickness requirement (Drawing)

The required wall thickness as per drawing (Fig. 5) was 80 ± 6 mm and measured thickness varied from 9-90 mm. The variation in wall thickness was 15-60 mm in some portions of the burden area. The seat area wall thickness was 9-10 mm. Only 90% of the wall thickness of the seat area was worn out in service. From the measurement of the wall thickness at various locations, it was concluded that worn out magnitude does not have any pattern and the variation is too high across the large bell.

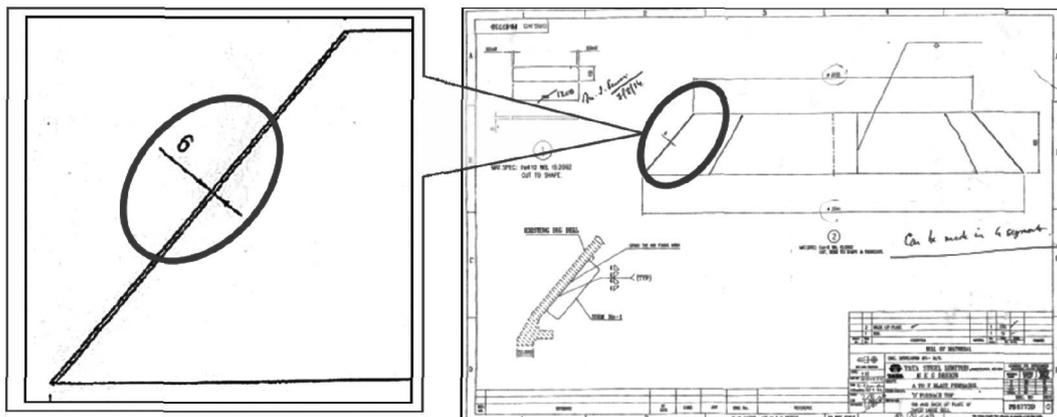
Fig. 6 : Wall thickness requirement as per (Drawing)

The plant design initially proposed for a circular conical as depicted in the Fig. 6.

The plate thickness was 6 mm and the whole thing suggested to weld from inside. Based on the practical experience, modification of the plant design was suggested.

With the circular ribs to be placed from inside. These circular members will be supported by number of vertical stiffener to be placed at equal space. These stiffeners were fabricated from 32 mm thick plate of IS 2062. These members after gas cutting and debarring fixed in inner wall of the large bell. The detail of the stiffener drawing is depicted in Fig. 7 and after erection of the stiffener is shown in Fig.8:
