Role of geological discontinuities during application of continuous miner technology in underground coal mines

3.0 Continuous miner technology in VK-7 incline mine, SCCL

4.0 Continuous miner technology in GDK-11 Incline, SCCL

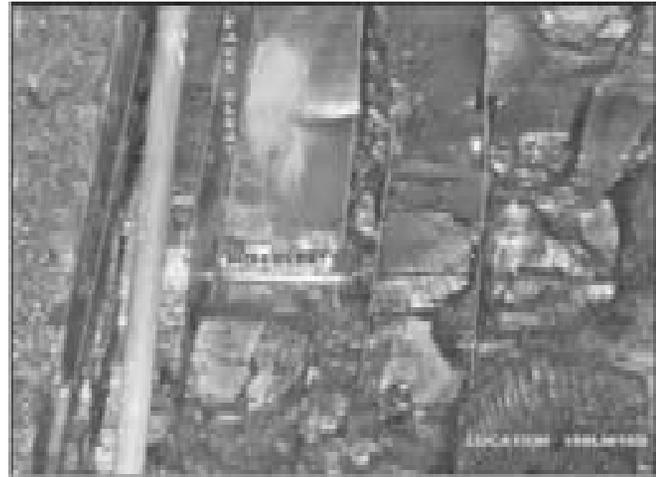
Cleats are weakness planes occurring perpendicular to bedding and they are specific to coal. Generally, two types of cleats; namely, face and butt cleats occur at right angles to each other: (i) face cleats are more prominent cleats which are continuous over some length and even cut across bedding planes in coal and (ii) butt cleats are short, discontinuous

planes which terminate against the face cleats. Face cleats are believed to be extension fractures formed during erosion and uplift (Fig. 4a-b) [3].

Fig.4a Face cleat and butt cleat

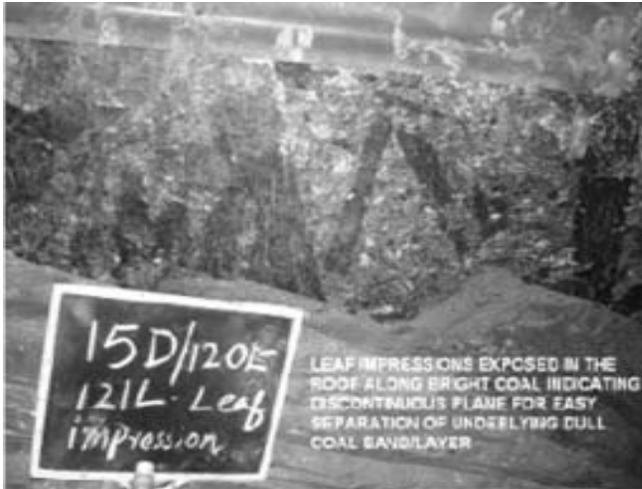
Fossil remains are the remnants of plants (Fig.5) [3] and animals that lived during the time when the sediments that later become rocks were being deposited. For example, kettlebottoms are fossil trees that grew in ancient peat swamps. Fossil remains can fall without warning and should always be carefully supported. Roof bolt holes should never be drilled directly in fossil remains because the vibrations could cause them to be dislodged.

Fig.5 Leaf impressions in the exposed roof

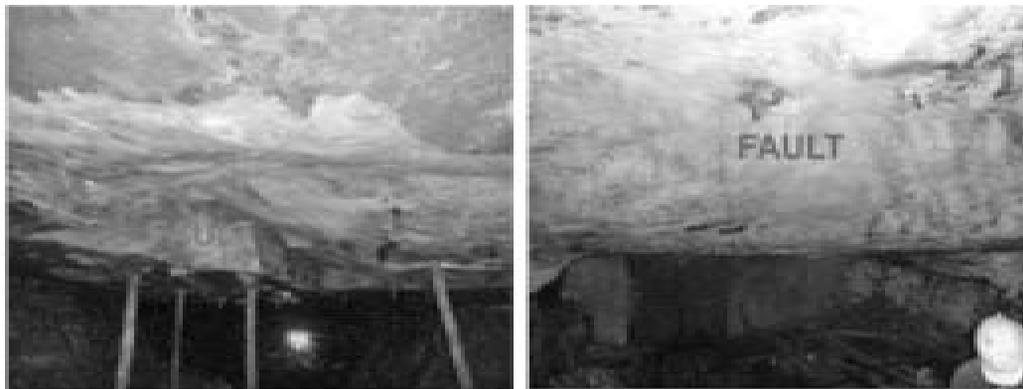
A fault is a dislocation of the strata whereby beds which were once continuous are displaced relatively to one another by tectonic forces acting regionally. Displacements may be either vertically upwards or downwards or horizontally in mining (Fig.6) [3]. In mining, the smaller faults are also often referred to as slips. Faults are divided into three main classes namely, (a) normal (b) reversed and (c) transcurrent. The first two cause vertical displacement. Normal faults are most common in coal-measure strata. The third variety causes only horizontal movement and is relatively rare in the coal-measures. Faults often contain weak gouge material, often cited as contributing to large roof falls in underground.

Fig.6 Faults in a coal mine

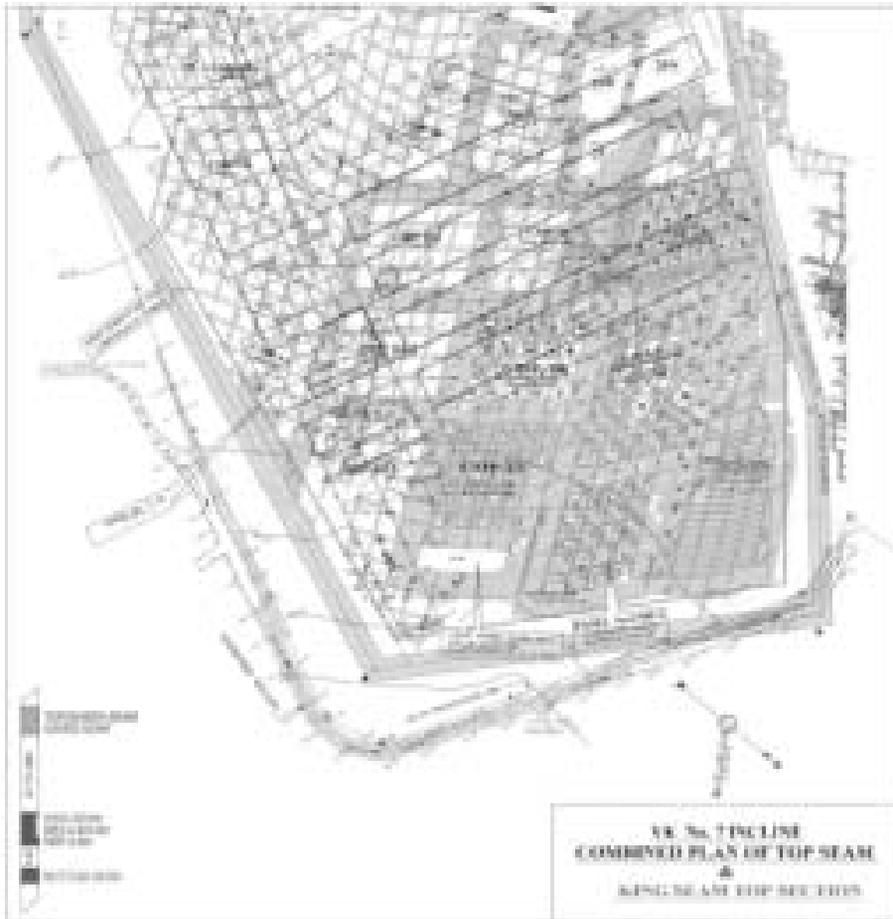
Continuous miner technology was introduced at VK-7 Incline mine [4] in the year 2006 at the dip side property to extract standing pillars in 6m thick king seam below 300 to 380m depth of cover (Fig. 7). The seam is dipping at 1 in 7.5 and is overlain by caved goaf of top seam with a parting of around 40m. There was setback initially with caving method of extraction which has lead to employing the yield pillar non-caving (YPNC) method for four numbers of panels as a confidence building measure. As many strata control problems have been faced with YPNC method, caving method of extraction was re-adopted with the support of CSIR-CIMFR scientific study. Till now, eight sub panels were extracted by caving method of mining with recovery of around 70%. Presently, extraction in the ninth sub panel with caving is in progress.

Fig.7 Plan showing the dip side property of king seam where CM is introduced

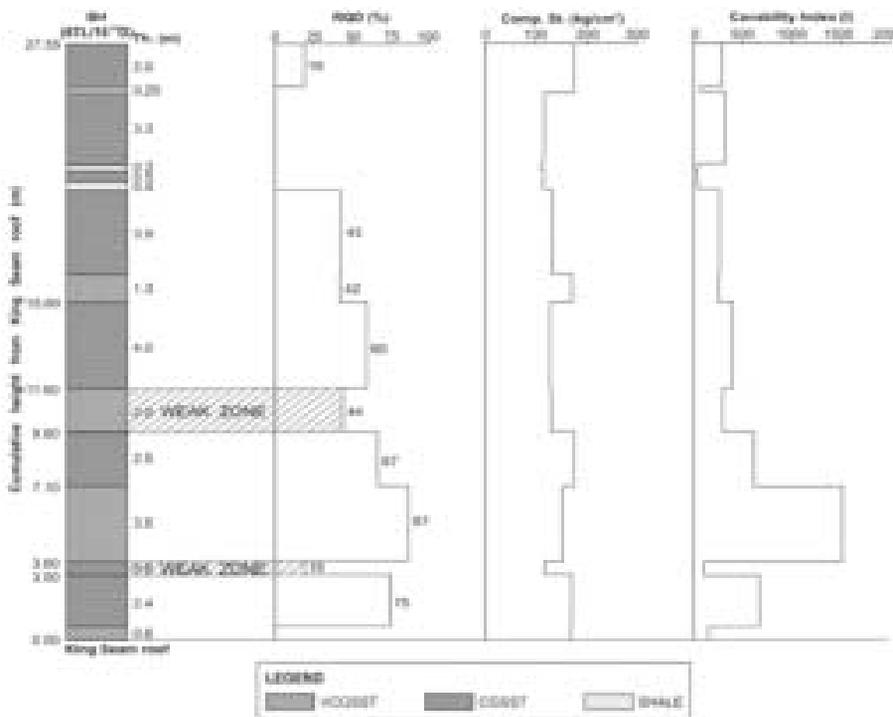
found to be 30 MPa. RQD of immediate roof rock varied from 0 to 87%. Low strength of the upper strata was responsible to give the low cavability index of the overlying rock strata. This characteristic of the upper strata would help in caving. But, the core samples recovered from hole was found to be severely fractured during

Fig.8 Compressive strength, RQD, cavability index of immediate roof rock strata above king seam of BH located at 67L/16½D

drilling and recovery. Fractures were inducted into the core during upward drilling causing vibration despite much of the rock consisting of good quality sandstones. RQD is a very good index to account for fracture spacing and depends on joint volume, bedding frequency and strength of rock. However, it is rarely possible to obtain cores maintaining the strict requirements like NX diamond drilling with double tube core barrels and without much vibration. This might be the reason for low RQD as obtained and strength of king seam roof. Therefore, it would be prudent to consider the roof difficult to cave as experienced in BG panels in king seam.

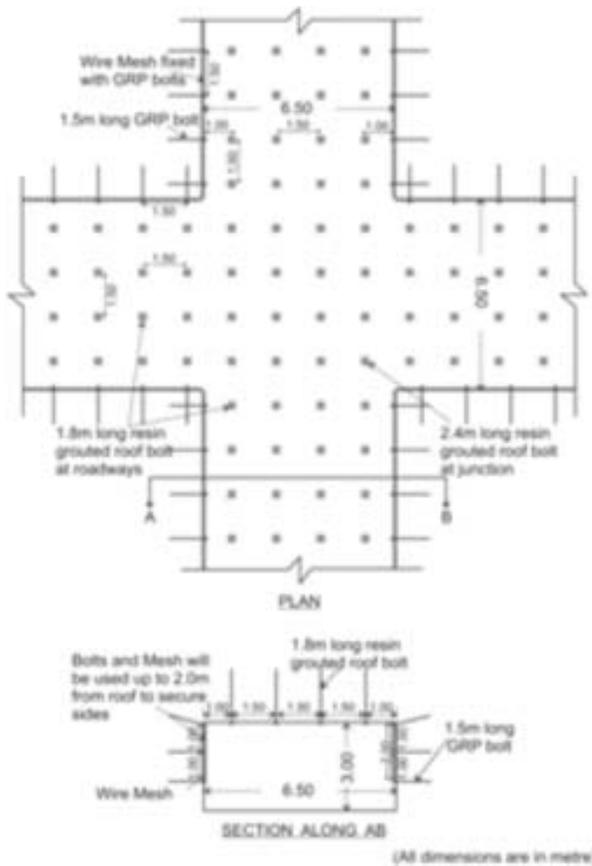
Fig.11a Support system for 6.5m wide gallery and junction below top seam goaf

For split, instead of additional flexi bolts at goaf edge, it was suggested to keep coal stumps of $3.25\text{m} \times 5.0\text{m}$ in the dip side at the end of the split (Fig.13). Only half width of split was remained open at the end of the split. This left out stook along with normal breaker line support system provided in the split goaf edge prevented any possible goaf encroachment. To arrest the side spalling due to presence of numerous cleats, all the pillar sides were supported with plastic mesh fixed with 1.5m long GRP bolts in three rows at 1.5m interval within the row and 1.0m between the rows (Figs.10-12).

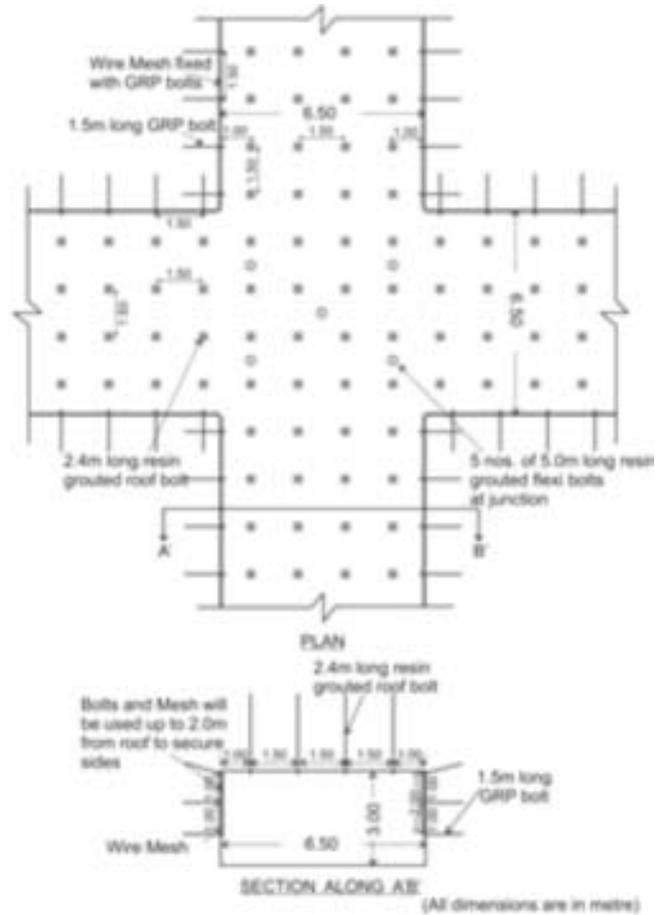
Fig.11b Support system for 6.5m wide gallery and junction below top seam barrier

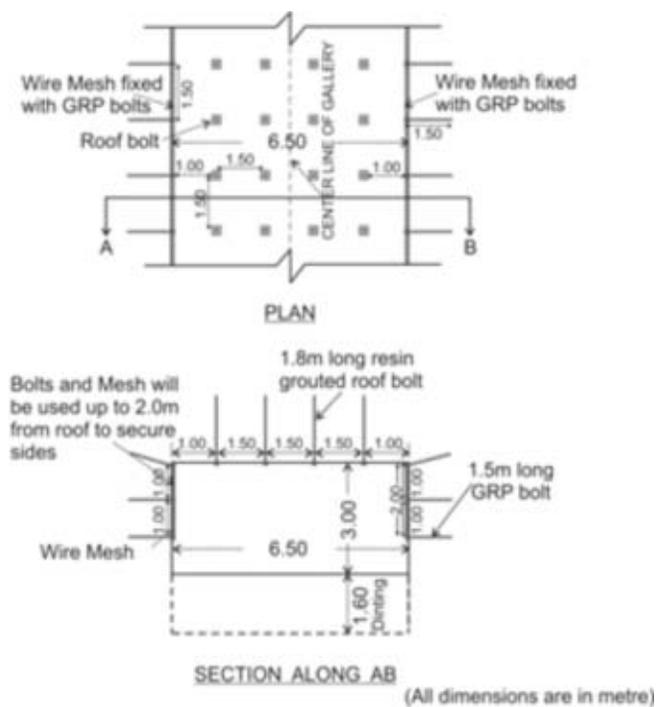
Fig.12 Support design for level splits and sides

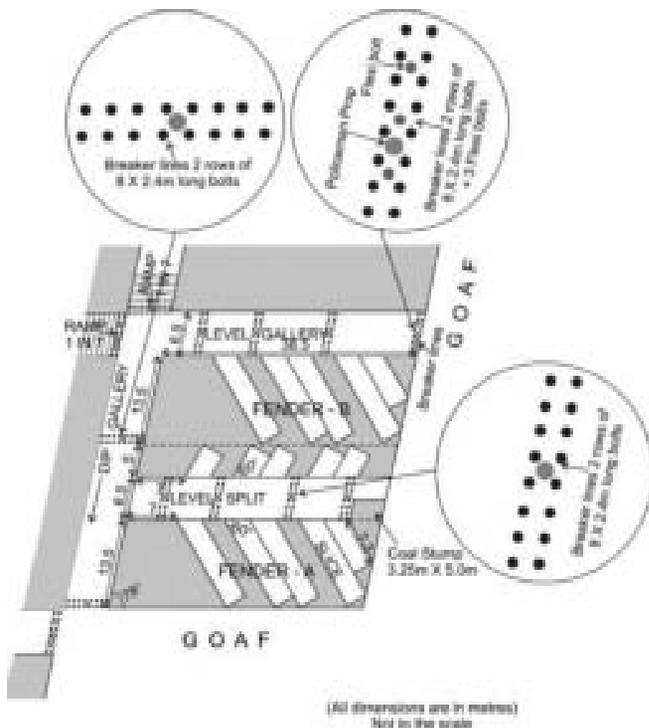
Fig.13 Goaf edge breaker line support for original galleries and level splits

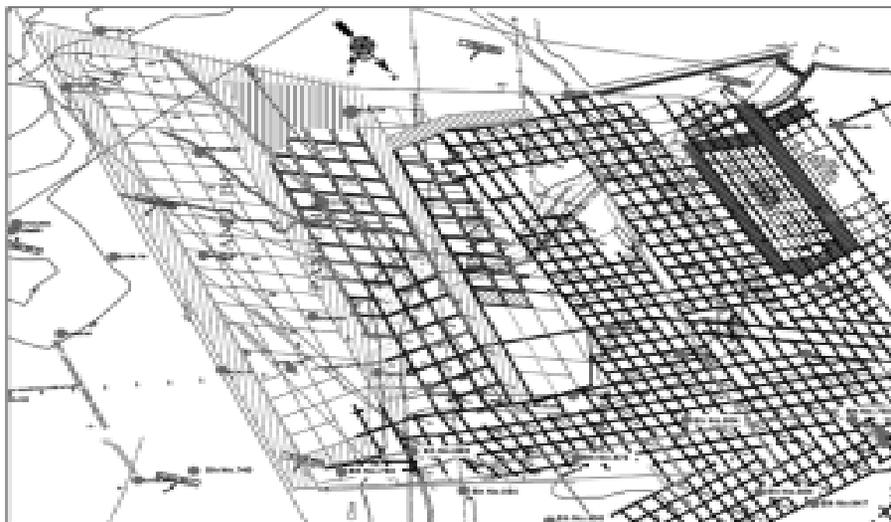
In GDK-11 Incline, CM technology was introduced in the year 2009 in No.1 seam with a depth of cover of around 325m (Fig.16) [5]. Due to the presence of adverse mining conditions in the dip-rise gallery, geological mapping technique was used to measure in-situ horizontal stress orientation. Based on horizontal stress orientation, pillars were re-oriented from proposed square geometry to rhombic-shaped geometry, resulting into reduced frequency of roof falls in dip-rise galleries and considerable improvement in roof stability. Panels were extracted by caving method safely without much strata control problems.

Fig.16 GDK-11 Incline mine plan showing panels B1, B2 and B3 in No.1 seam

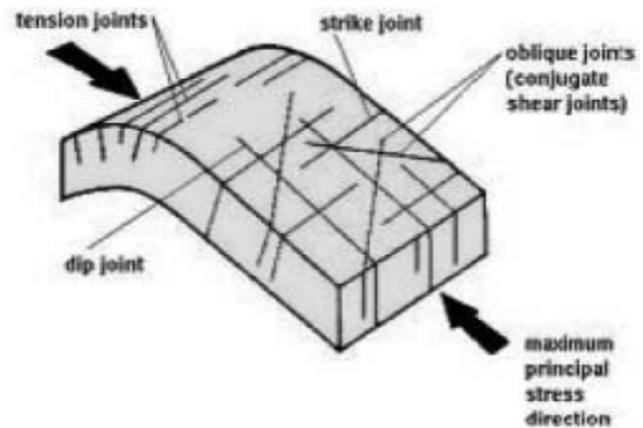
estimate the orientation of major principal stress (σ_1) [6]. Features such as roof guttering (Fig.17) [6] or roof pots are mapped along with structural discontinuities (i.e., fault, slip, joint, cleat) in underground working and the stress direction is inferred from their orientation and severity (Fig.18).

Fig.18 Stress orientation and joints
