The source of increased carbon content in gas cut steel surfaces

By F GOLDBERG*

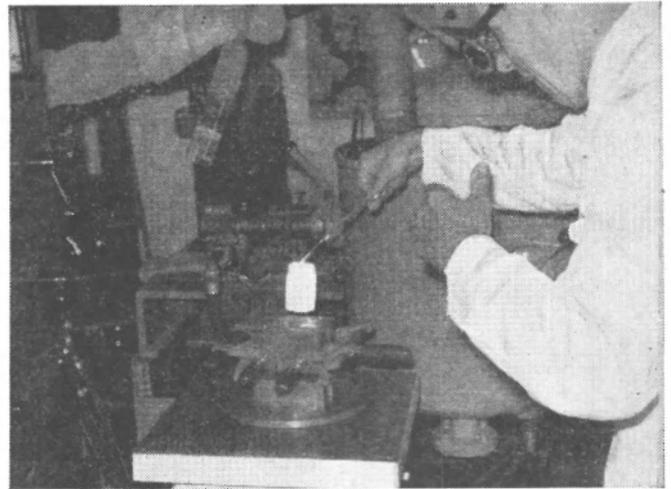
Fig. 1.

When the different ingredients had melted together, they were poured into a casting with the dimensions 20 × 30 × 70 mm. (fig. 1). The casting was then treated in a rolling mill at the Swedish Institute for Working of Metals, KTH, Stockholm. It was rolled four times and was reduced to a thickness of 4.8 mm. After rolling, one side of the steel plate was ground free from mill scale and straightened. The steel plate then was cut in a hand-cutting machine, being kept, during this operation, inside a box of perspexglass. The box was filled with argon gas at 2 atmos pressure in order to eliminate the influence of CO₂ from the air in the room and its possible participation in the chemical reactions when the steel was being cut.

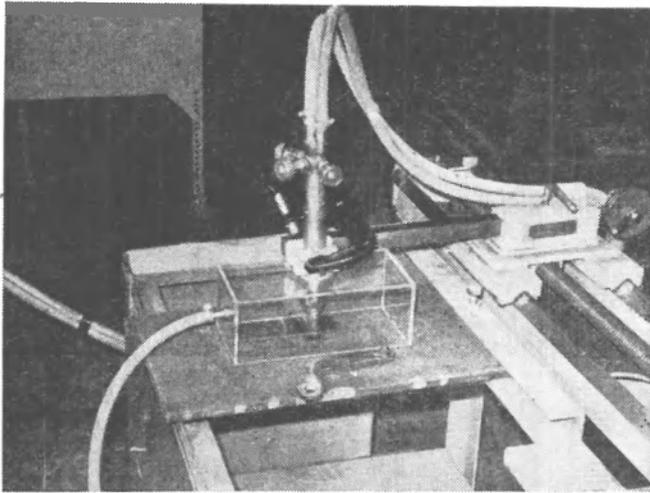
Fig. 2. Picture taken just after the cutting operation was completed.

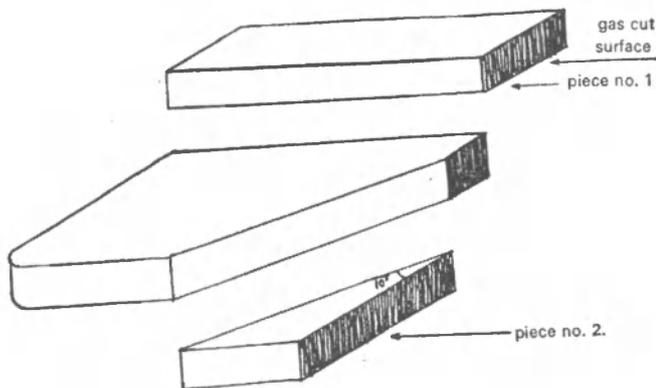
Fig. 3.

When the cut was completed, two pieces were taken out and prepared for microscopic studies. Piece No. 1 was cut out perpendicularly to the kerf and piece No. 2 was cut out at an angle of 10 degrees to the kerf (fig. 3).

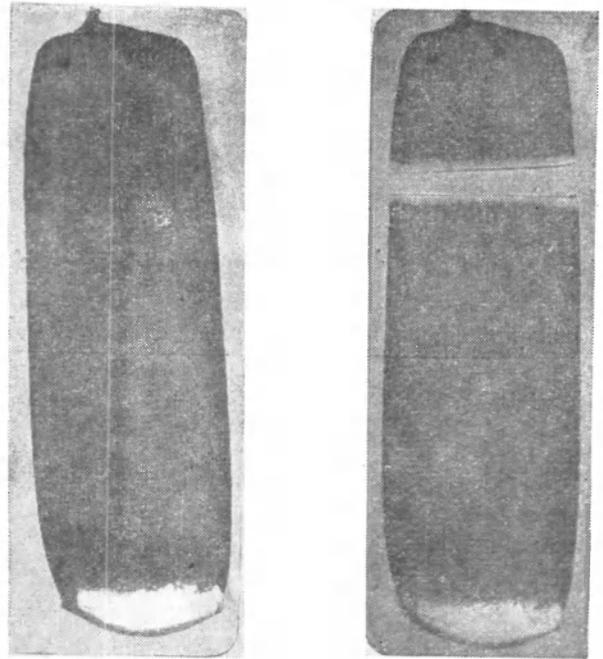
Fig. 4. Autoradiographic picture on X ray film of steel plate before and after the cut. Dark parts show the exposure to radioactive carbon-14. The light area at the bottom is mill scale which the radiation could not penetrate. The exposure time was 18 hrs. scale 1 : 1.

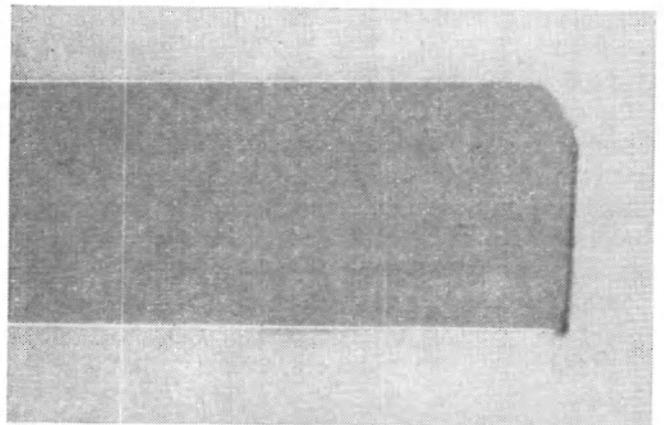
Fig. 5. Autoradiographic picture of piece No. 1 with the cut surface on the right side.

Figures 5 and 6 clearly show a carbon concentration at the surface of the cut. This indicates that the carburized edge contains carbon which comes from the steel itself and not from the acetylene.

Fig 5 also shows that the carbon concentration increases towards the bottom of the cut, which was also observed by Miller in 1925.

The picture further reveals that there was no carbon migration at the very top of the kerf. In fact, when comparing the autoradiographic picture and a metallographic picture, it is found that a small area near the top is missing on the autoradiographic picture. This indicates that the area has been decarburized and this is confirmed when the microstructure is studied (Fig. 12). This decarburization is probably caused by the acetylene flame, as it is a known phenomenon that an open flame decarburizes a steel surface. The decarburization of the cut steel plate is also disclosed by the light bands across the piece parallel with the cut (Fig.4). From the autoradiographic picture it is easy to measure the thickness of the carburized zone. It was here found to be approximately 0.04 mm.

reaches the solid steel. This means that the carburized edge is mainly formed in a narrow band of liquid iron. This also explains why we often get carbon-rich drops at the bottom of the kerf (Fig.5). Part of the liquid Fe+C is transported down the kerf by the jet action of the oxygen, giving the cut surface an increasing carbon content with the depth. This is also the reason why there is almost no carbon at the top of the kerf.

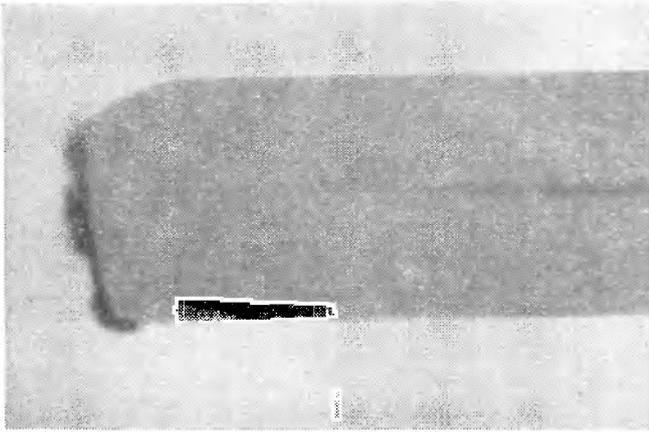
Fig. 6. Autoradiographic of piece No. 2 with the cut surface on the left side.

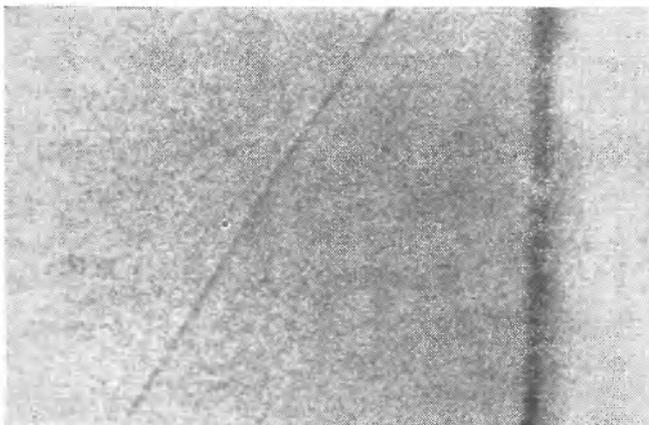
Fig. 7. Microphotograph of film exposed to radioactive carbon in steel; from left to right original material, carburized surface, unexposed film.

When studying in the microscope the film exposed to radio-activity, it was not possible to observe a zone behind the carburized edge which was lighter than the original material. This indicates that there was no carbon diffusion from central regions to the areas at the edge of the plate. The carbon must have come from the material that was burnt off in the kerf (see fig. 7).

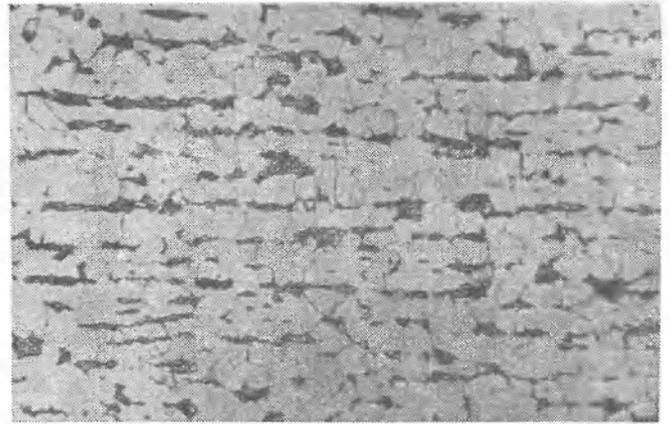
Fig. 8.

The original microstructure of the steel plate, (Fig. 8), consists of ferrite and pearlite in a typical band structure. At a distance of 2 mm from the cut surface the microstructure is influenced by the heat from the cutting process and turns into a fine-grained structure (Fig. 9), while at 0.5 mm from the cut surface

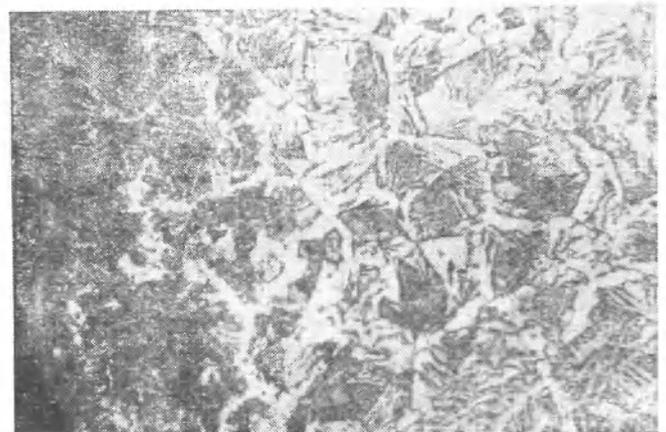
Fig. 10.

the pearlite grains grow larger and have grain boundary ferrite and Widmanstatten-ferrite (Fig. 10).

The very thin carburized layer on the cut surface, approximately 0.04 mm thick, has a structure very similar to 100% pearlite (Fig. 10).

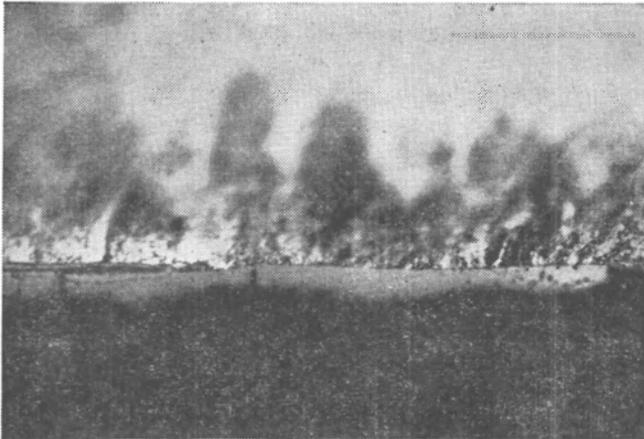
Fig. 11.

Here and there on the lower part of the kerf, a layer of ledeburite approximately 0.015 mm thick has been found on top of the 0.04 mm thick carburized structure (Fig. 11).

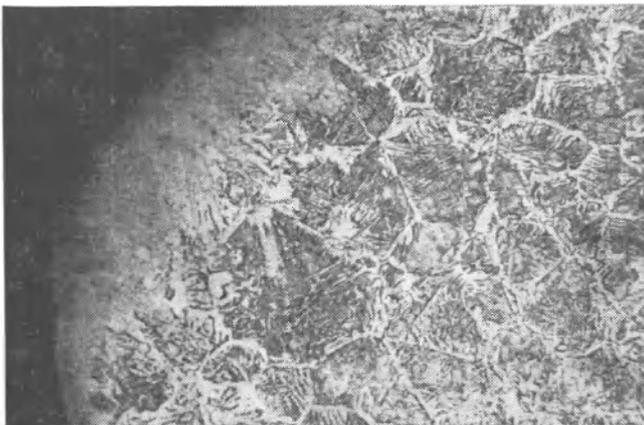
Fig. 12. Ferrite structure to the left due to the decarburization effect.

A series of hardness measurements has been made with a Reichert micro hardness using a load of 20 gram. The first series of measurements (Fig. 13) was made in the upper part of the cut where the structure was ferritic on the edge (Fig. 12). The rise of hardness 0.15 mm from the edge is perhaps a quenching effect resulting from the heating flame.

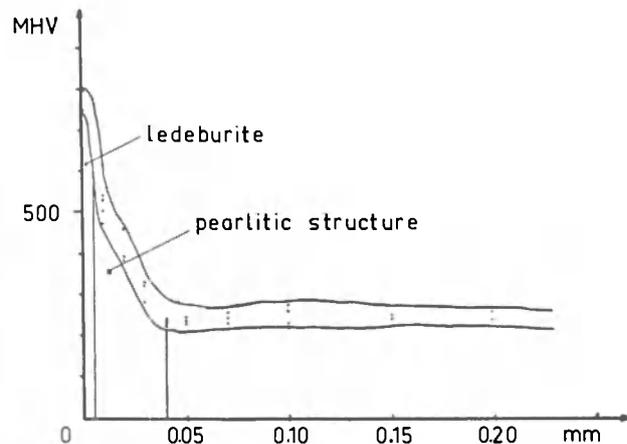
Fig. 14.

The second series of hardness measurements (Fig. 14) was made in the middle of the cut. The diagram reveals that the hard structure has approximately the same thickness as the carburized layer, which is logical having regard to the facts mentioned above.

The unaffected original structure had an average hardness of 218 MHV and the martensite layer had a hardness of 750-650 MHV.

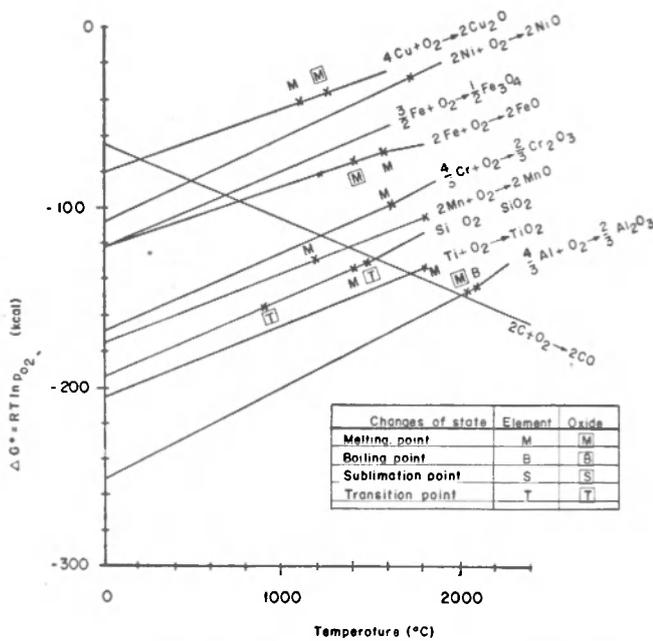
Fig. 15. Standard free energy of formation of oxides as a function of temperature.

When steel is gas cut, not only carbon is enriched in the cut surface but also nickel and copper (8, 9). This is because the oxygen jet causes a selective oxidation of the steel. The selective oxidation is explained by Gibbs' diagram of free energy of formation of oxides as a function of temperature (Fig. 15). The diagram shows that curves of Ni and Cu lie above the curves $3/2 \text{Fe} + \text{O}_2$ and $6 \text{FeO} + \text{O}_2$, which means that iron is more easily oxidated than the other metals mentioned above.

In Gibbs' diagram (fig. 15) the carbon line crosses the 1500°C line below the iron oxidation lines which should indicate that the carbon should oxidise easier than Fe. If this really is the case, a carburization effect should not result. The explanation why the carbon oxidation does not follow the Gibbs' diagram is that the carbon monoxide cannot nucleate. The same occurs in a blast furnace where the CO is formed only along the walls of the furnace where it can nucleate, and not in the middle of the melt. An attempt to explain the cutting operation is done in fig. 16.

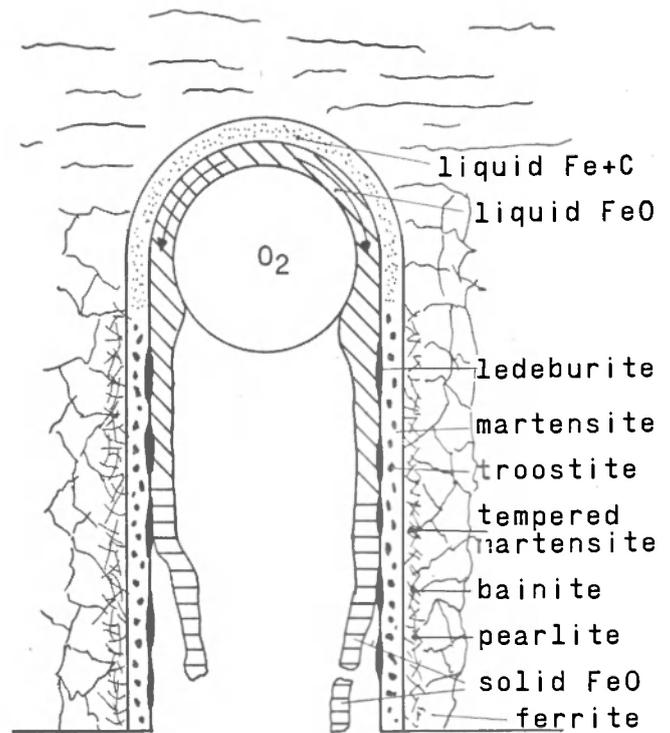
Fig. 16. This figure is an attempt to describe the oxygen cutting process. The oxygen jet oxidises the preheated iron forming different iron oxides in a liquid state. Most of the oxides are blown away by the jet action, thereby forming a cut. But on the sides of kerf there is always a thin layer of oxides which after solidification falls off by itself, while the layer of liquid iron and carbon solidifies; layers (0.015 mm) of ledeburite are formed in the lower parts of the kerf.

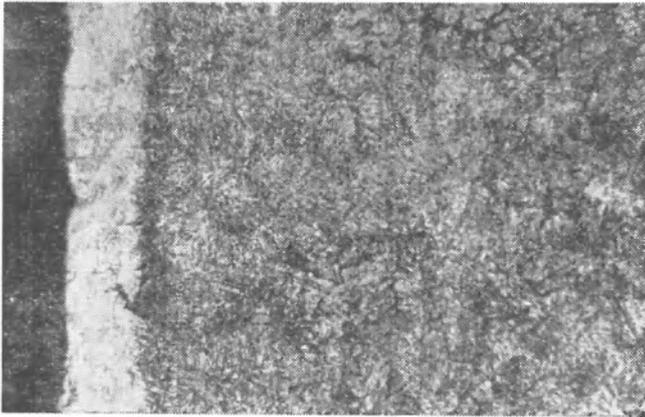
Fig. 17.

The steel piece in this investigation containing radioactive carbon was a small, only 5 mm thick, plate. When cutting this piece, the cooling conditions are not the same as when cutting a thicker piece. Therefore, the micro-structure of the gas cut edge varies with different thicknesses. Fig. 17 shows the micro-structure in a plate 18 mm thick with approximately the same analysis as the radioactive steel plate.

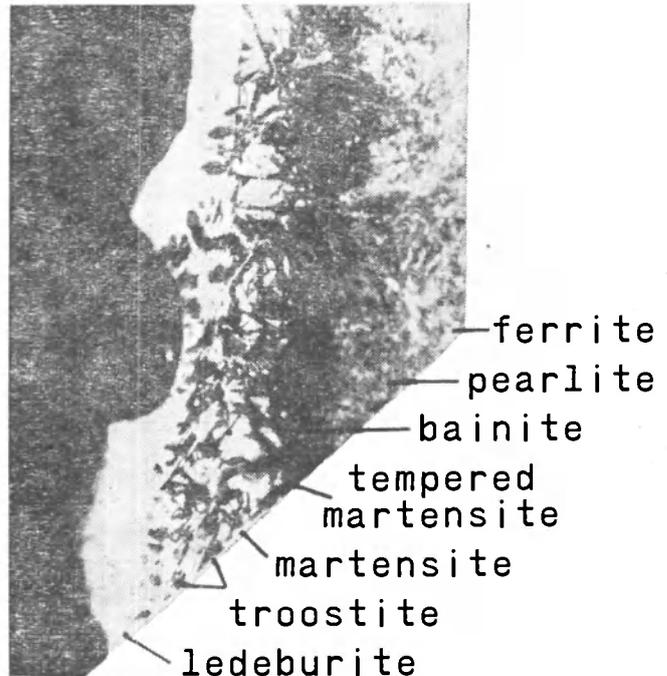
Fig. 18.

The microstructure also strongly depends on the analysis of the steel. Fig. 18 shows the microstructure of a St-52-3 steel which is very different from the earlier mentioned steel. St-52-3 has the following analysis: 0.18 C, 0.47 Si, 1.40 Mn, 0.01 Cr, 0.02 Ni, 0.025 Nb, 0.008 Al.
