# Application of continuous miner technology for extraction of deep seated coal seam under hard roof conditions – a case study of Churcha mine

Messrs. Shyam Sundar Prasad, Rabindra Kumar Sinha, Department of Mining Engineering, Indian Institute of Technology (Indian School of Mines) Dhanbad, Jharkhand 826004 and Katla Sudheer, General Manager (Mining), GMMCO Ltd. (CK Birla Group), Email: rksinha@iitism.ac.in

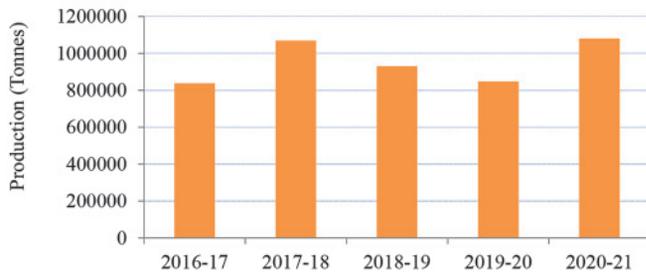
Fig.1: Financial yearwise production (tonnes)

The project has shown tremendous growth last year (Fig.1). By proper planning of mining activities coupled with good equipment maintenance practices has improved the equipment availability to 85% which resulted in the best production performance of 10.8 lakh tonnes in the financial year 2020-21 and is expected to improve further. But the only constrain in achieving improved availability is the pre-existing geo-mining condition which makes it difficult for the technology to achieve maximum production. Hence various scientific agencies were engaged to investigate the strata behaviour of the mine. Celtis Geotechnical cc was the first scientific agency to do research on the behaviour of superincumbent strata followed by SRK Mining Services (India) Pvt. Ltd and CSIR- Central Institute of Mining and Fuel Research (CIMFR). With the advice and guidance of scientists from these three agencies, the mine management has successfully completed four Annual Production Programmemes (APPs), and now with the scientific assistance of CSIR-CIMFR on strata behaviour, SECL and GMMCO have stepped into the final APP of the 5 years contract.

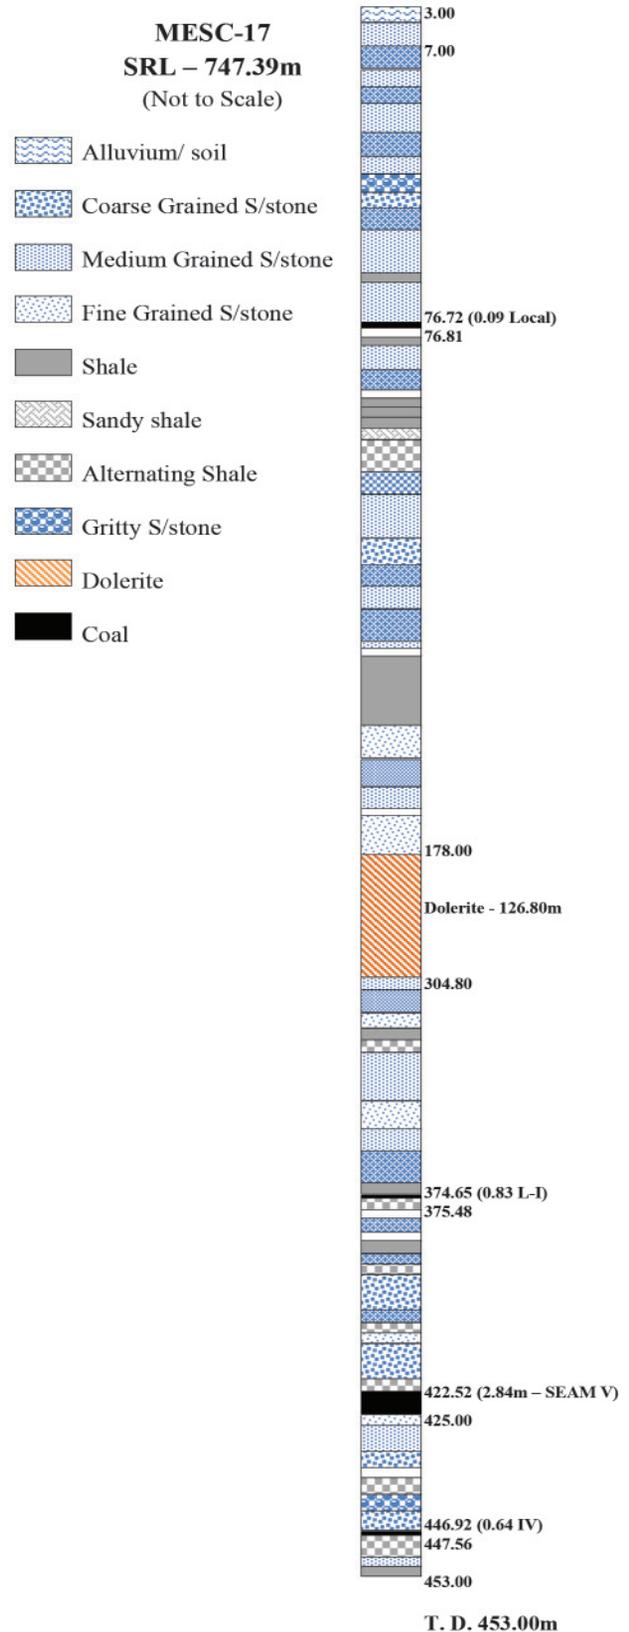
Fig.2: Borehole section MESC-17 showing seam V and position of dolerite sill above seam V (Not to Scale)

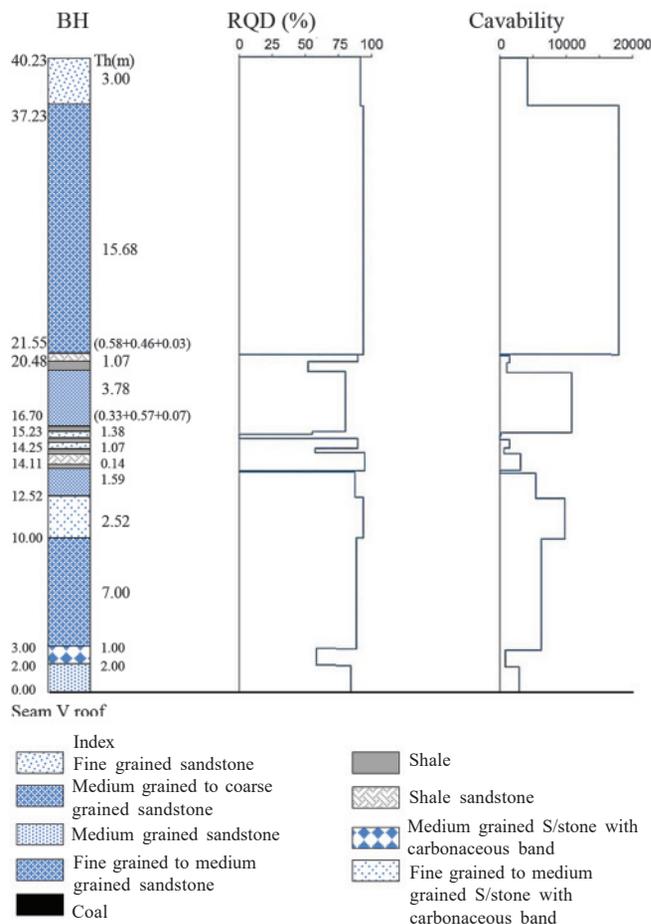
Fig.3: Plot showing RQD and cavability index of roof rock strata of various layers at Churcha mine (RO)

(unadjusted) of the mine is 71. To assess the physico-mechanical properties of roof strata, core drilling was done in coal measure strata up to 40.23m at 125 LE of 7 dip junction. The core samples were sent for testing to CSIR-CIMFR and the results are given in Table 2 (Source: GMMCO Ltd.). Based on those physico-mechanical properties the caving nature of the overlying strata is determined. Fig.3 shows the cavability index and RQD of different roof strata. From this figure, cavability index of 10462.78 and an RQD of more than 80%

are obtained. Such higher RQD of the immediate roof favours the extraction of seam V with a stable cut-out distance (COD) up to the length of CM, which is 12m. But the resulted cavability index of the roof is categorized as cavable with substantial difficulty.

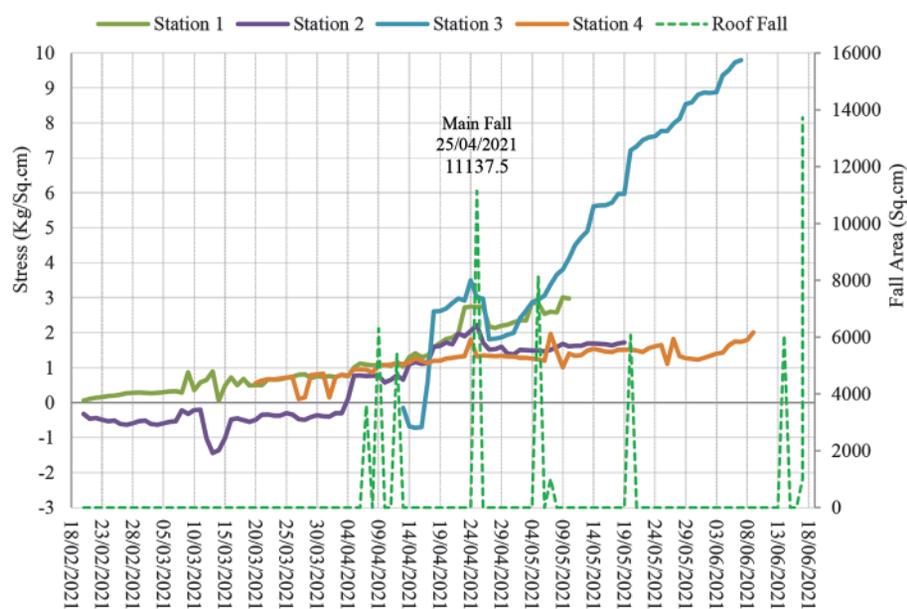
Fig.4 Interpretation between stress and roof fall of 97LE panel

Fig.4 shows the interpretation between stress and roof fall in a recently depillared 97LE panel, where the trend in stress readings shows a variation before each fall. Especially on 24/04/2021, before the main fall (25/04/2021) occurred, the trend in all the four stations shows an elevation. Similarly, Figs.5 and 6 show the interpretation between stress and roof fall in earlier depillared panels 110LE and C2 dip respectively.

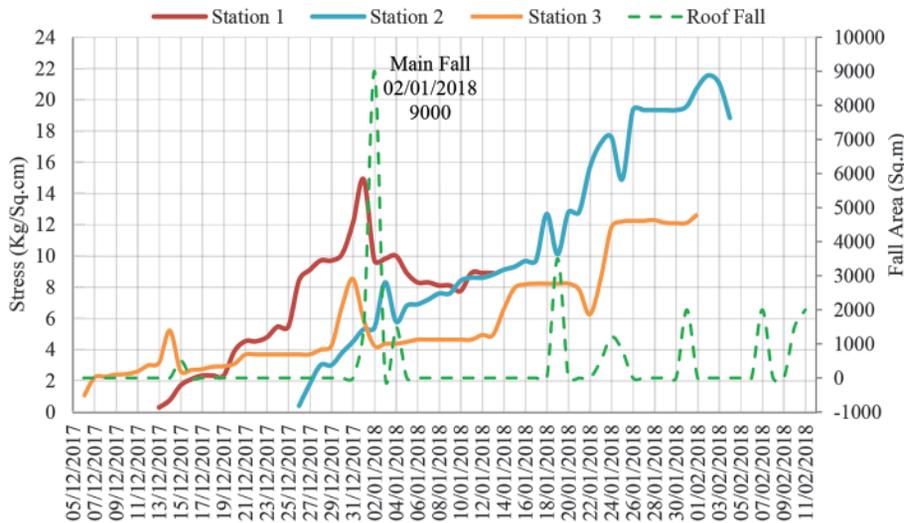
Fig.5: Interpretation between Stress and roof fall of 110LE panel

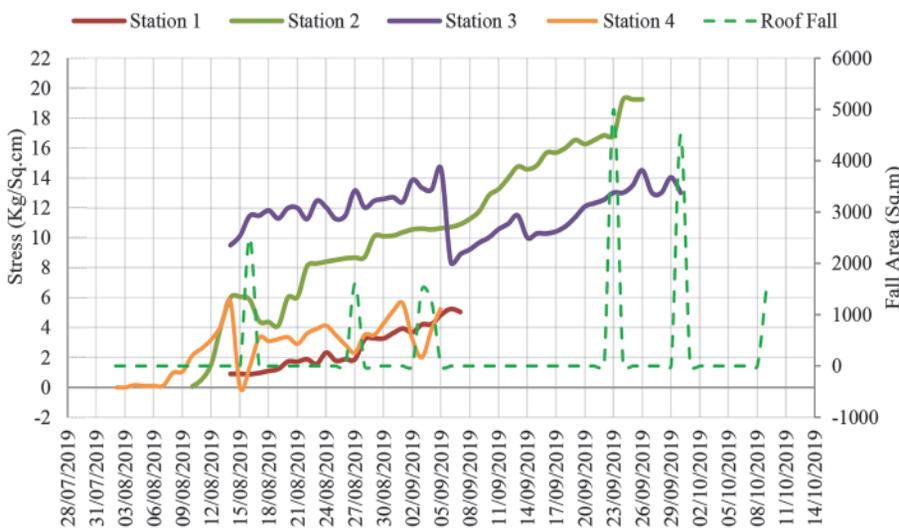
Fig.6: Interpretation between stress and roof fall of C2 Dip panel

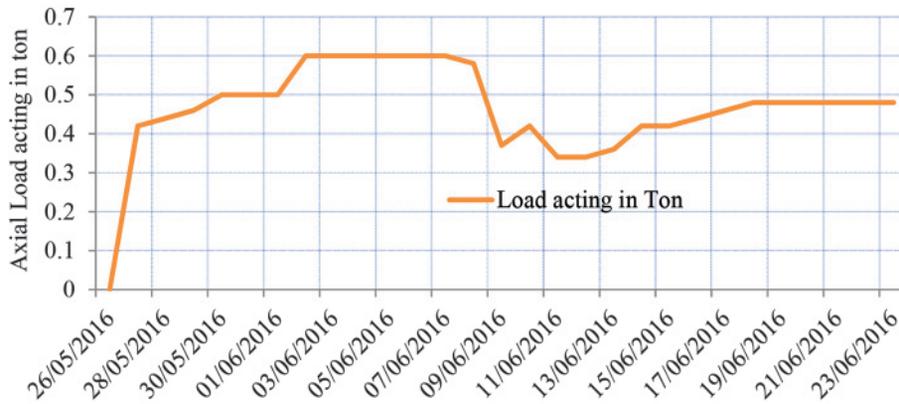
Fig. 7: Interpretation of axial load using Instrumented rock bolt in 124LW panel

128LW/6FX of 124LW panel was chosen for installing an instrumented rock bolt for determination of vertical load acting on roof bolts during main fall. The resulted trend is shown in Fig.7.

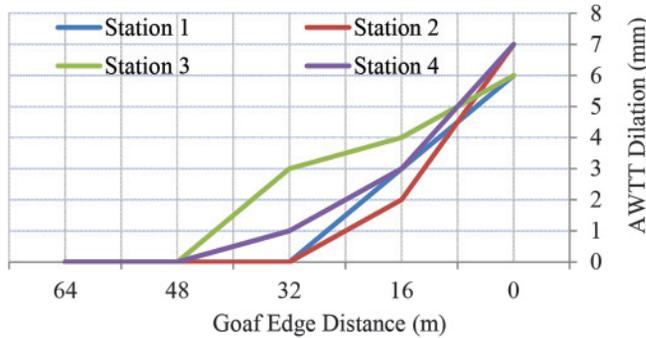
Fig. 8: Interpretation of roof convergence with AWTT dilation in C2 Dip panel

Figs. 8 and 9 shows the convergence observations in the C2 dip panel obtained from AWTT and RTT dilations respectively. The sudden increase of convergence near the zero line is mainly due to the huge abutment pressures during roof fall. At zero line, there is no effective natural support so the convergence shoots up just before the fall.

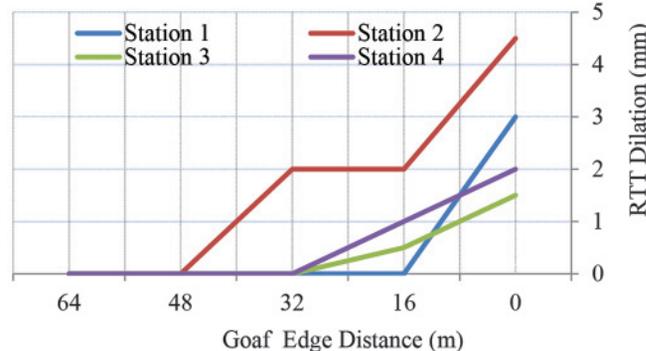
Fig. 9: Interpretation of roof convergence with RTT dilation in C2 Dip panel
