Application of continuous miner technology for extraction of deep seated coal seam under hard roof conditions – a case study of Churcha mine

Messrs. Shyam Sundar Prasad, Rabindra Kumar Sinha, Department of Mining Engineering, Indian Institute of Technology (Indian School of Mines) Dhanbad, Jharkhand 826004 and Katla Sudheer, General Manager (Mining), GMMCO Ltd. (CK Birla Group), Email: rksinha@iitism.ac.in

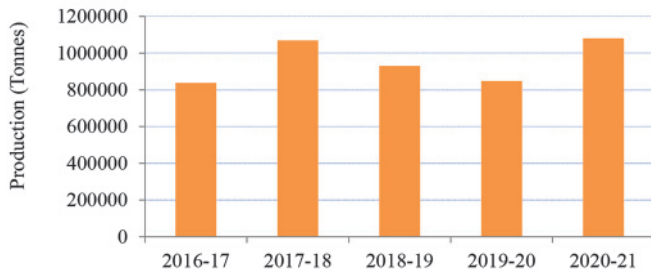
Fig.1: Financial yearwise production (tonnes)

The project has shown tremendous growth last year (Fig.1). By proper planning of mining activities coupled with good equipment maintenance practices has improved the equipment availability to 85% which resulted in the best production performance of 10.8 lakh tonnes in the financial year 2020-21 and is expected to improve further. But the only constrain in achieving improved availability is the pre-existing geo-mining condition which makes it difficult for the technology to achieve maximum production. Hence various scientific agencies were engaged to investigate the strata behaviour of the mine. Celtis Geotechnical cc was the first scientific agency to do research on the behaviour of superincumbent strata followed by SRK Mining Services (India) Pvt. Ltd and CSIR- Central Institute of Mining and Fuel Research (CIMFR). With the advice and guidance of scientists from these three agencies, the mine management has successfully completed four Annual Production Programmemes (APPs), and now with the scientific assistance of CSIR-CIMFR on strata behaviour, SECL and GMMCO have stepped into the final APP of the 5 years contract.

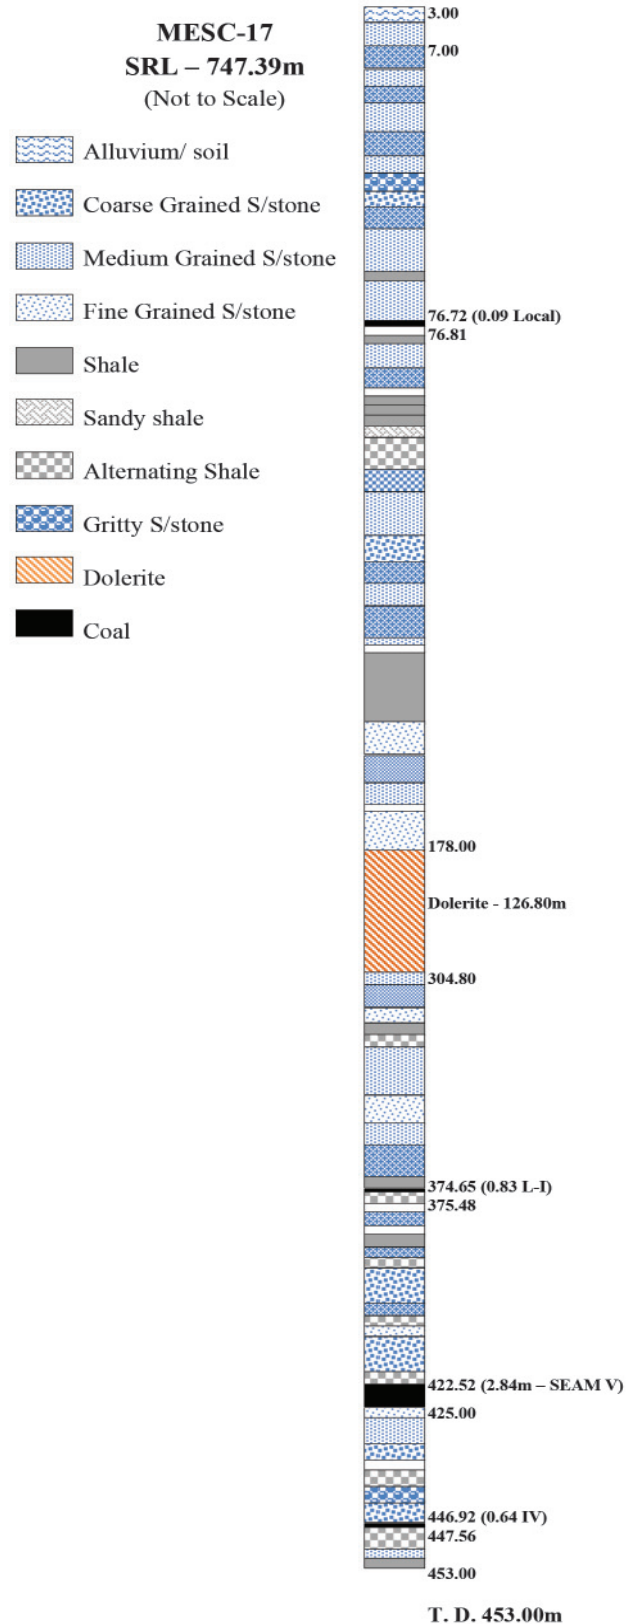
Fig.2: Borehole section MESC-17 showing seam V and position of dolerite sill above seam V (Not to Scale)

The mine is presently working at a depth of 300 to 380m. A small layer of shale having a thickness of 0.1m to 1m is present in the immediate roof, which gets separated from the roof on exposure. Above which a massive competent sandstone roof exists up to the dolerite sill. This massive sandstone in the roof does not favour natural caving, which in turn increases the area of exposure while depillaring. Due to this large hanging area, the pillars in the front abutment zone are being pressurized extensively. As the coal formation in the middle portion of the seam is vertical or angularly cleated the propensity of side spalling and floor heaving during abutment pressures is high, resulting in heaping of coal lumps on both sides of the roadway. This increases the gallery width but narrows down the roadway width. The increase in gallery width causes further expansion of the pressure arch, which in turn increases the height of the immediate roof. On the other hand, the narrowing of roadway width by coal lumps restricts the passages for machinery. So, compulsory sweeping by multi-utility vehicles is required

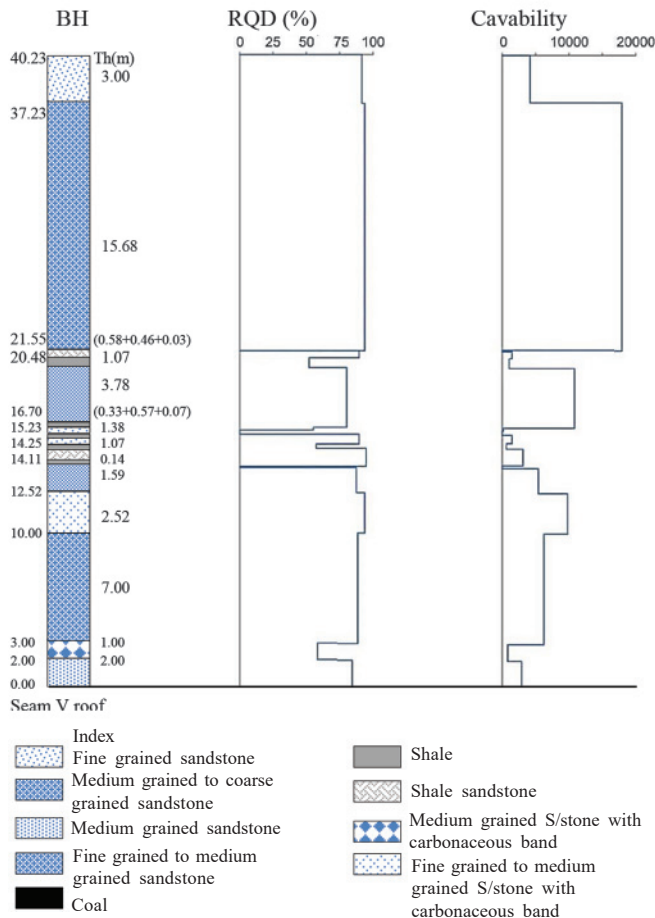
Fig.3: Plot showing RQD and cavability index of roof rock strata of various layers at Churcha mine (RO)

(unadjusted) of the mine is 71. To assess the physico-mechanical properties of roof strata, core drilling was done in coal measure strata up to 40.23m at 125 LE of 7 dip junction. The core samples were sent for testing to CSIR-CIMFR and the results are given in Table 2 (Source: GMMCO Ltd.). Based on those physico-mechanical properties the caving nature of the overlying strata is determined. Fig.3 shows the cavability index and RQD of different roof strata. From this figure, cavability index of 10462.78 and an RQD of more than 80%

are obtained. Such higher RQD of the immediate roof favours the extraction of seam V with a stable cut-out distance (COD) up to the length of CM, which is 12m. But the resulted cavability index of the roof is categorized as cavable with substantial difficulty.

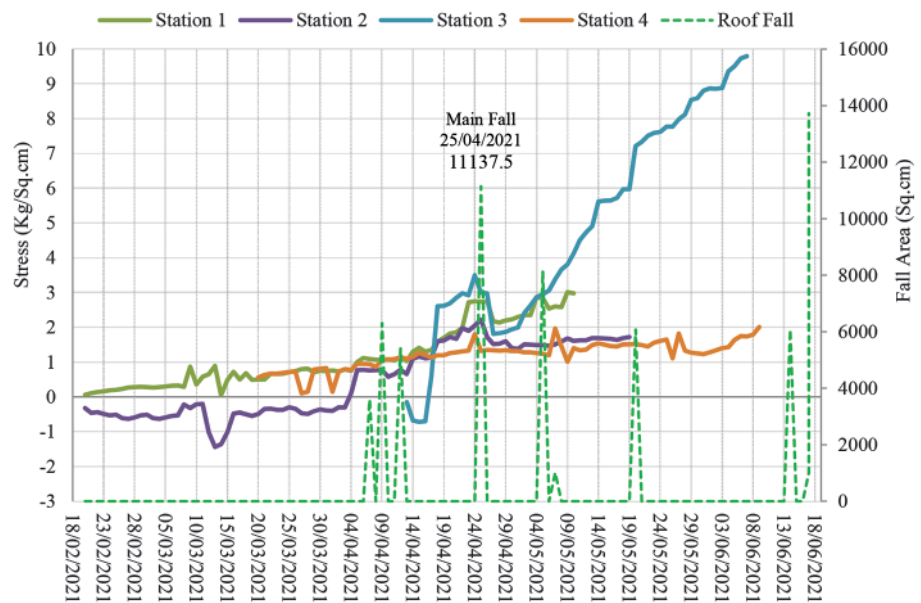
Fig.4 Interpretation between stress and roof fall of 97LE panel

immediately and the panel was sealed after marching CM to the next panel. After that incident, the numbers of instrumentation in the succeeding panels were increased and the readings were interpreted. From the interpretation, it was observed that before every fall only the stress readings of the nearest station show an elevation in the value, but before the main fall, stress readings of all the stations show an increase in their value. The same was observed in all the depillared panels.

Fig.4 shows the interpretation between stress and roof fall in a recently depillared 97LE panel, where the trend in stress readings shows a variation before each fall. Especially on 24/04/2021, before the main fall (25/04/2021) occurred, the trend in all the four stations shows an elevation. Similarly, Figs.5 and 6 show the interpretation between stress and roof fall in earlier depillared panels 110LE and C2 dip respectively.

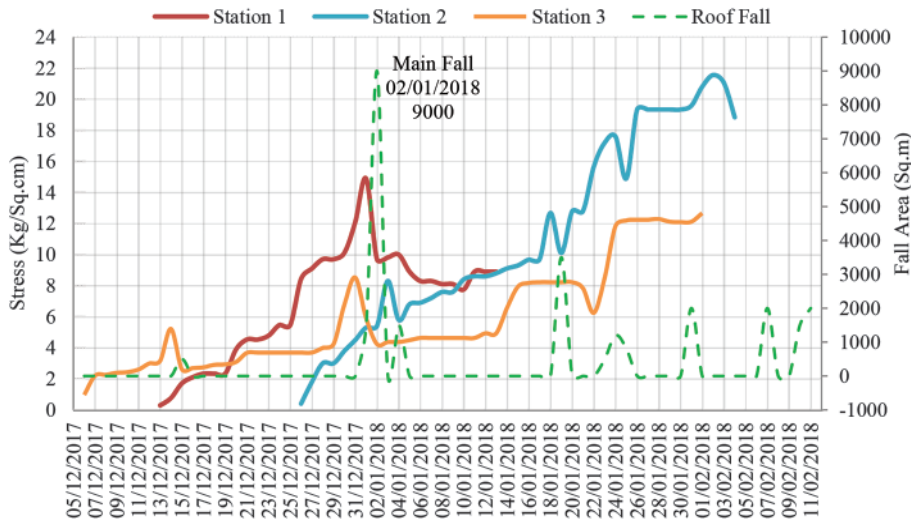
Fig.5: Interpretation between Stress and roof fall of 110LE panel

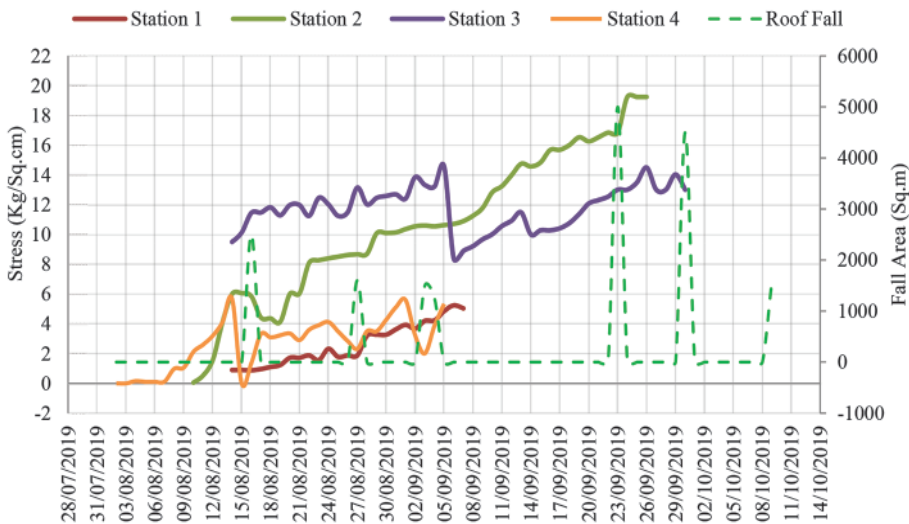
Fig.6: Interpretation between stress and roof fall of C2 Dip panel

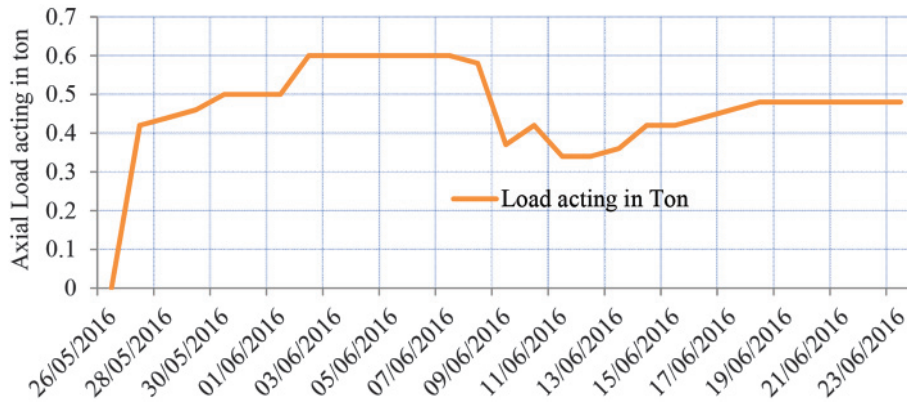
Fig. 7: Interpretation of axial load using Instrumented rock bolt in 124LW panel

128LW/6FX of 124LW panel was chosen for installing an instrumented rock bolt for determination of vertical load acting on roof bolts during main fall. The resulted trend is shown in Fig.7.

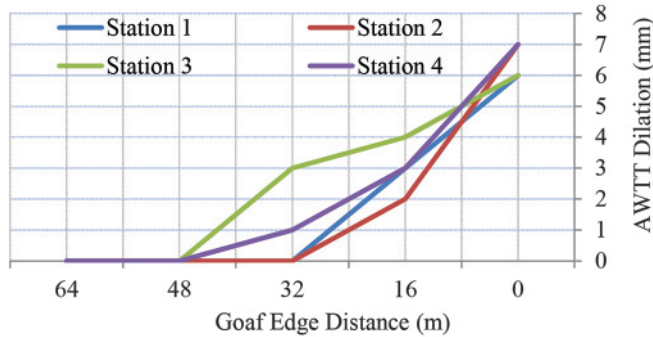
Fig. 8: Interpretation of roof convergence with AWTT dilation in C2 Dip panel

Figs. 8 and 9 shows the convergence observations in the C2 dip panel obtained from AWTT and RTT dilations respectively. The sudden increase of convergence near the zero line is mainly due to the huge abutment pressures during roof fall. At zero line, there is no effective natural support so the convergence shoots up just before the fall.

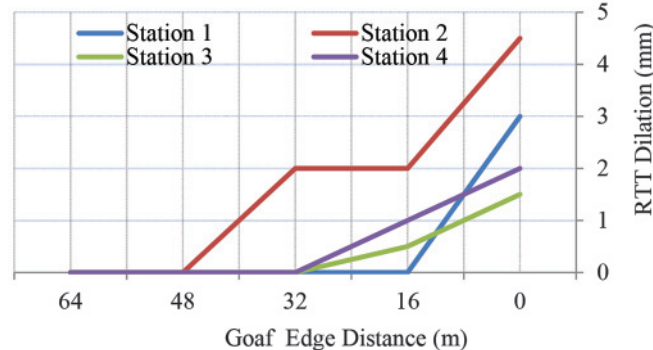
Fig. 9: Interpretation of roof convergence with RTT dilation in C2 Dip panel
